# UTILITY REPORT

**MAY 2023**

**King George County  
Service Authority**

**Authored by:  
Inboden Environmental  
Services, Inc.**

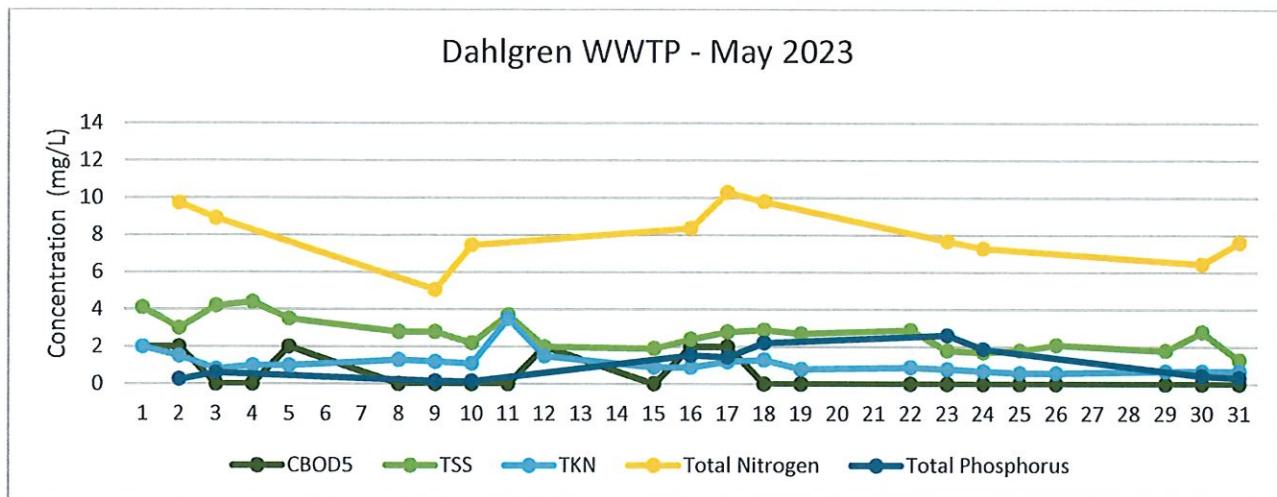
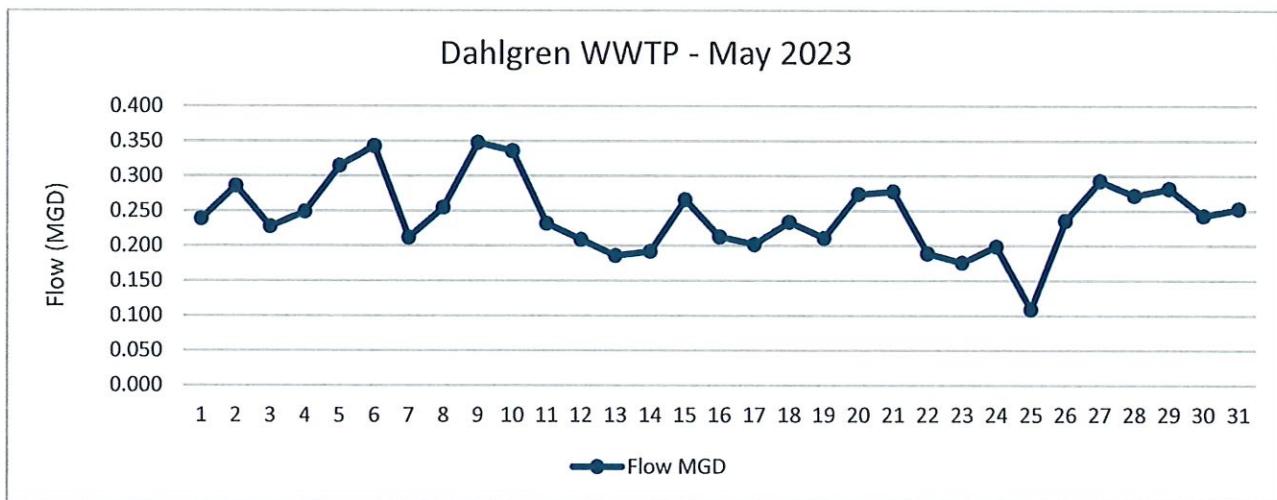
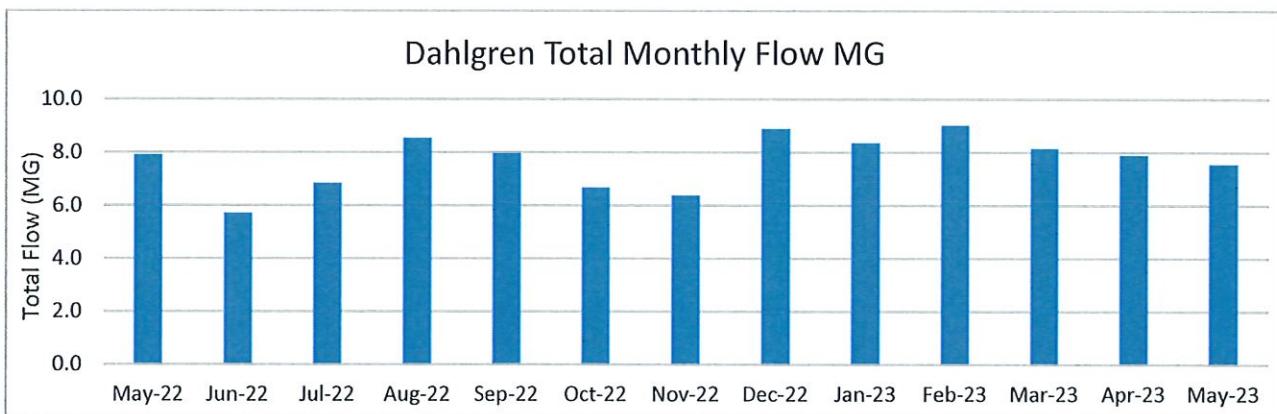
### Data Trending:

The Dahlgren WWTP met the sewer service area's sanitation demand with an average daily discharge of 0.244 MGD and a total monthly discharge of 7.562 MG.

The following charts depict a graphical analysis of effluent quality monitoring and treatment plant daily and total monthly flows.

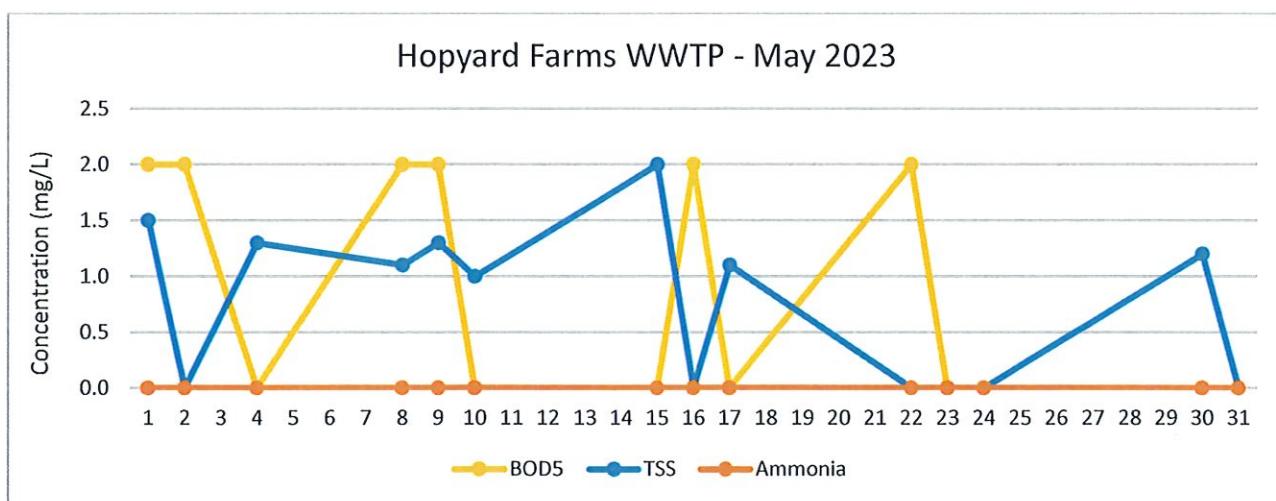
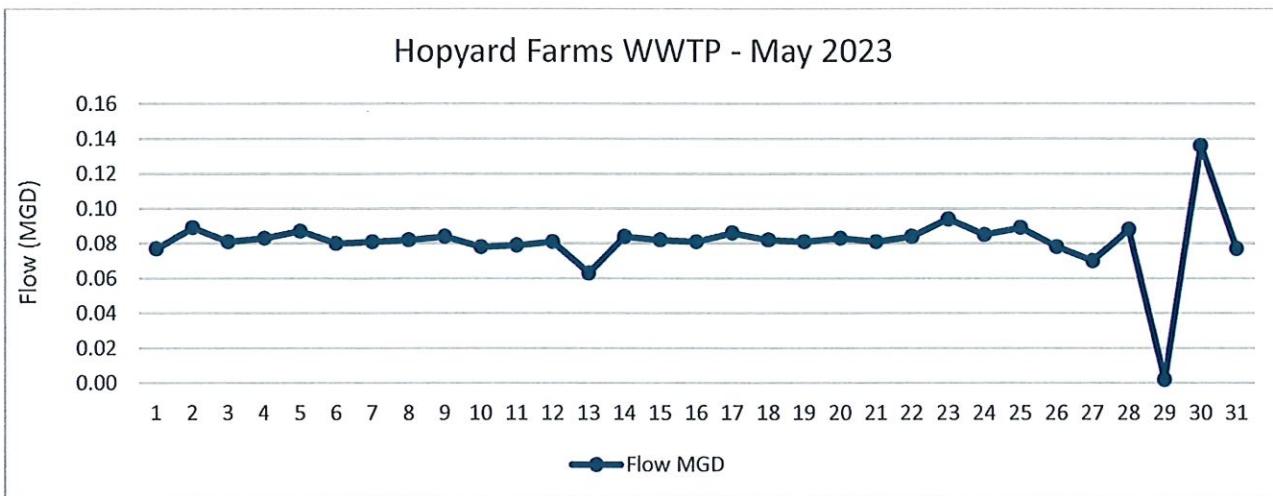
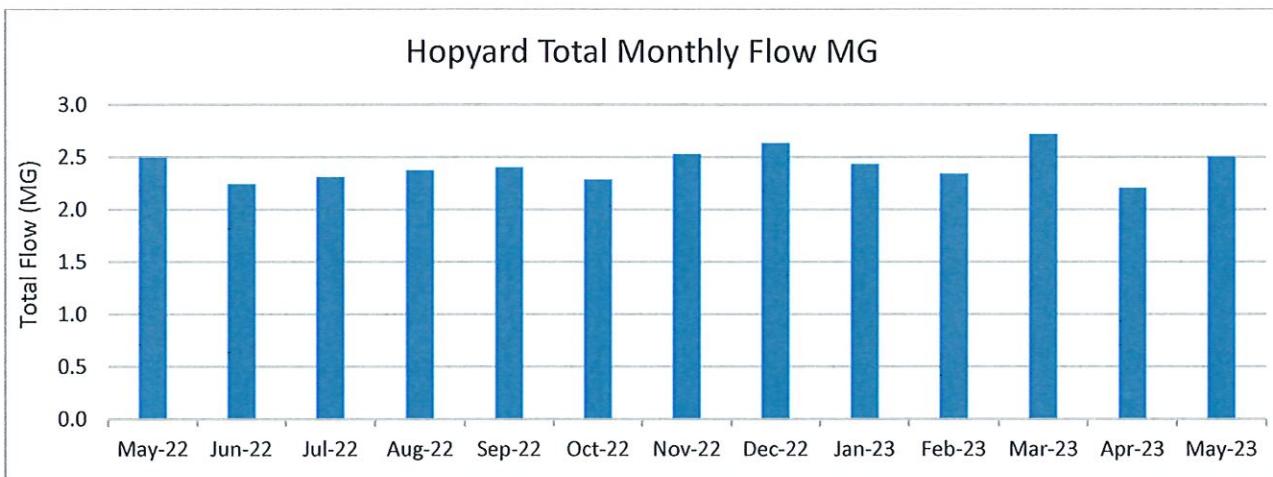
### Data Trending:

The Hopyard WWTP met the sewer service area's sanitation demand with an average daily discharge of 0.081 MGD and a total monthly discharge of 2.507 MG.

The following charts depict a graphical analysis of effluent quality monitoring and treatment plant daily and total monthly flows.

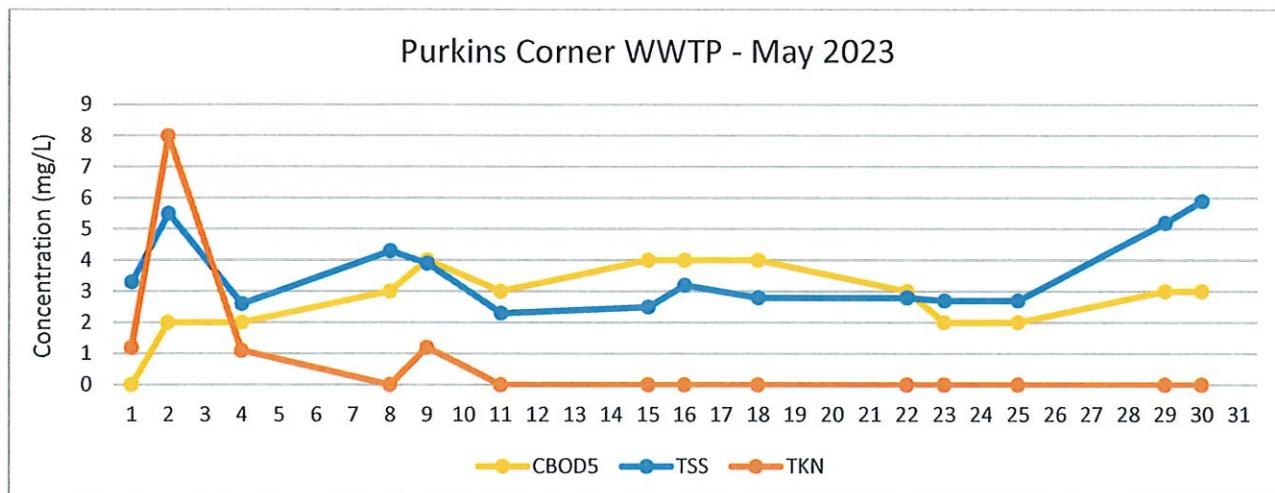
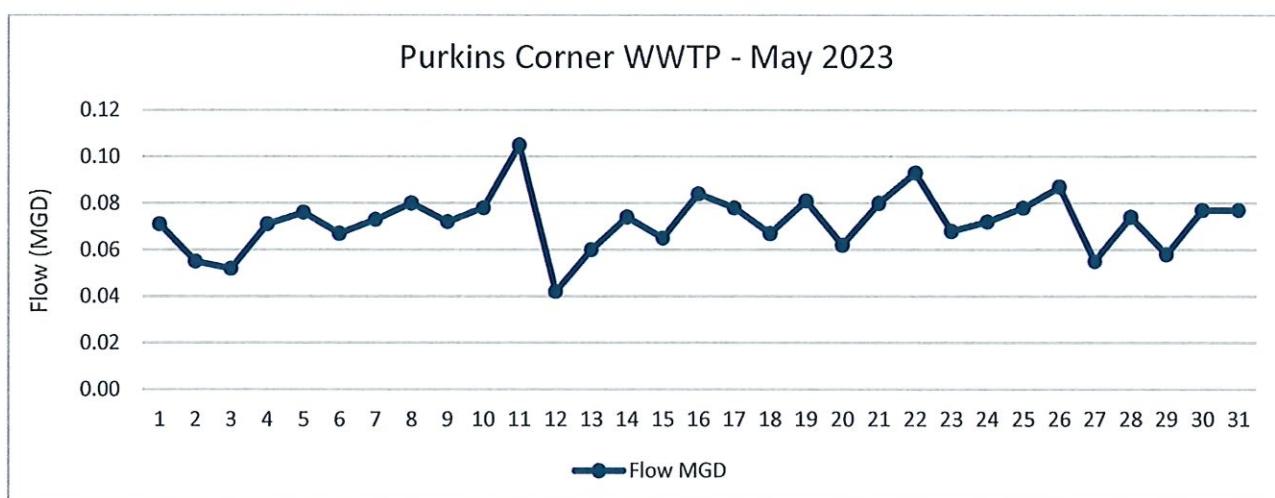
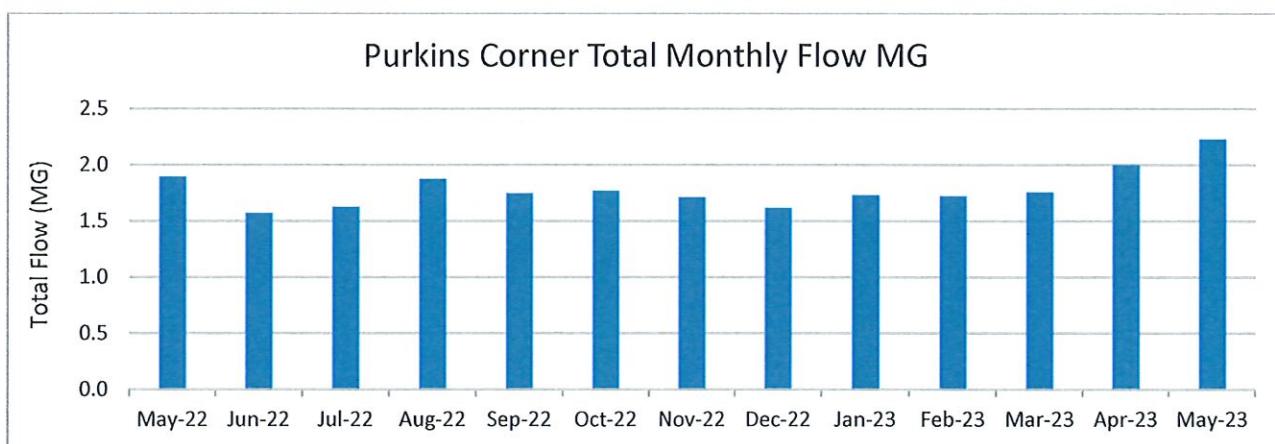
## Data Trending:

The Purkins Corner WWTP met the sewer service area's sanitation demand with an average daily discharge of 0.072 MGD and a total monthly discharge of 2.232 MG.

The following charts depict a graphical analysis of effluent quality monitoring and treatment plant daily and total monthly flows.

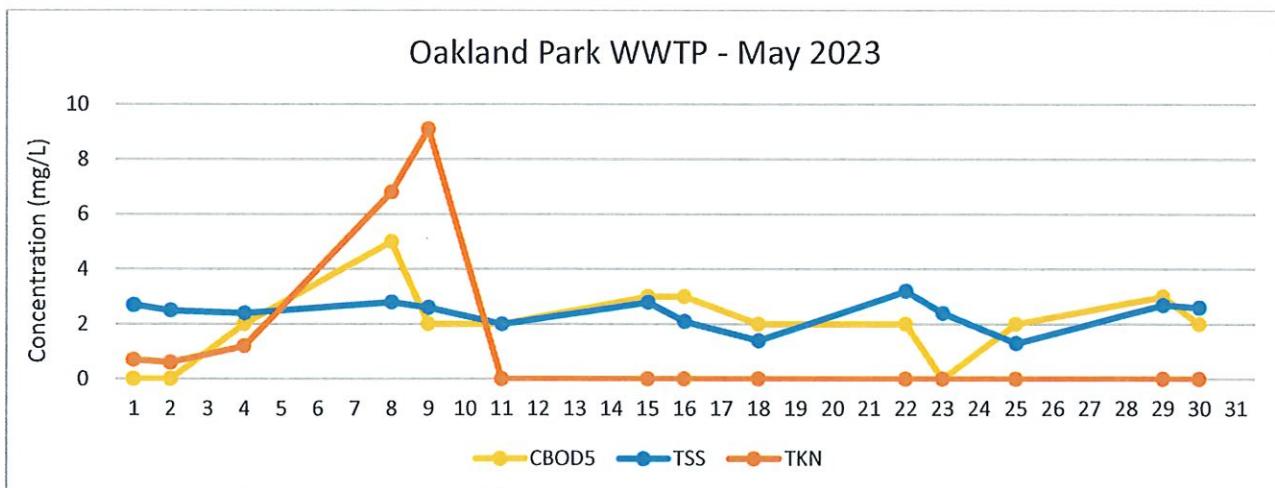
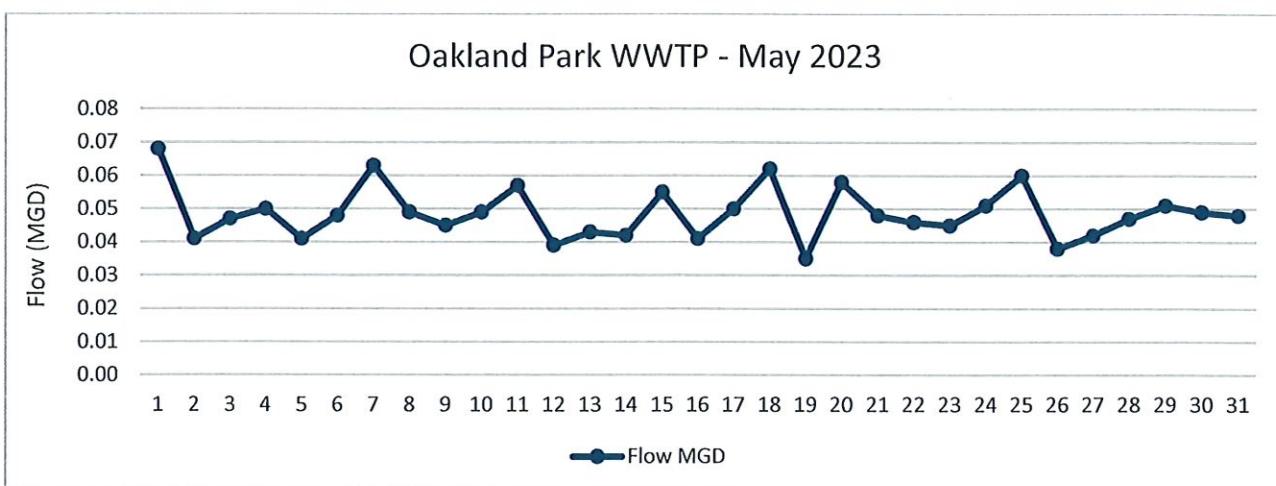
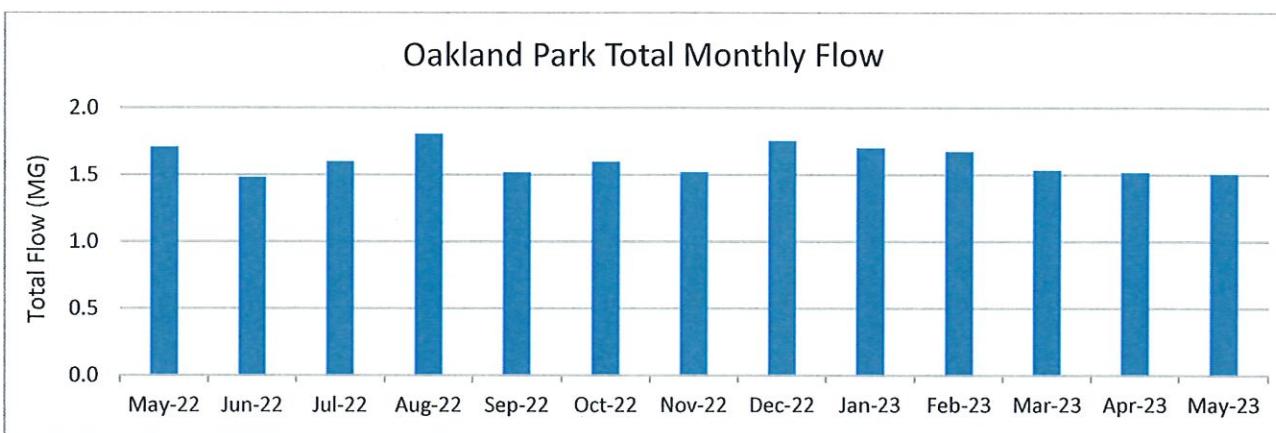
### Data Trending:

The wastewater treatment facility operated well for the most part of the month. However, issues with the Bio-Carb feed system combined with electrical issues on the anoxic mixer, the facility exceeded the weekly average concentration of 5.30 mg/L. Chemical feed and electrical system repairs were made resulting in subsequent TKN sampling to be within compliance.

The Oakland Park WWTP met the sewer service area's sanitation demand with an average daily discharge of 0.049 MGD and a total monthly discharge of 1.508 MG.

The following charts depict a graphical analysis of effluent quality monitoring and treatment plant daily and total monthly flows.

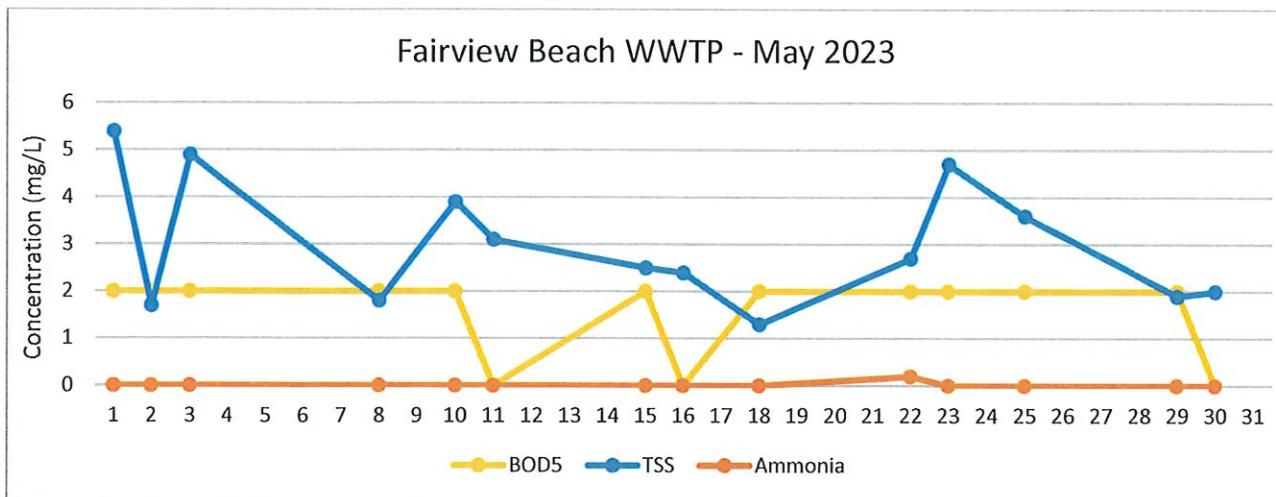
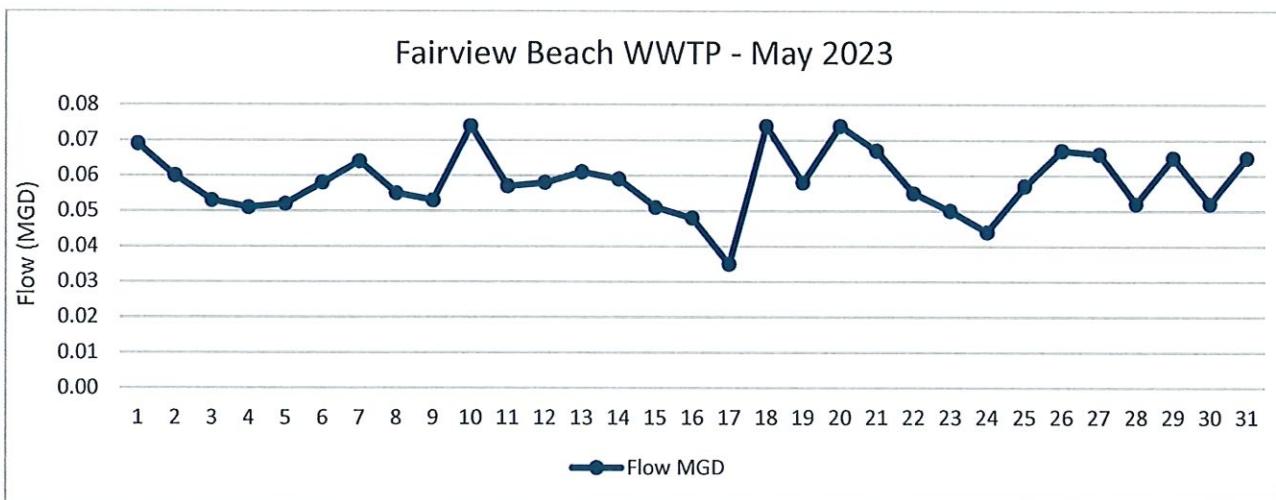
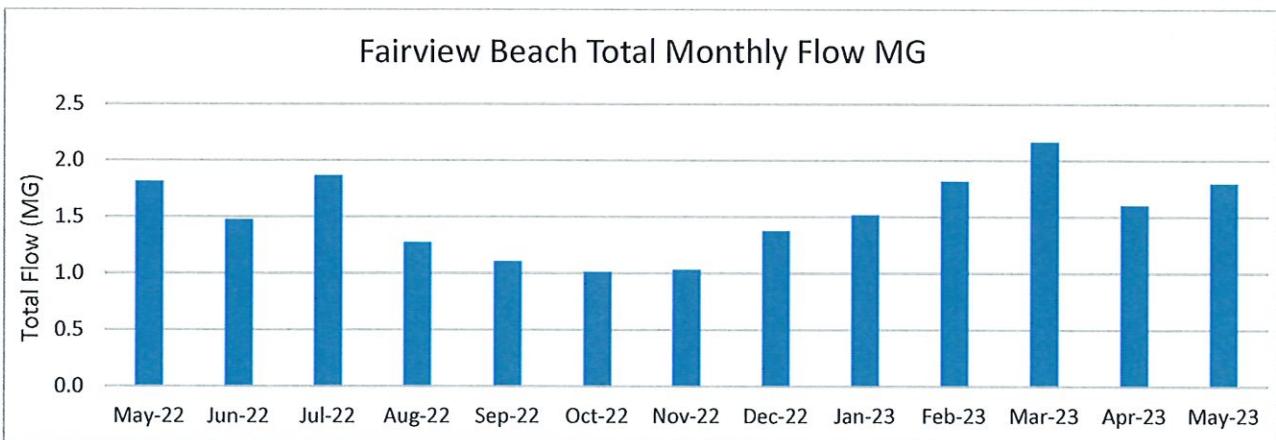
## Data Trending:

The Fairview Beach WWTP met the sewer service area's sanitation demand with an average daily discharge of 0.058 MGD and a total monthly discharge of 1.801 MG.

The following charts depict a graphical analysis of effluent quality monitoring and treatment plant daily and total monthly flows.
