UTILITY REPORT

JUNE 2023

King George County
Service Authority

Authored by:
Inboden Environmental
Services, Inc.

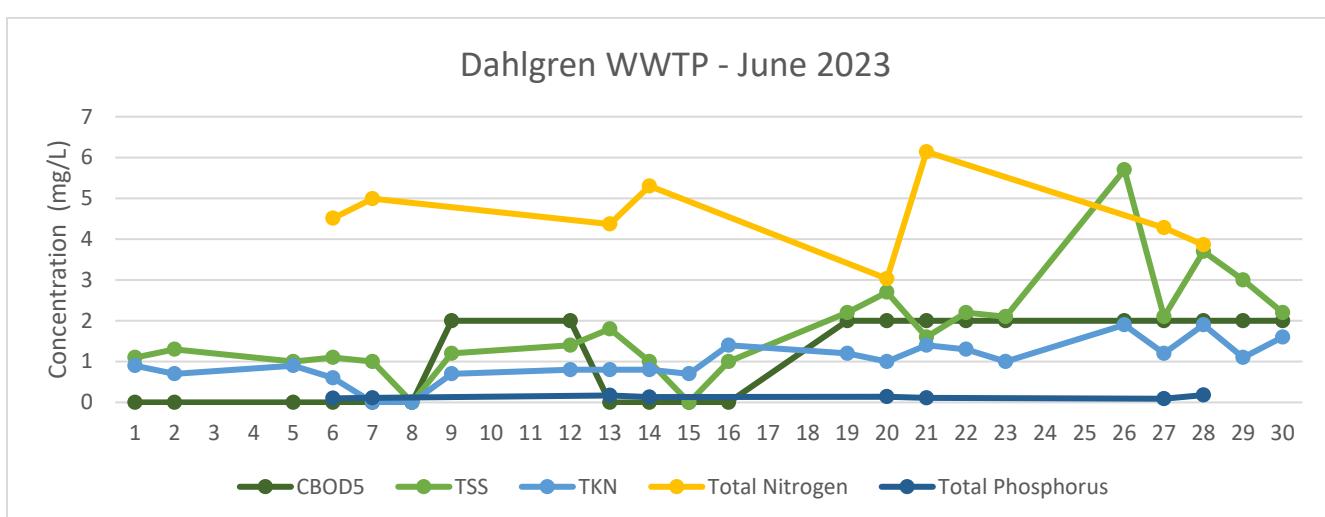
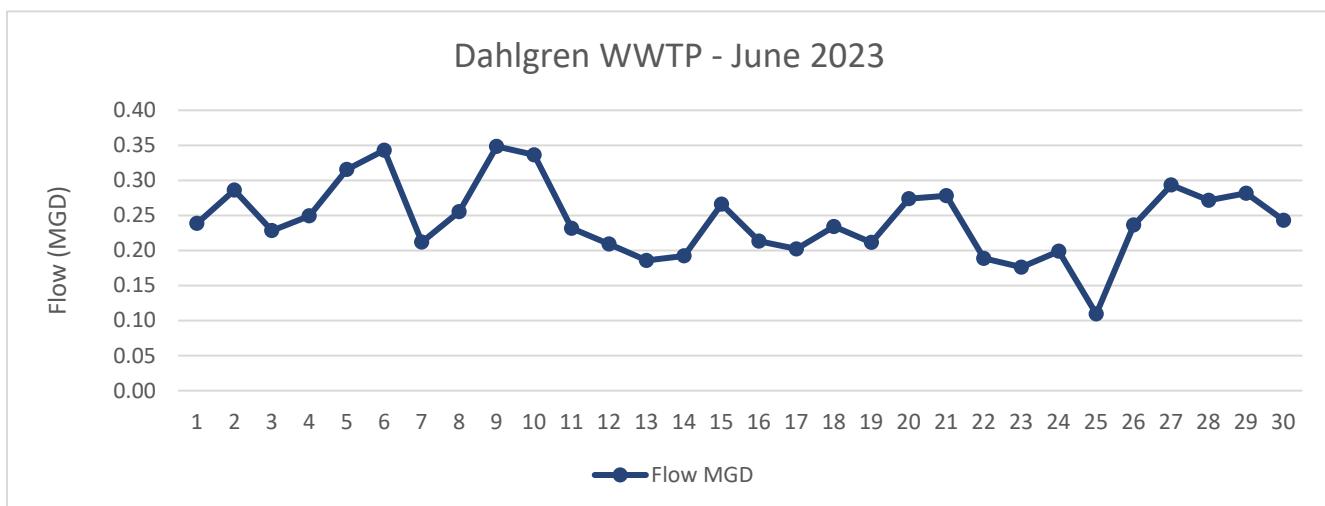
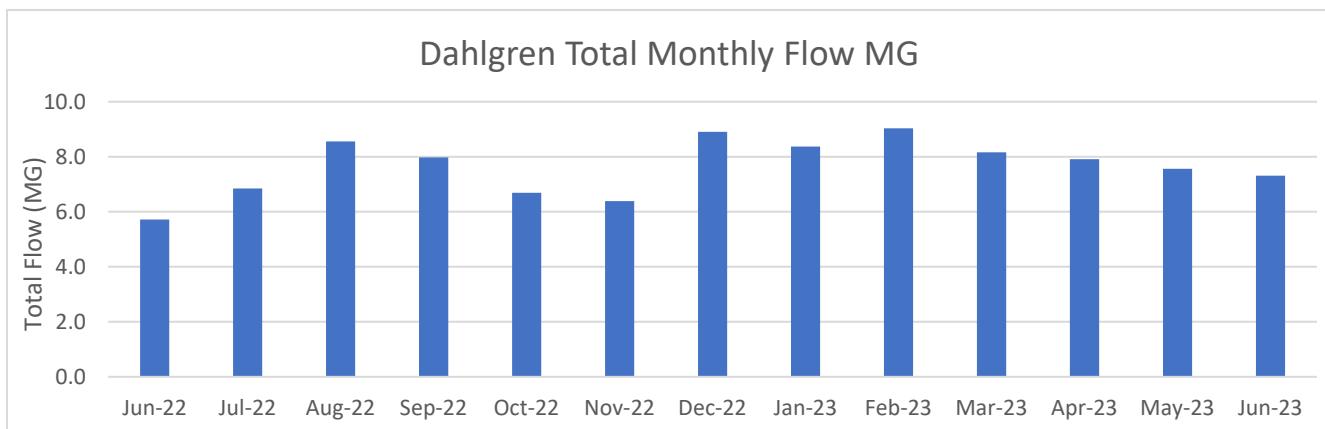
The Dahlgren WWTP met the sewer service area's sanitation demand with an average daily discharge of 0.244 MGD and a total monthly discharge of 7.309 MG.

The following charts depict a graphical analysis of effluent quality monitoring and treatment plant daily and total monthly flows.

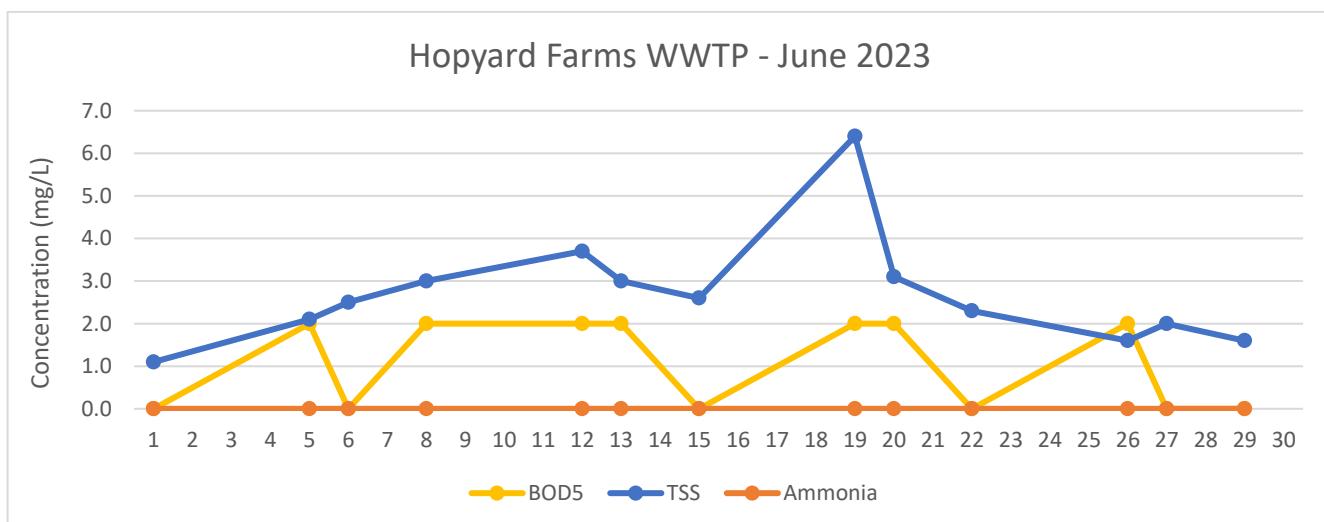
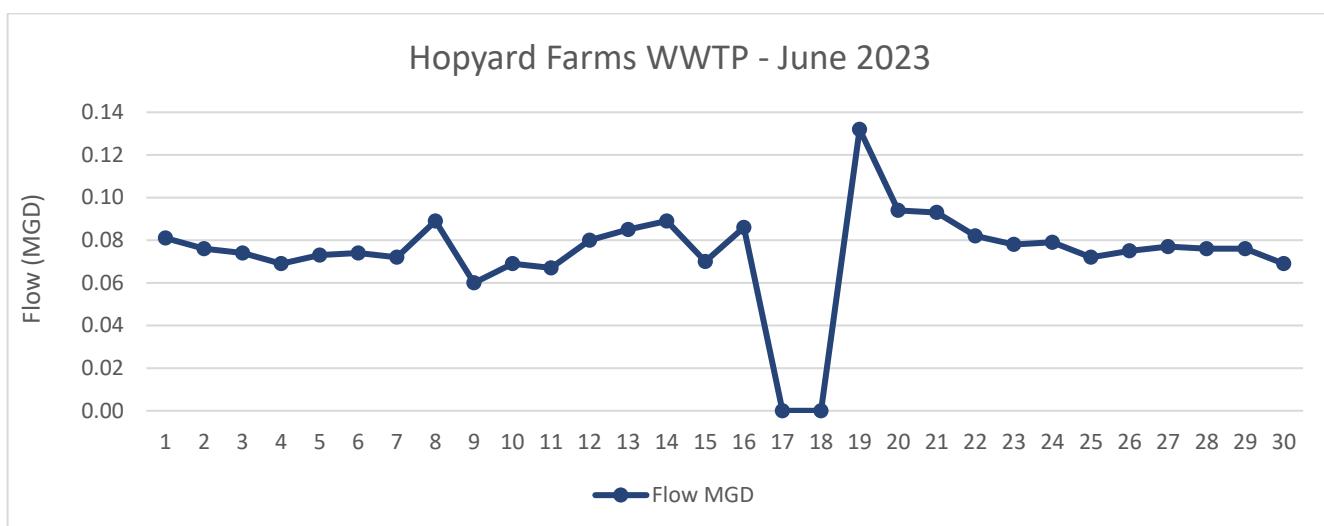
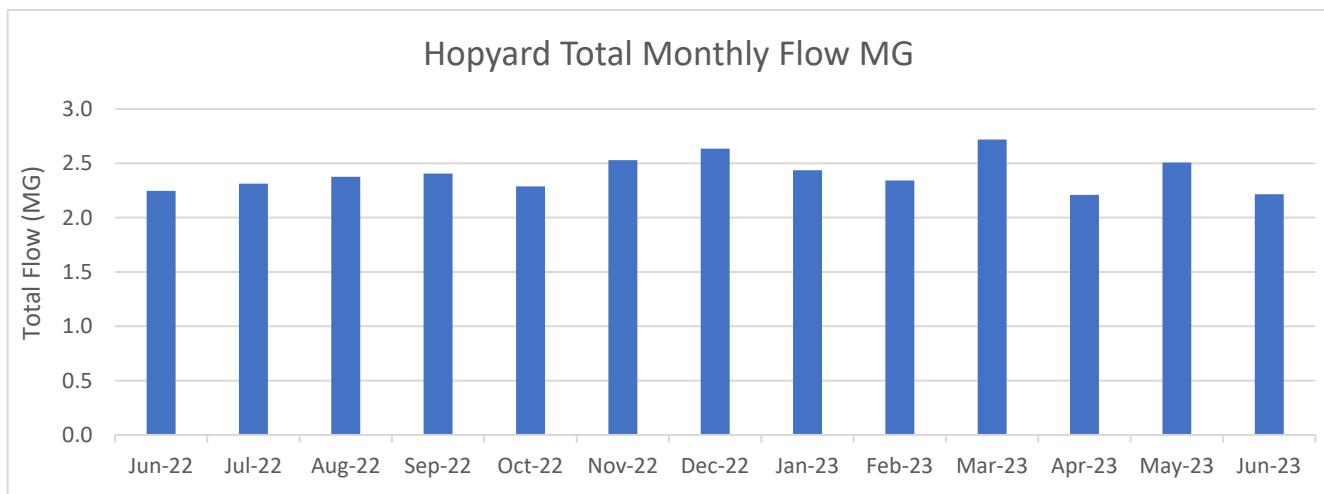
The Hopyard WWTP met the sewer service area's sanitation demand with an average daily discharge of 0.074 MGD and a total monthly discharge of 2.216 MG.

The following charts depict a graphical analysis of effluent quality monitoring and treatment plant daily and total monthly flows.

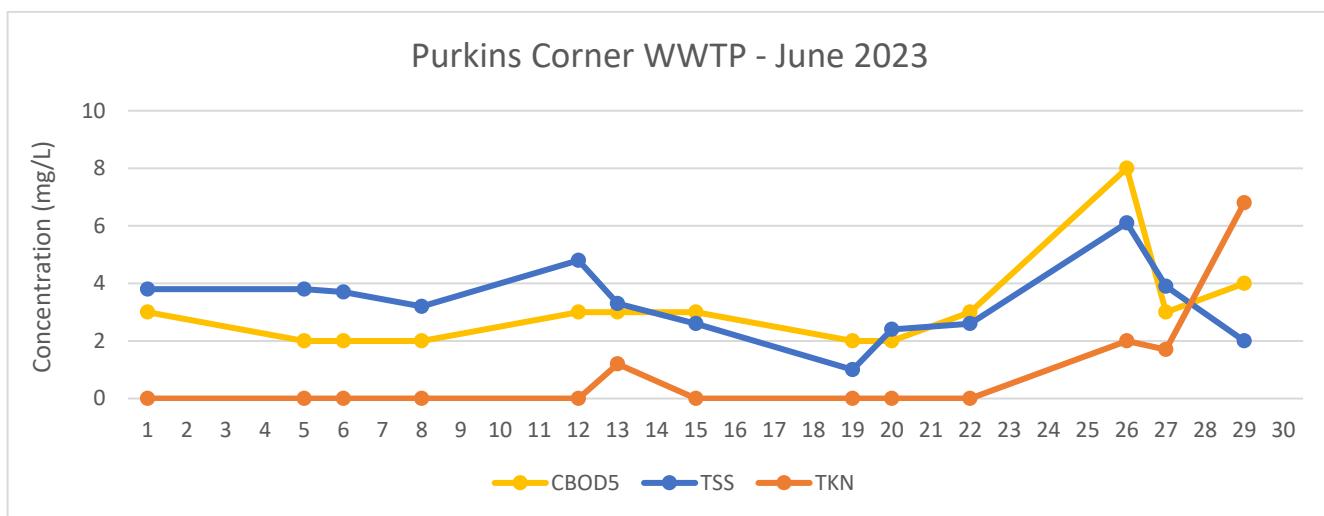
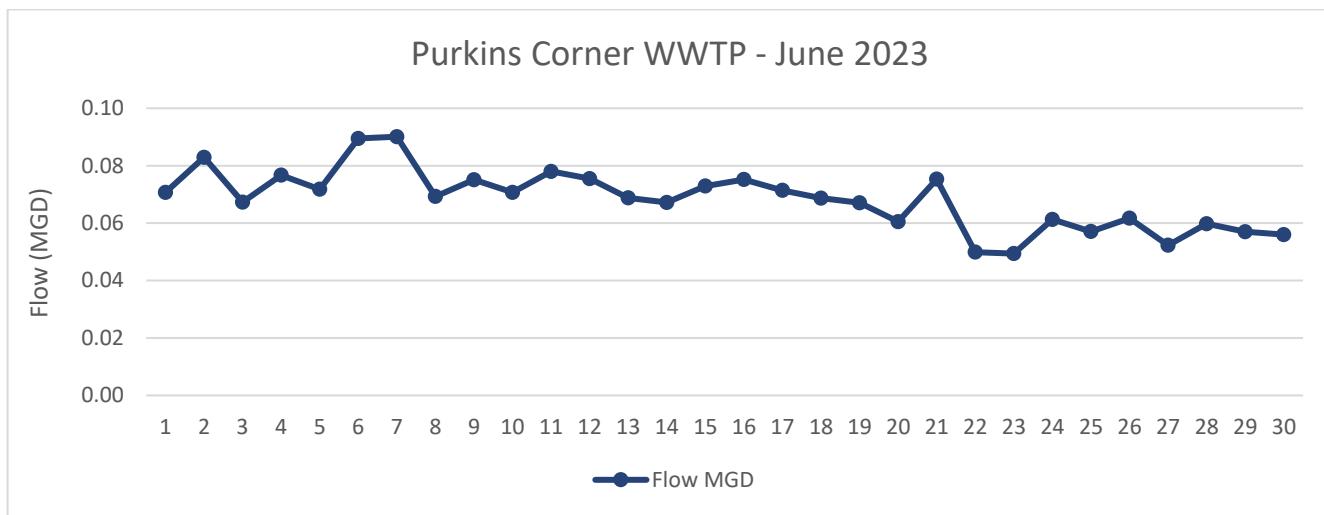
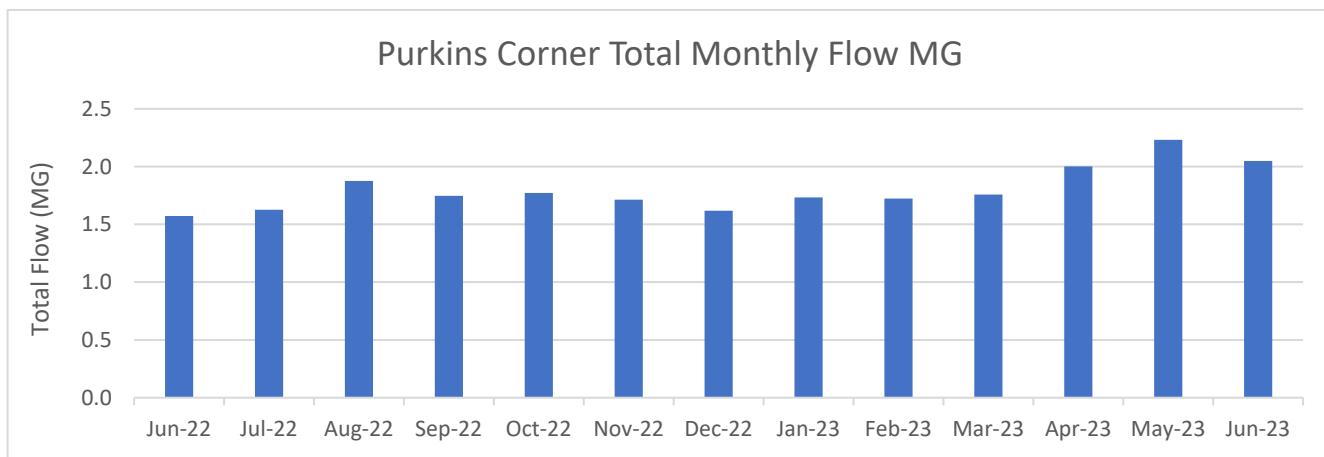
The Purkins Corner WWTP met the sewer service area's sanitation demand with an average daily discharge of 0.068 MGD and a total monthly discharge of 2.049 MG.

The following charts depict a graphical analysis of effluent quality monitoring and treatment plant daily and total monthly flows.

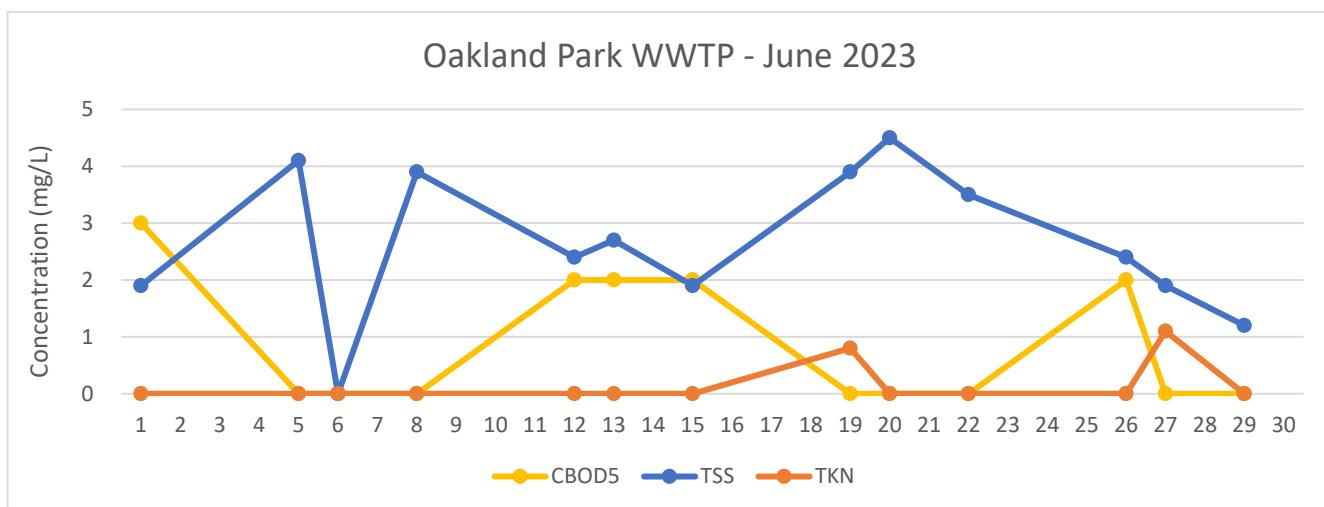
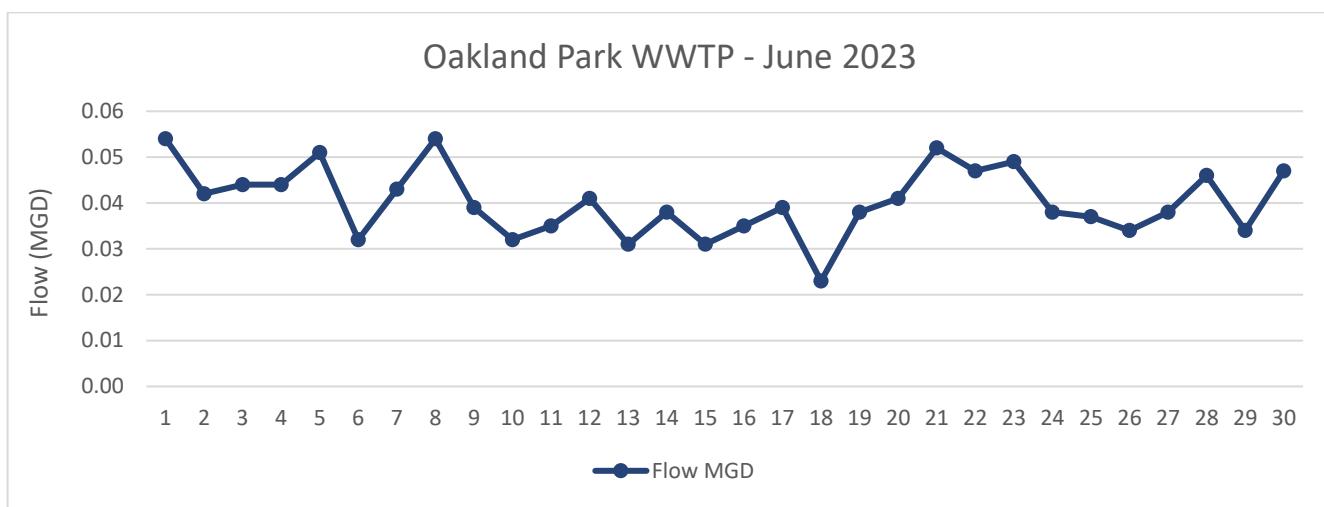
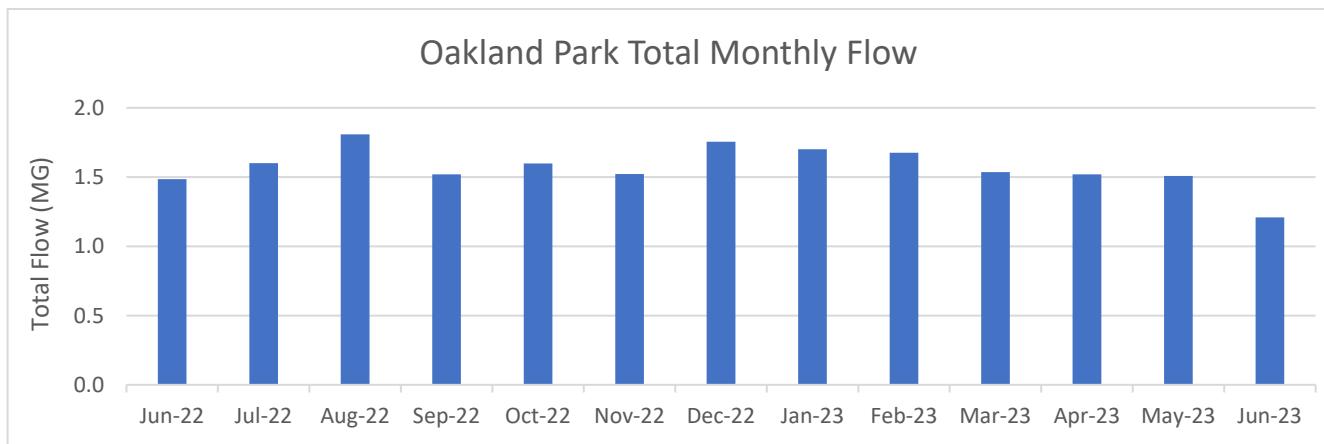
The Oakland Park WWTP met the sewer service area's sanitation demand with an average daily discharge of 0.040 MGD and a total monthly discharge of 1.209 MG.

The following charts depict a graphical analysis of effluent quality monitoring and treatment plant daily and total monthly flows.

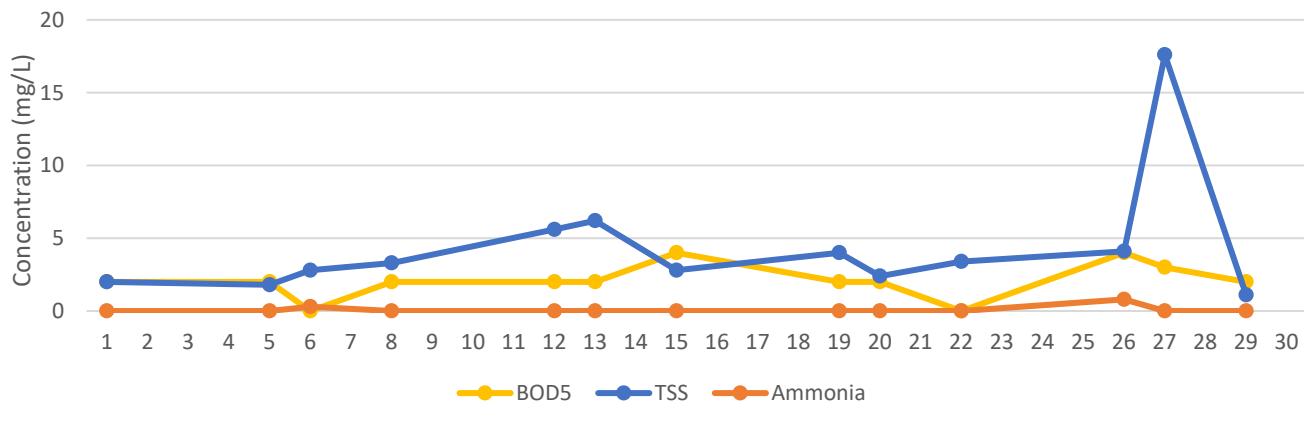
Fairview Beach WWTP - June 2023

The Fairview Beach WWTP met the sewer service area's sanitation demand with an average daily discharge of 0.058 MGD and a total monthly discharge of 1.740 MG.

The following charts depict a graphical analysis of effluent quality monitoring and treatment plant daily and total monthly flows.
