# UTILITY REPORT

**AUGUST 2023**

**King George County  
Service Authority**

**Authored by:  
Inboden Environmental  
Services, Inc.**

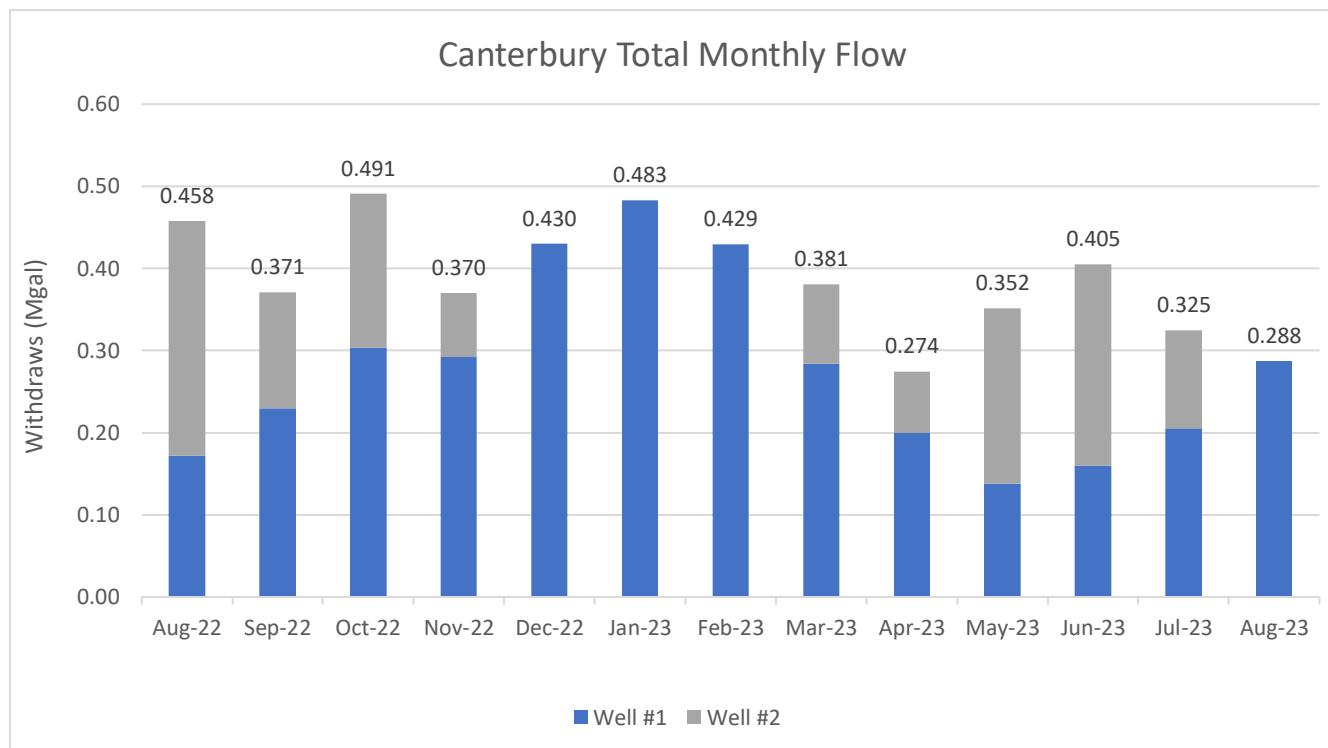
### System Production:

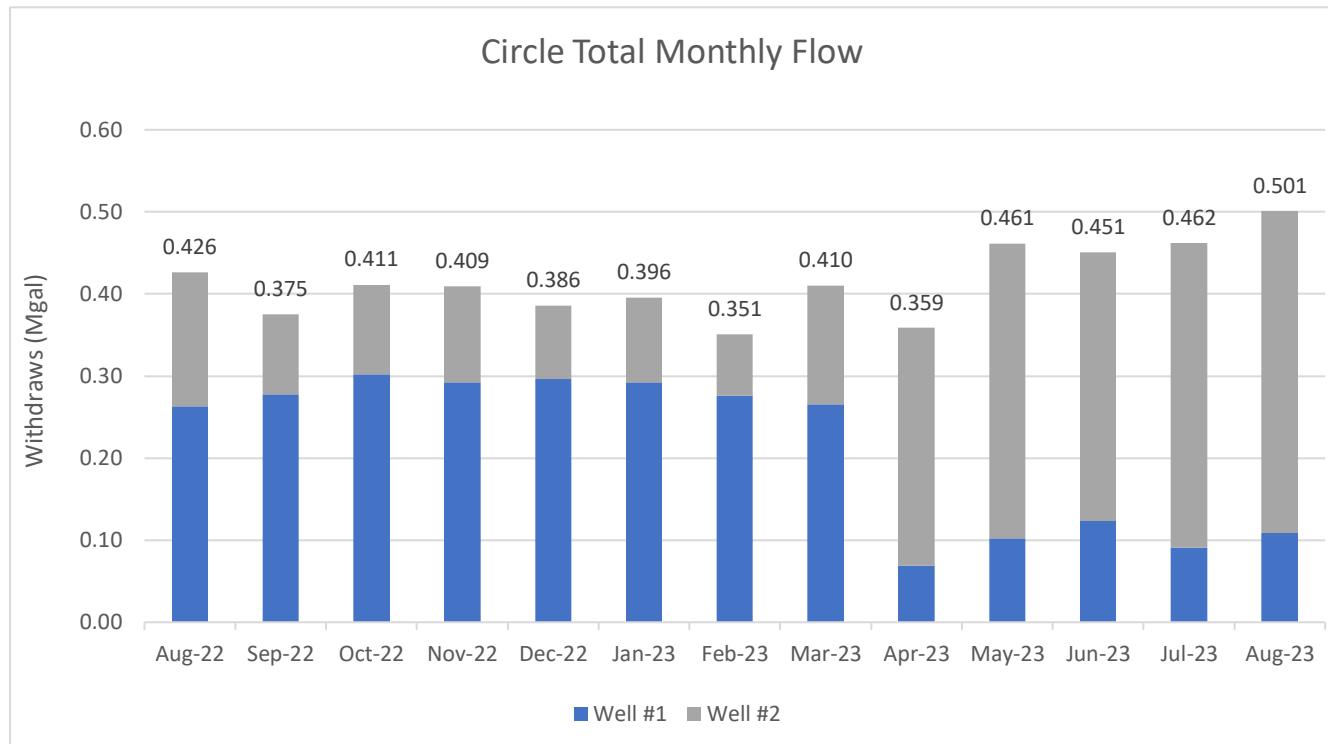
### System Production:

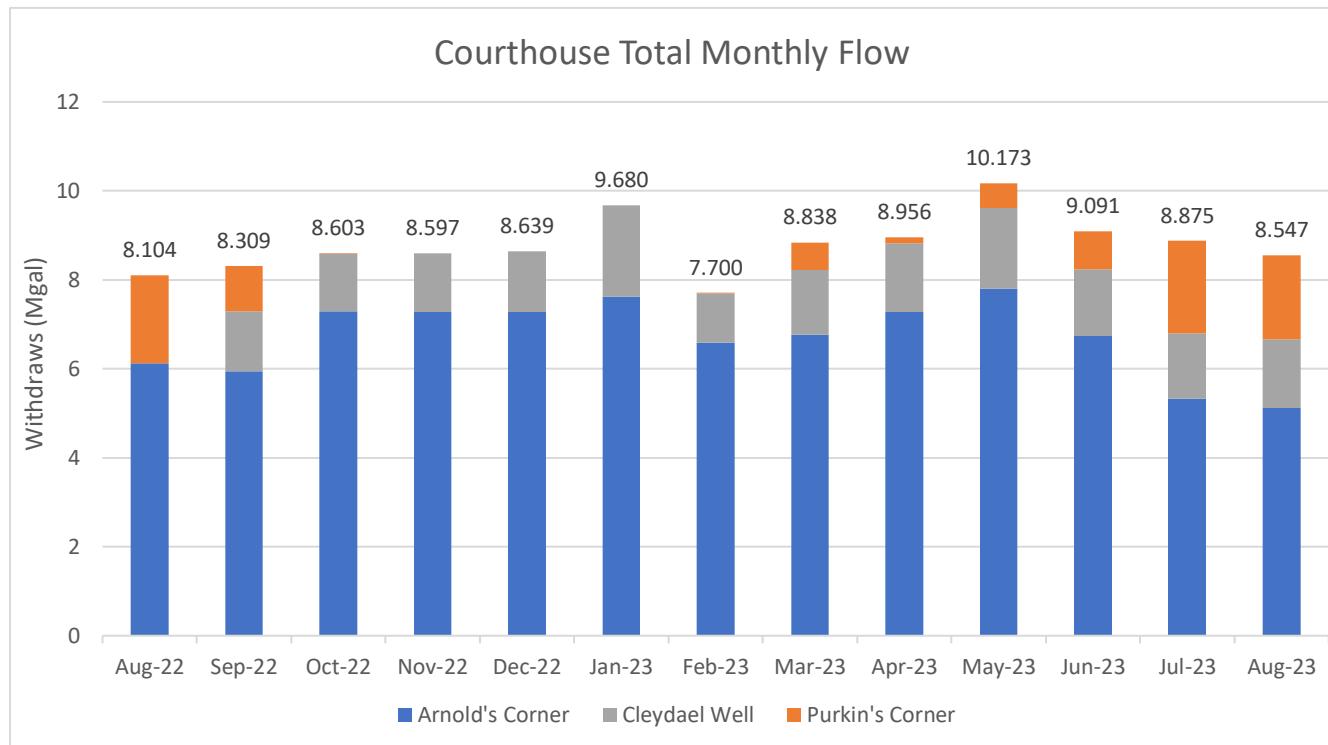
## System Production:

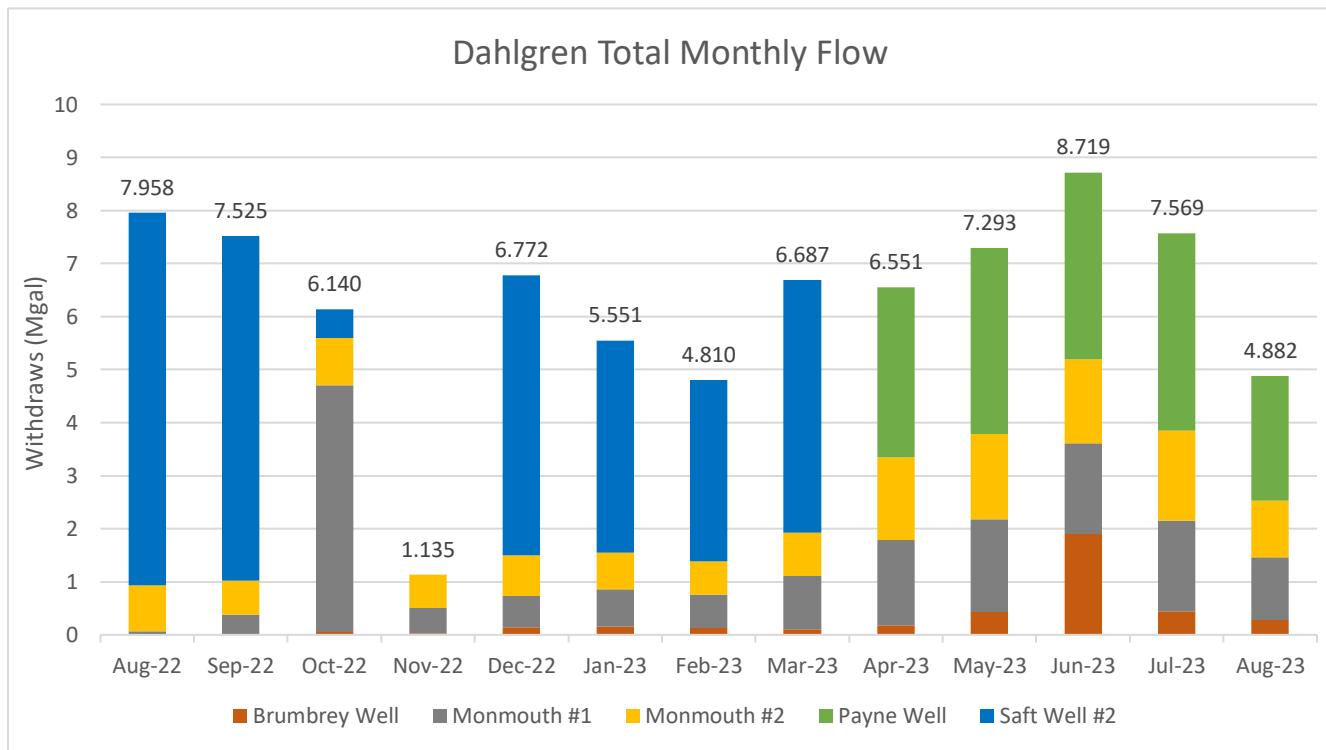
## System Production:

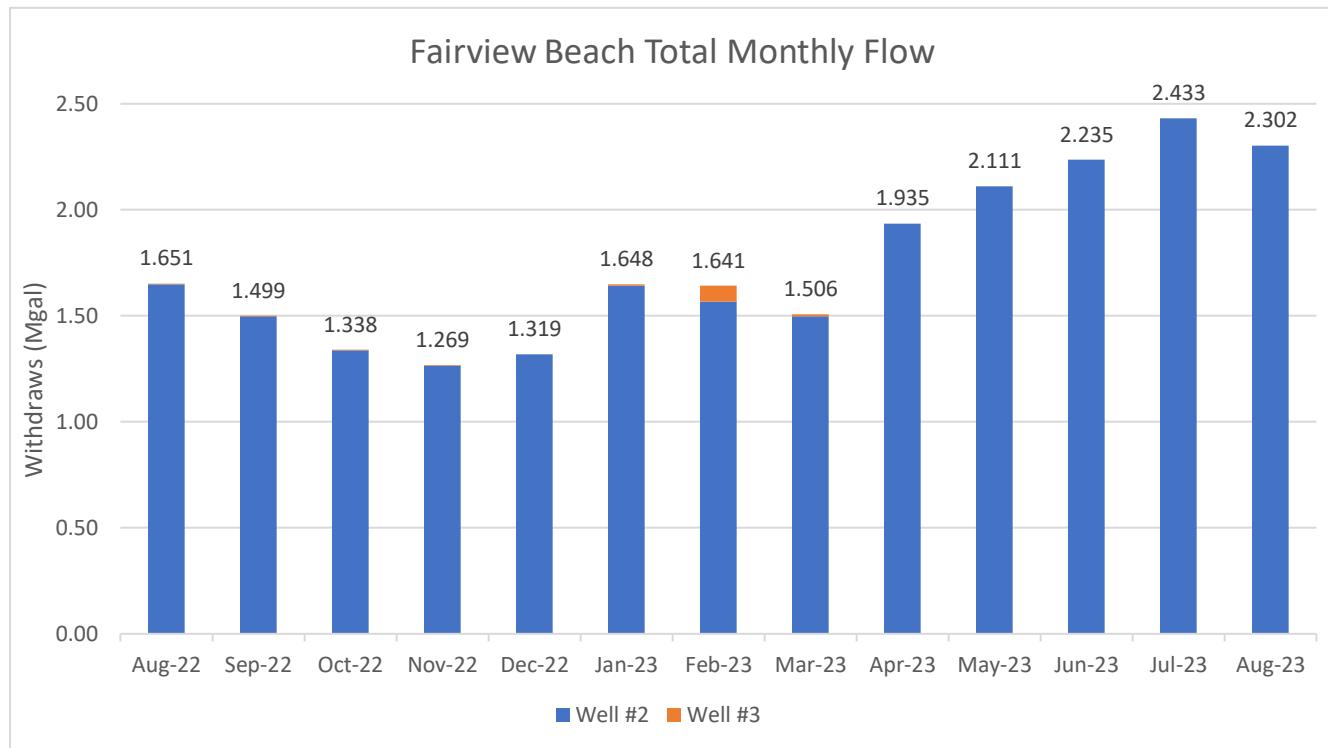
### System Production:

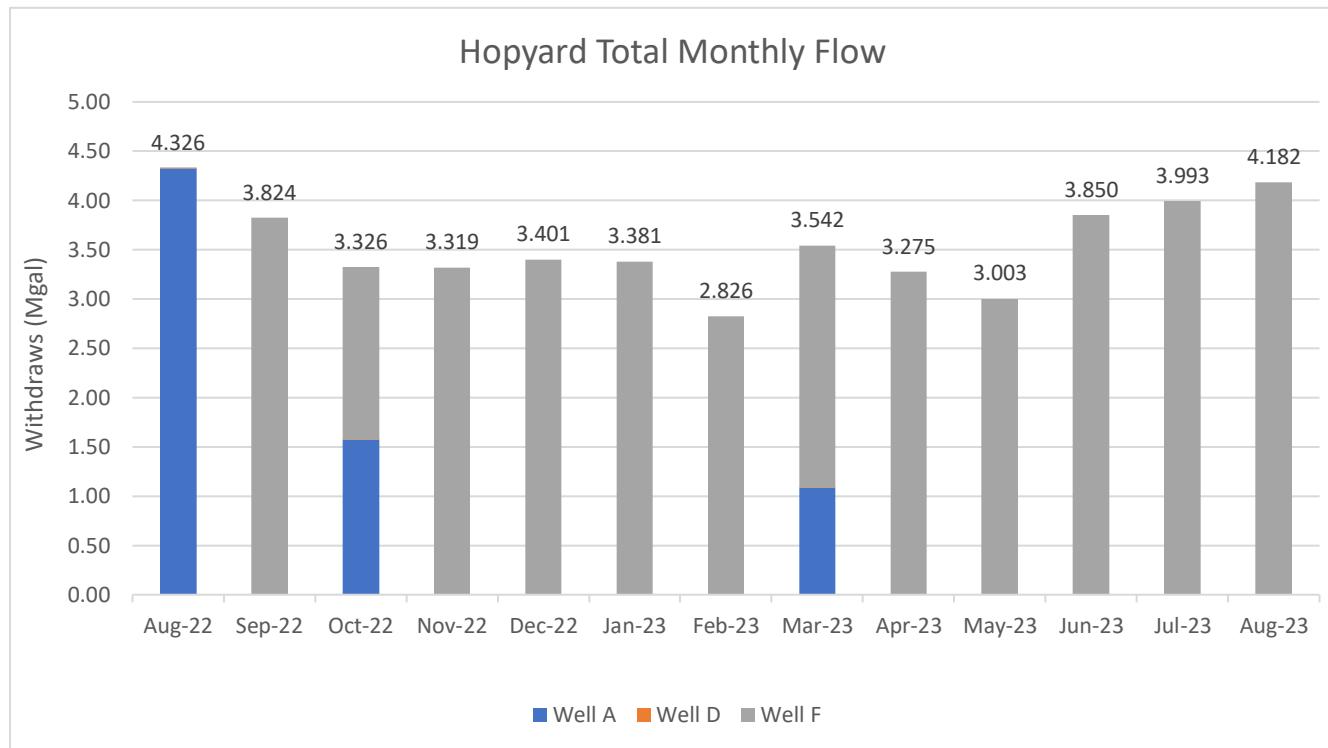
## System Production:

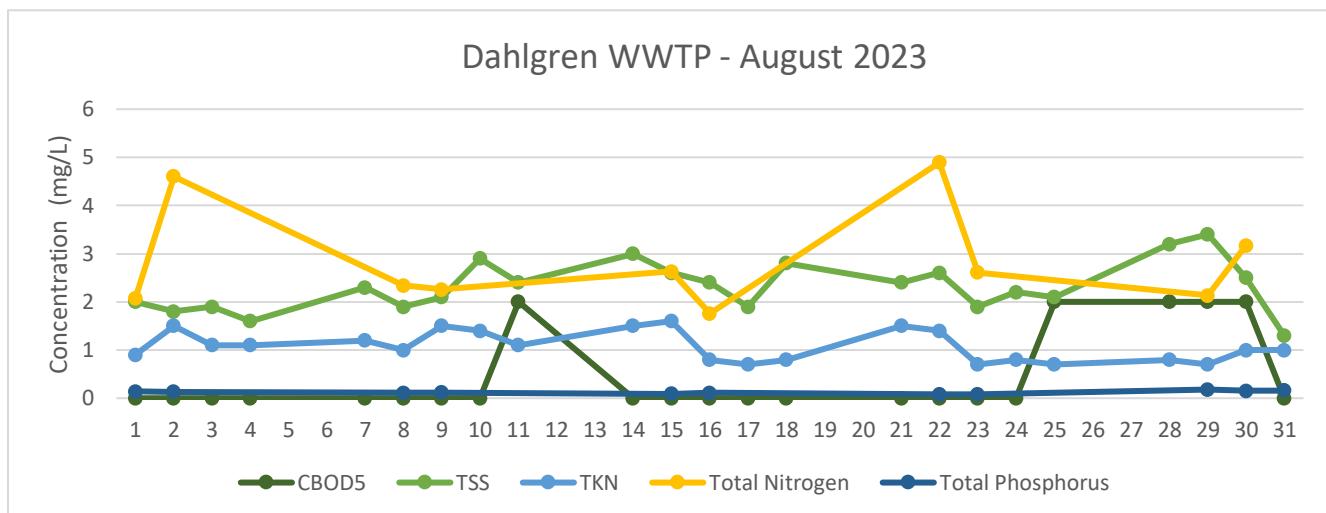
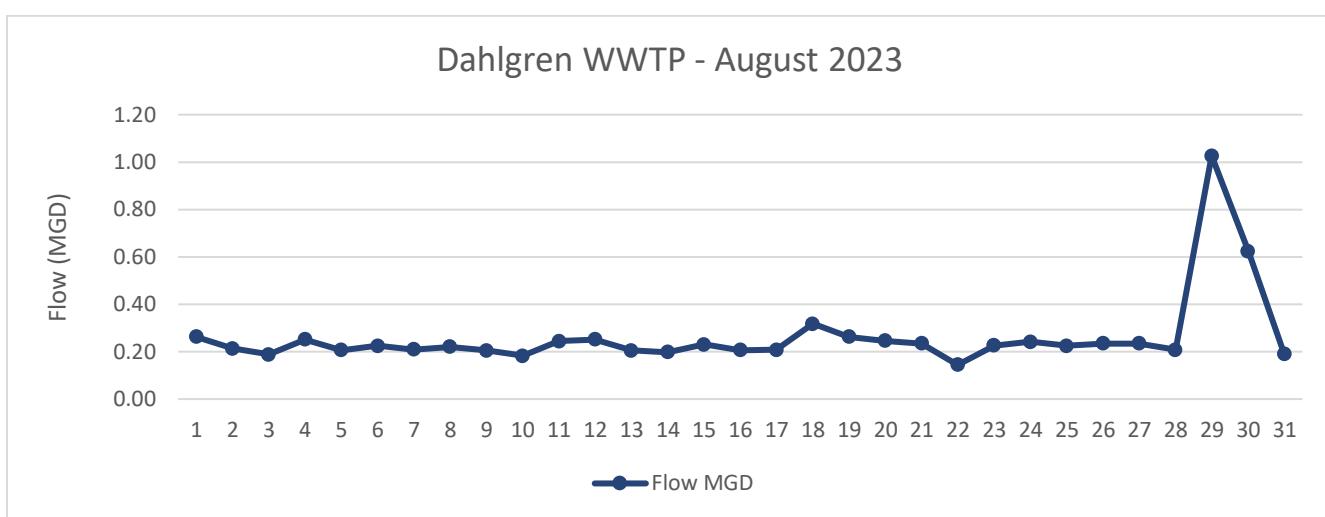
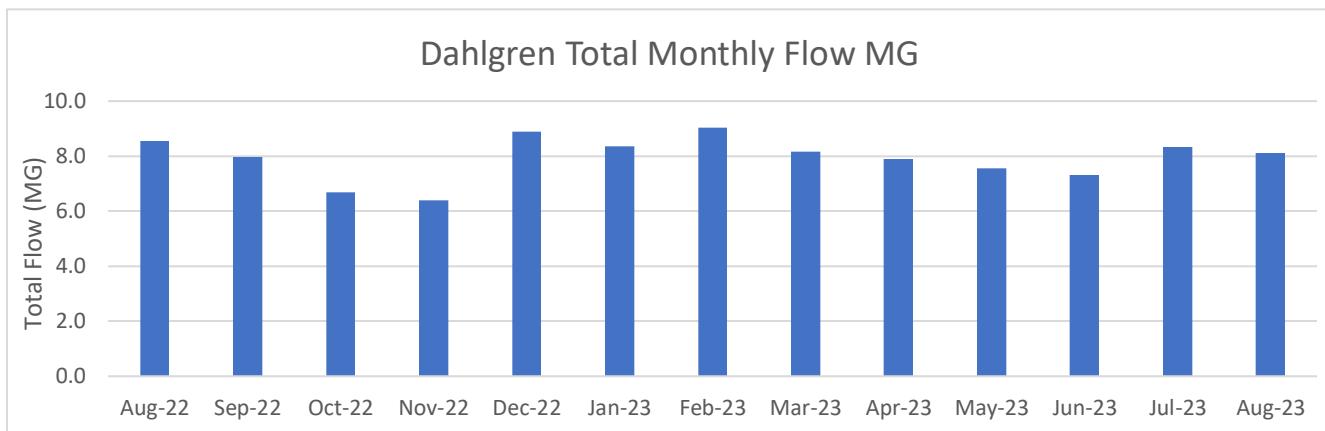
The Dahlgren WWTP met the sewer service area's sanitation demand with an average daily discharge of 0.262 MGD and a total monthly discharge of 8.122 MG.

The following charts depict a graphical analysis of effluent quality monitoring and treatment plant daily and total monthly flows.

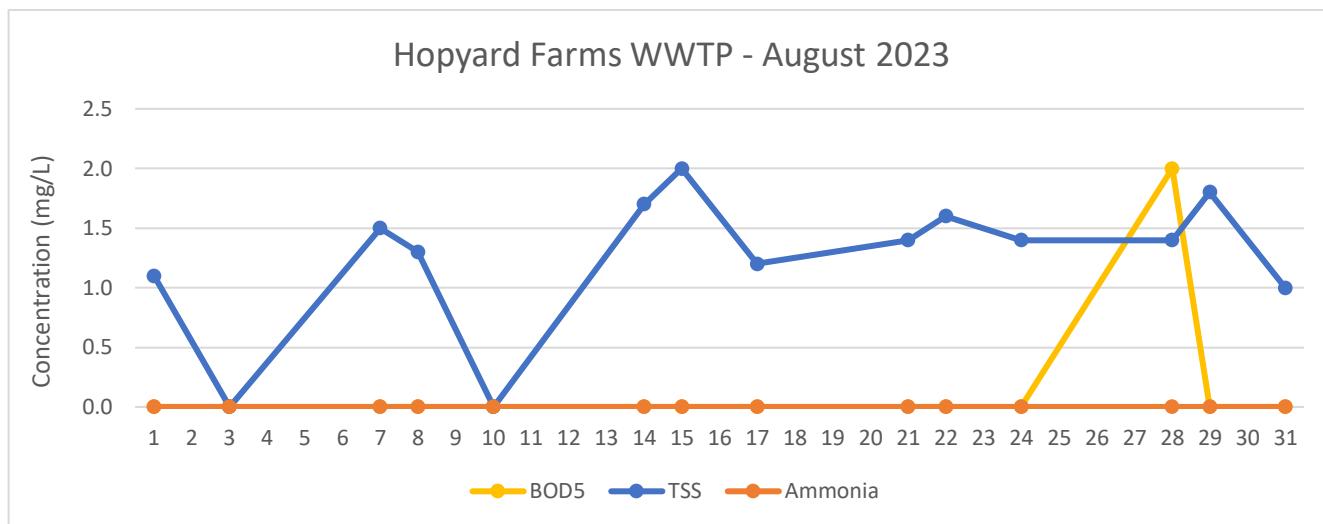
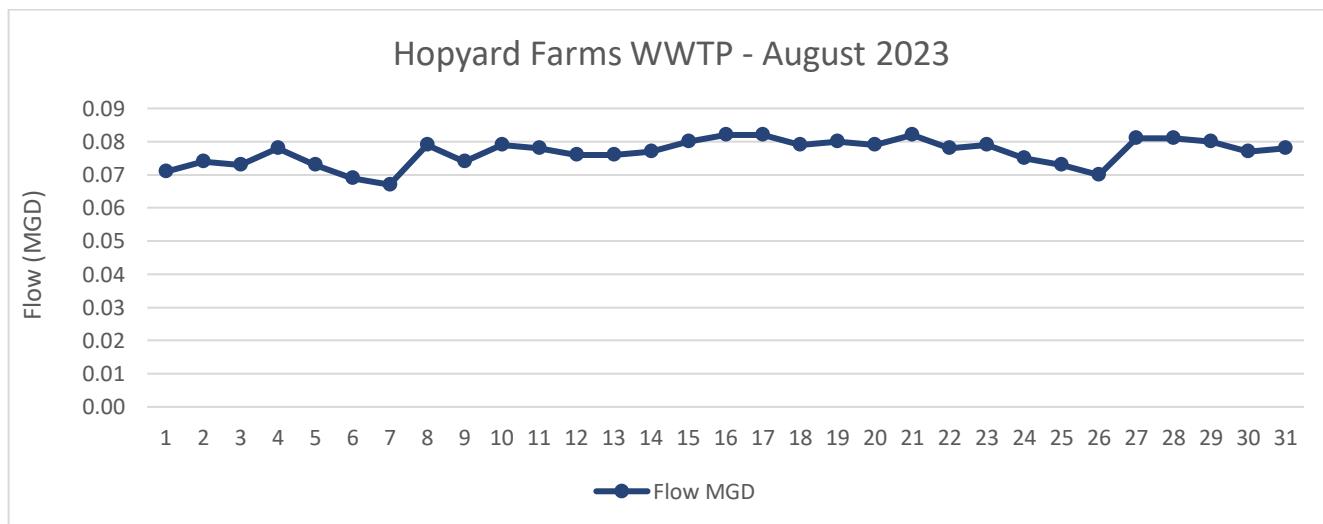
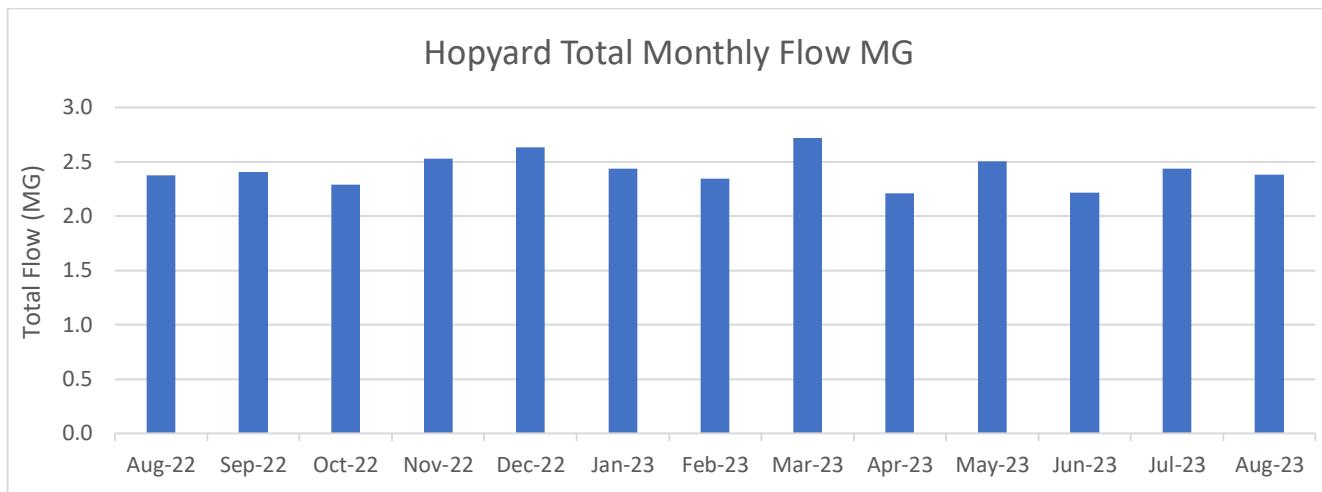
The Hopyard WWTP met the sewer service area's sanitation demand with an average daily discharge of 0.077 MGD and a total monthly discharge of 2.380 MG.

The following charts depict a graphical analysis of effluent quality monitoring and treatment plant daily and total monthly flows.

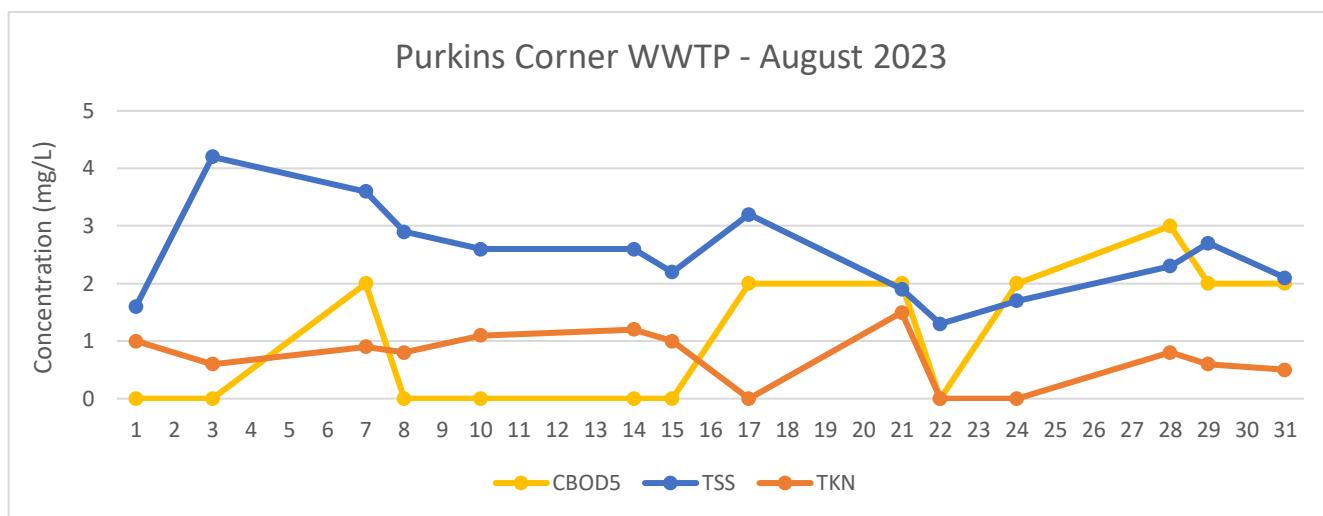
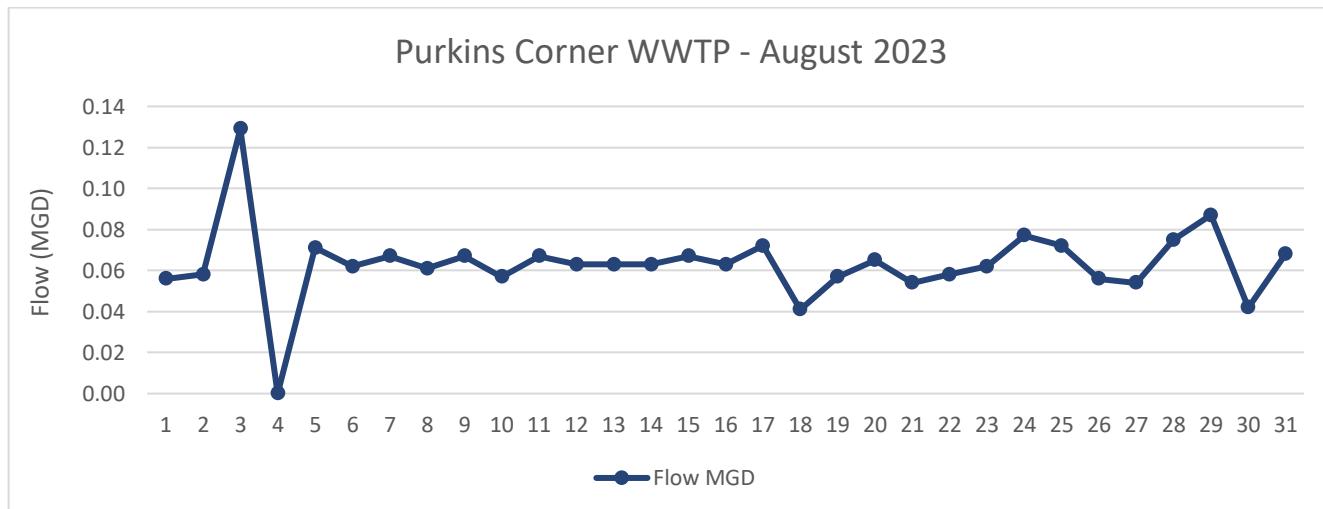
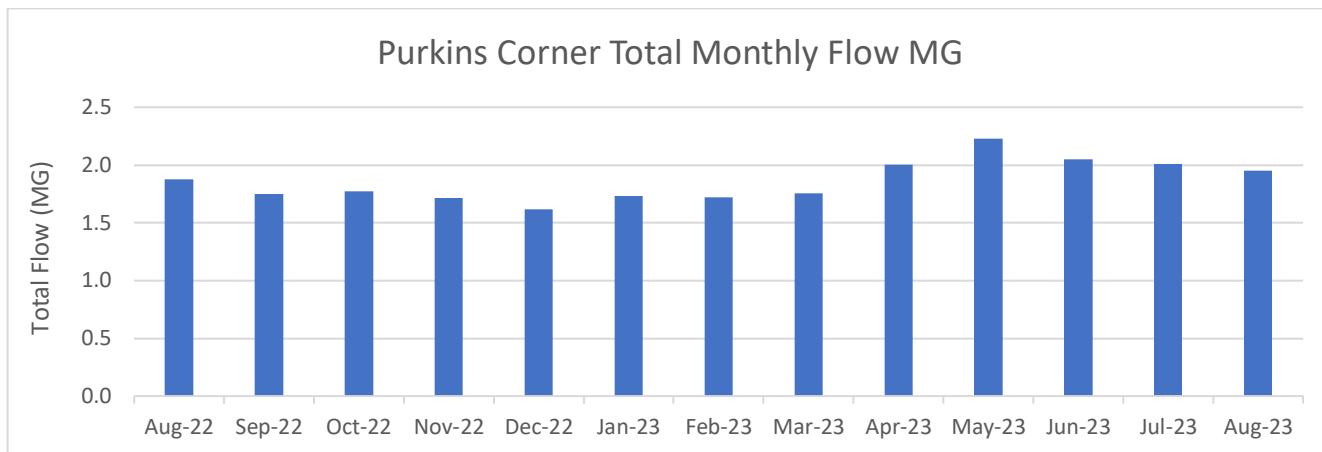
The Purkins Corner WWTP met the sewer service area's sanitation demand with an average daily discharge of 0.063 MGD and a total monthly discharge of 1.954 MG.

The following charts depict a graphical analysis of effluent quality monitoring and treatment plant daily and total monthly flows.

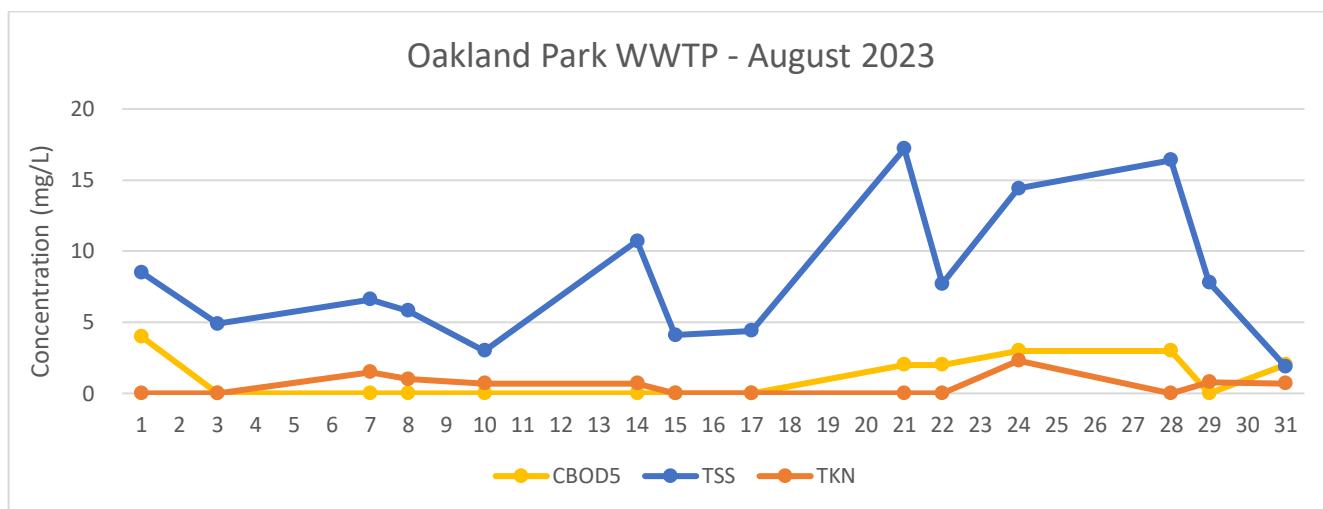
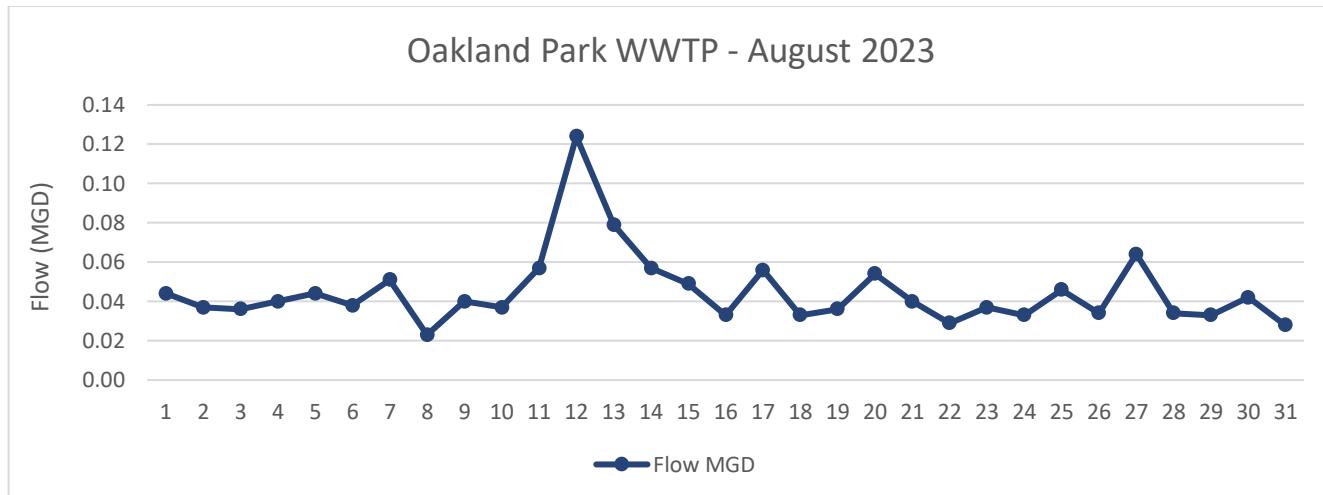
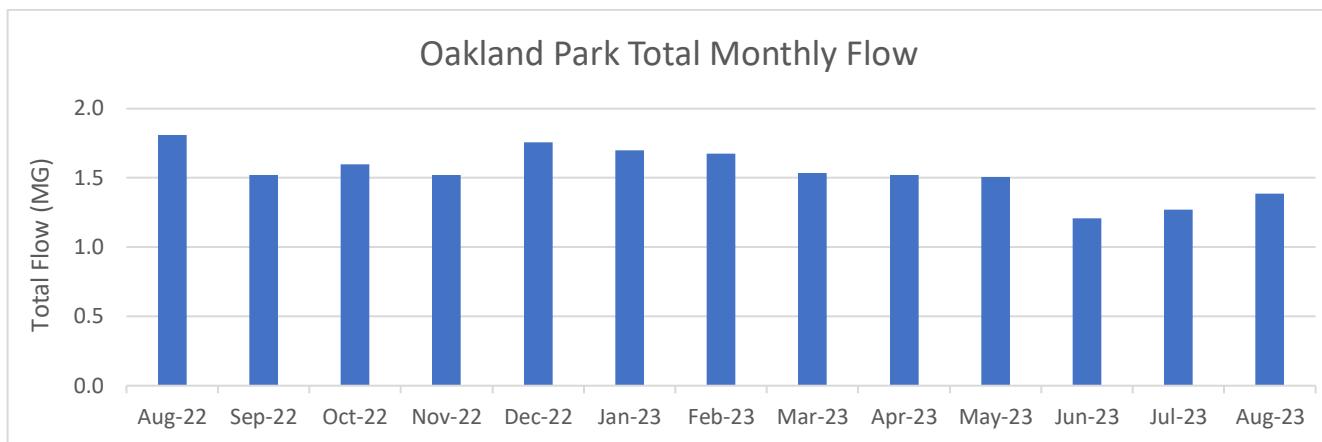
The Oakland Park WWTP met the sewer service area's sanitation demand with an average daily discharge of 0.045 MGD and a total monthly discharge of 1.388 MG.

The following charts depict a graphical analysis of effluent quality monitoring and treatment plant daily and total monthly flows.

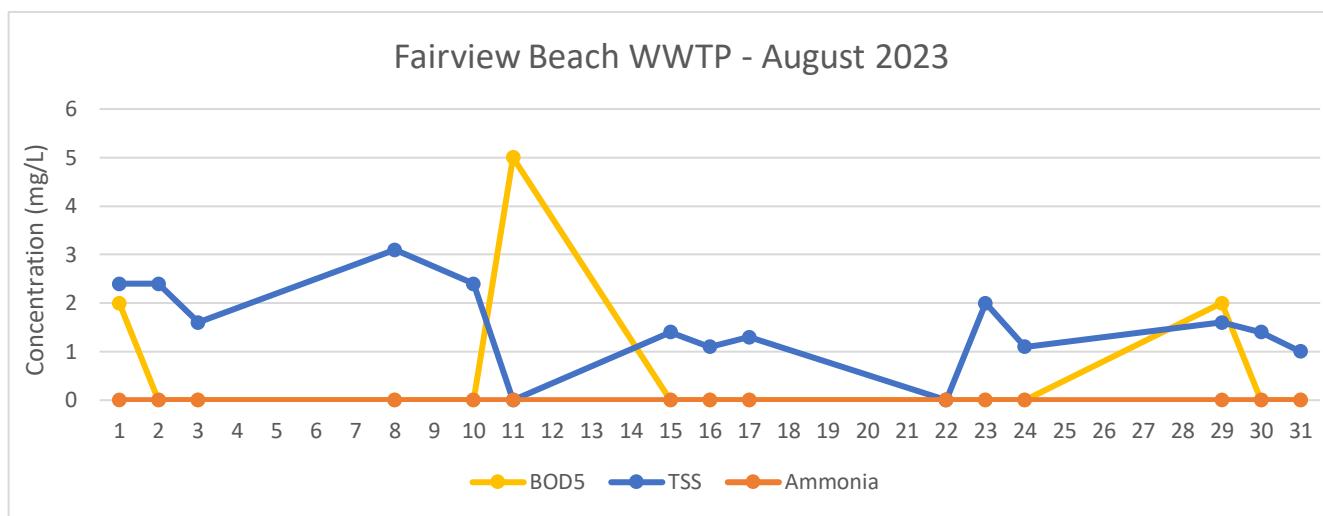
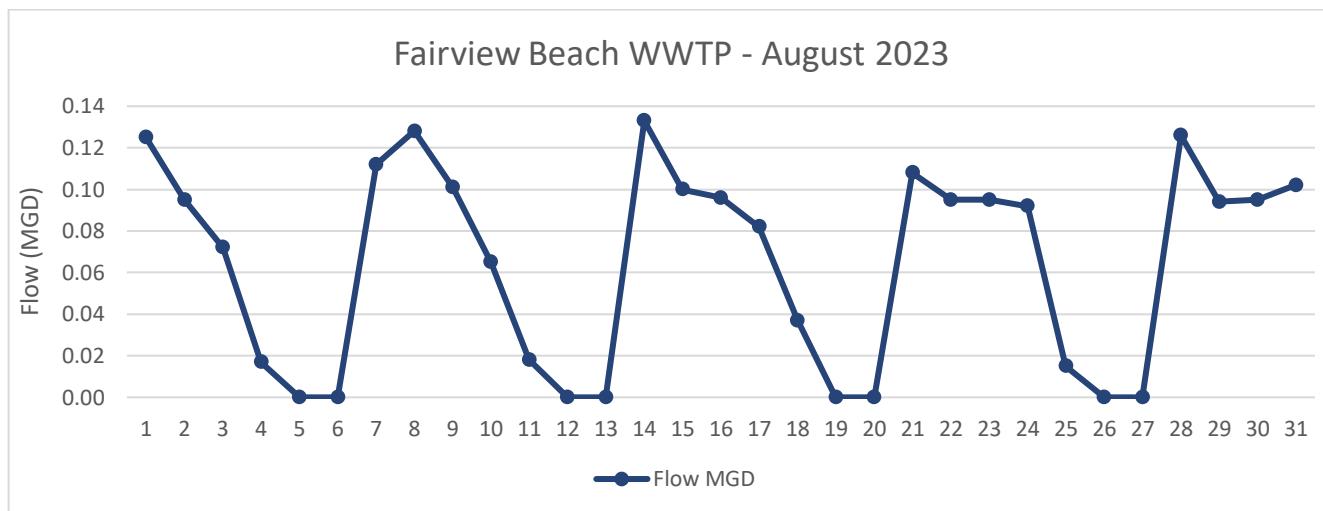
The Fairview Beach WWTP met the sewer service area's sanitation demand with an average daily discharge of 0.065 MGD and a total monthly discharge of 2.005 MG.

The following charts depict a graphical analysis of effluent quality monitoring and treatment plant daily and total monthly flows.

- Fairview Beach WWTP exceeded the permitted monthly average for Fecal Coliform (62 n/CML)
- Fairview Beach WWTP VPDES Permit Reissuance Application submitted—IES to follow up with additional effluent temperature data to DEQ-NRO
- Dahlgren WWTP effluent flow meter—but KGSA maintenance staff were notified of meter issues
