UTILITY REPORT

JULY 2023

**King George County
Service Authority**

**Authored by:
Inboden Environmental
Services, Inc.**

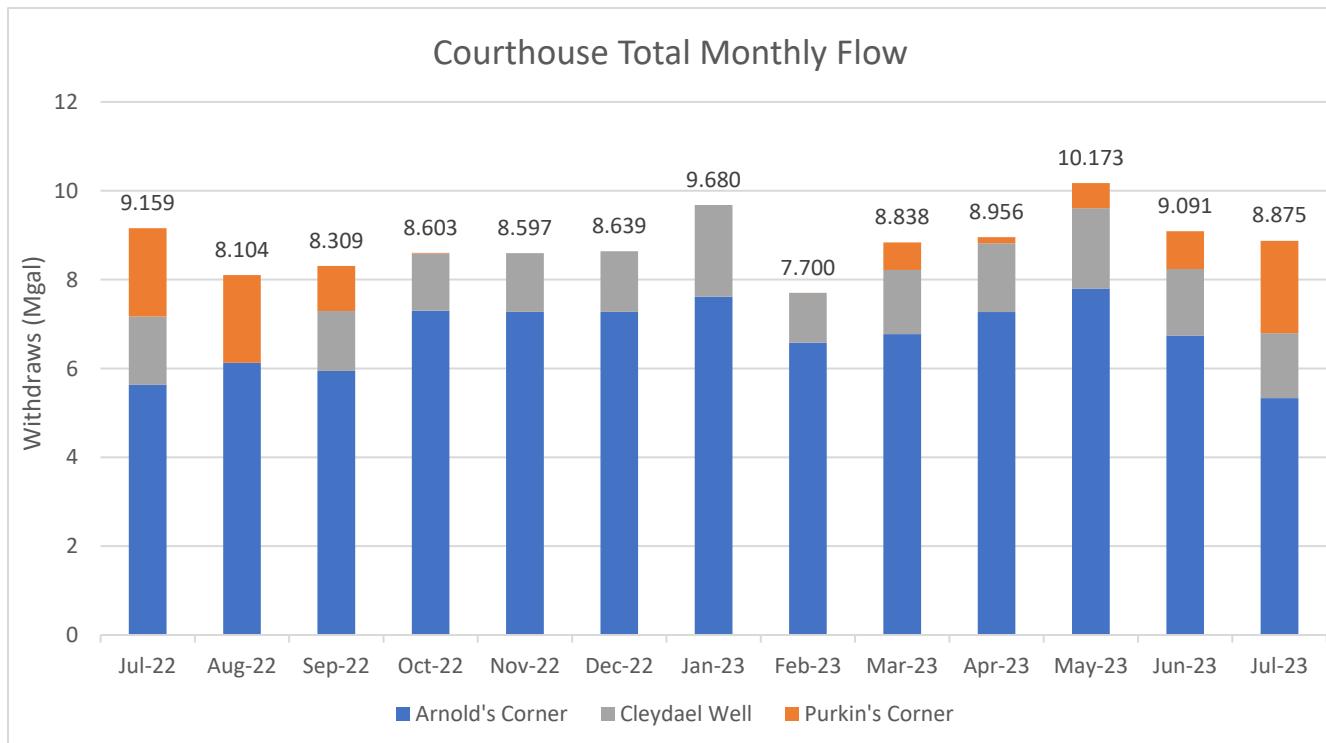
System Production:

- 7/5: Arnold's: Change injector
- 7/13: Arnold's: Change head on chem. pump

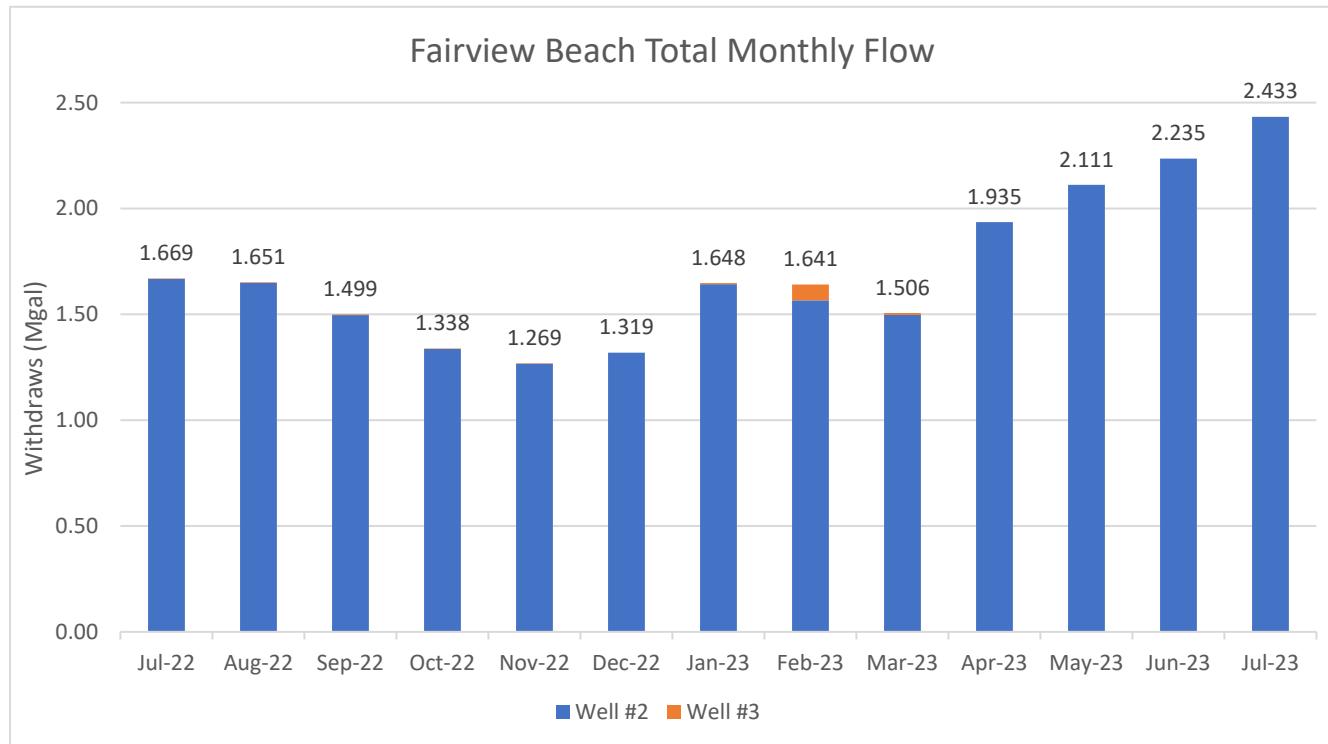
System Production:

- 7/3, 6, 10, 13, 17, 24, 28, 31: Well 2A: Backwash 1 + 2

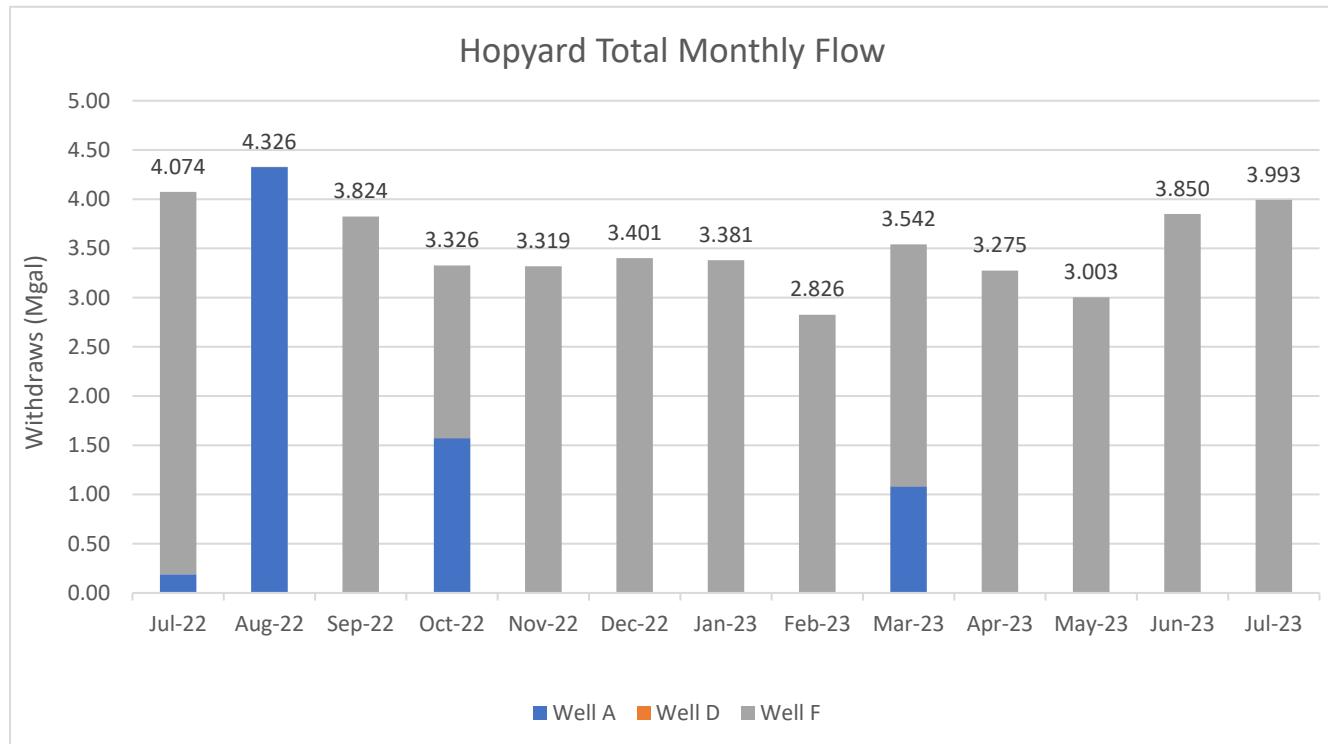
System Production:

- 7/1: Well D and A Offline

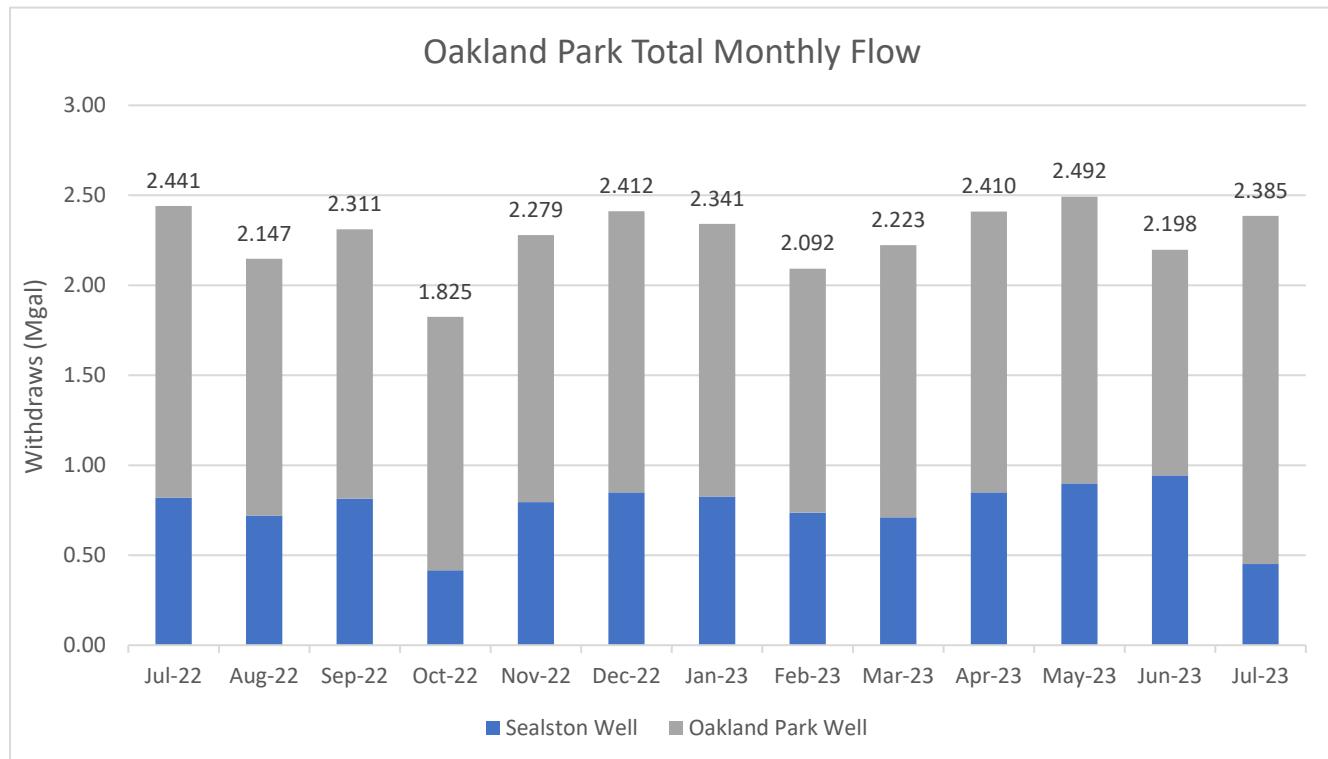
System Production:

- Inspected sand filter media at OP water plant.
- 7/3: Sealston: Backwash 1 + 2
- 7/5: Sealston: Backwash 1 + 2; OP: Backwash
- 7/6: Sealston Well offline
- 7/17: OP: Backwash 1 + 2 + 3

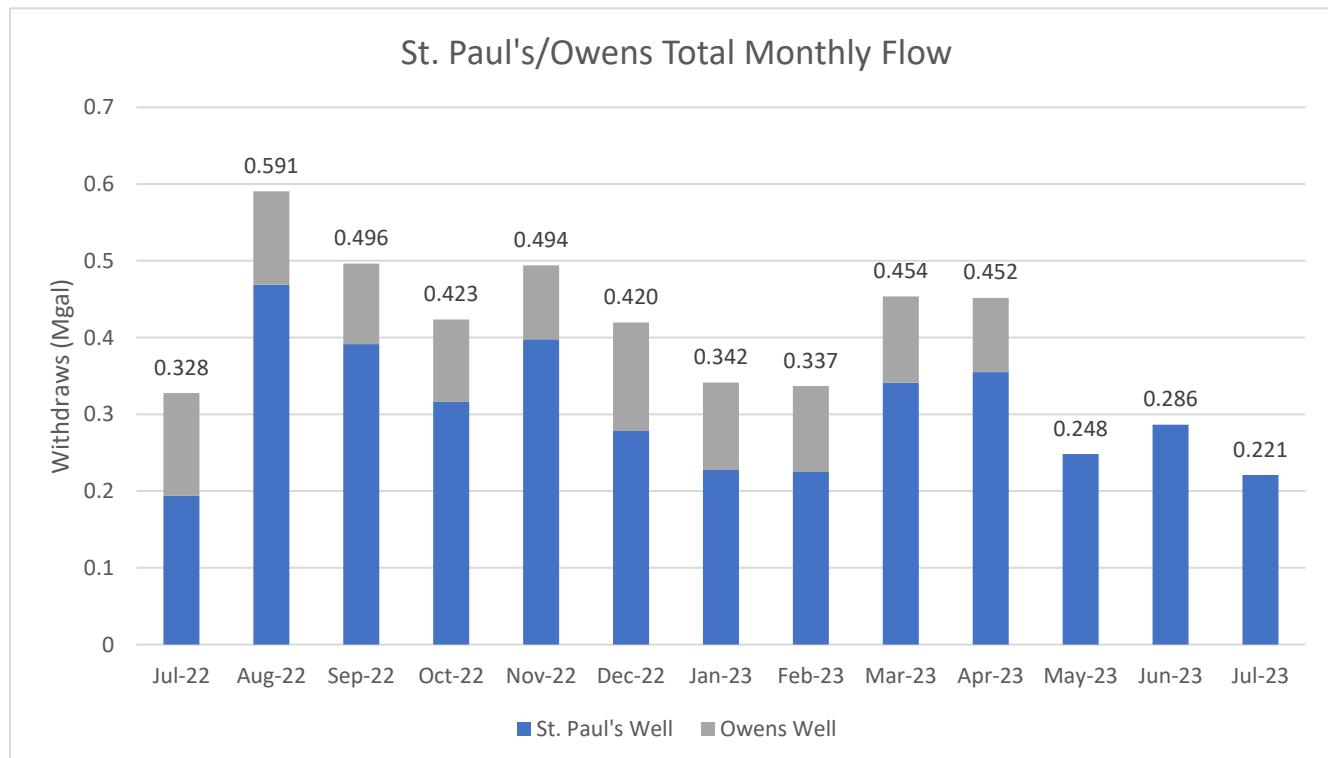
System Production:

- 7/1: Owens meter: Needs repaired/replaced

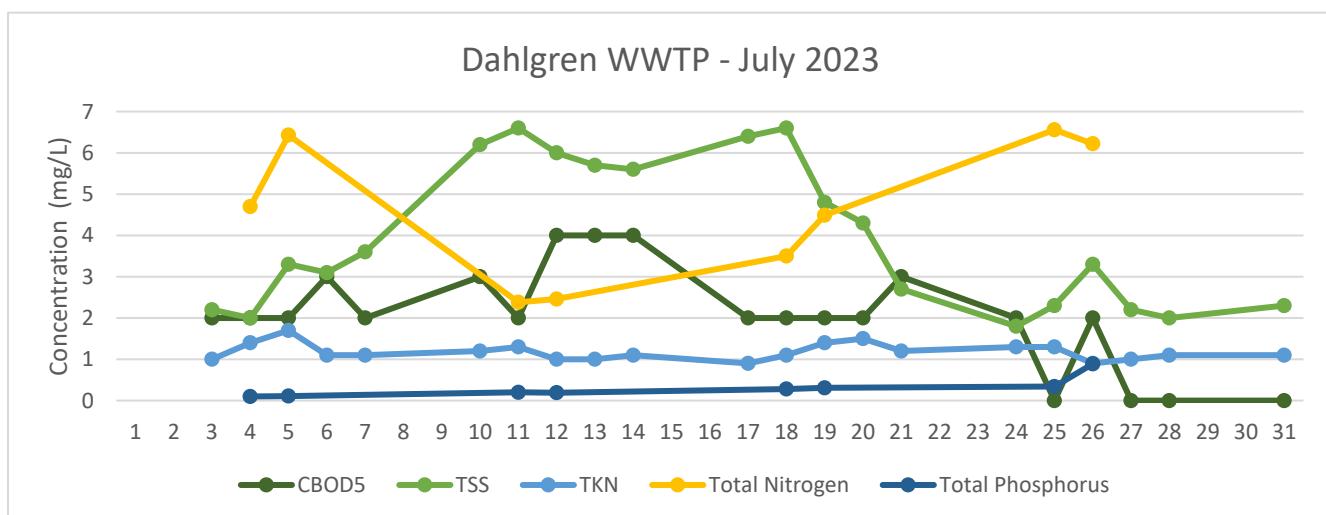
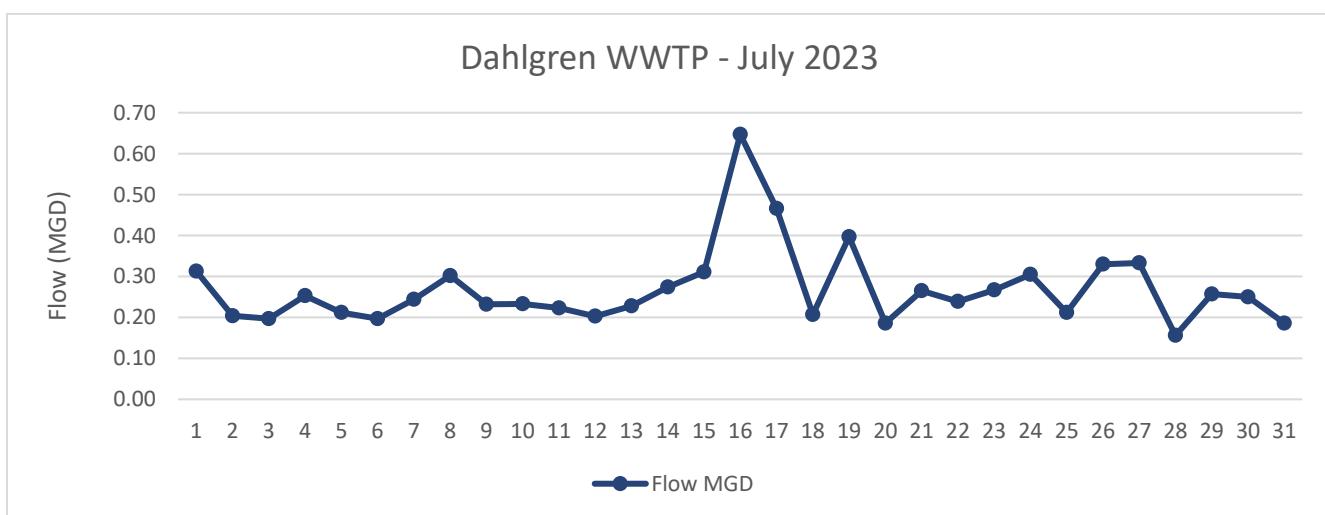
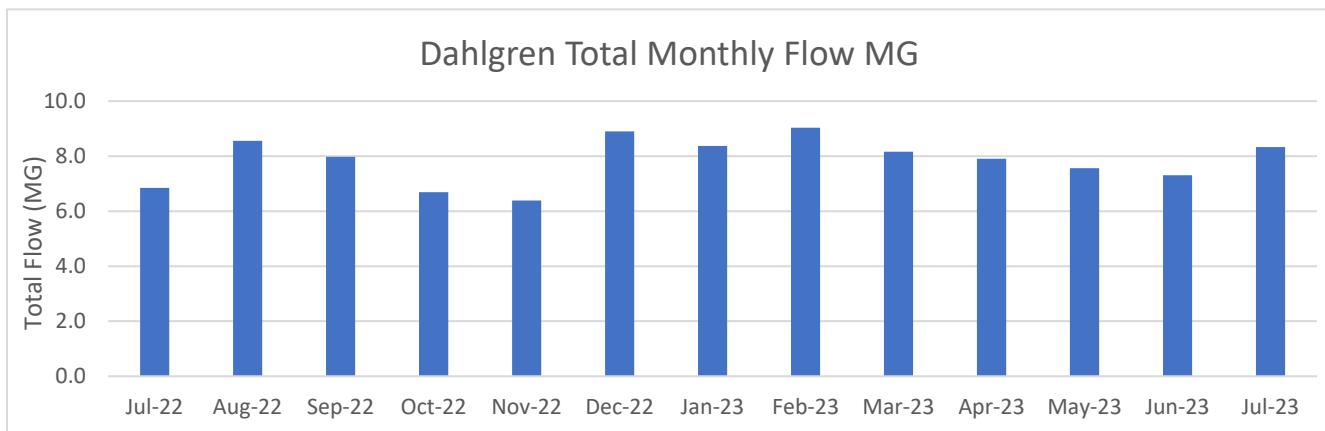
The Dahlgren WWTP met the sewer service area's sanitation demand with an average daily discharge of 0.269 MGD and a total monthly discharge of 8.329 MG.

The following charts depict a graphical analysis of effluent quality monitoring and treatment plant daily and total monthly flows.

- KG maintenance installed new suction pipe on BioCarb feed system to include a y strainer system and drawdown calibration tube to ensure chemical feed rates.
- Increased chances of thunderstorm systems prompted IES operators to bring second clarifier online.
- Repaired water line at influent screen, which will reduce run time on water reuse pumps. KG maintenance installed a screening unit w/ float due to faulty level sensor.
- KG maintenance replaced hardware on reuse pumps to keep packing from leaking.

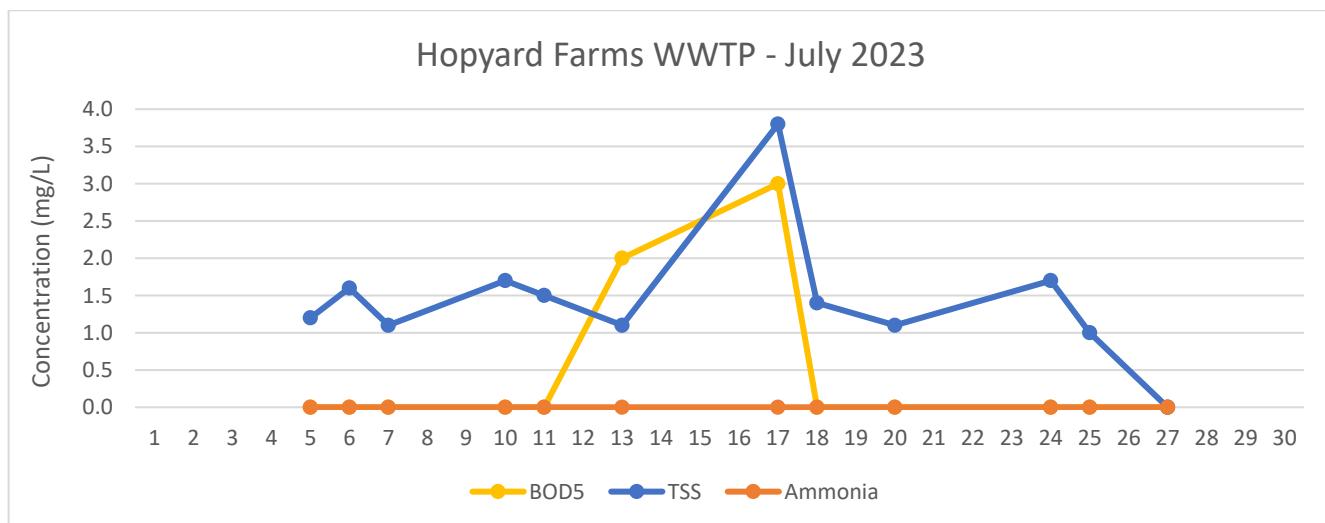
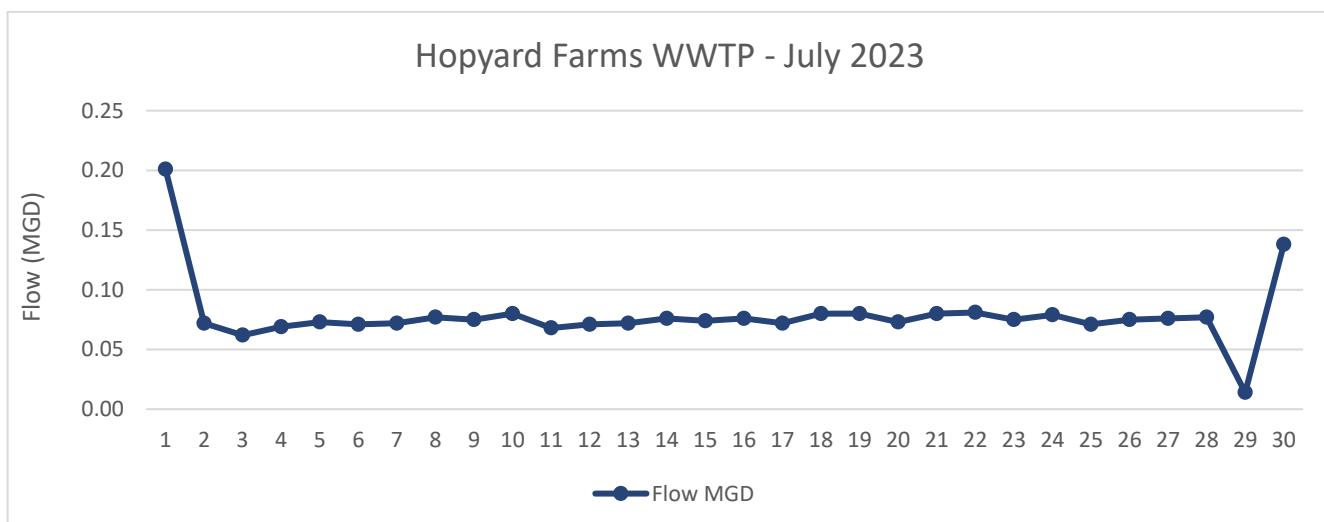
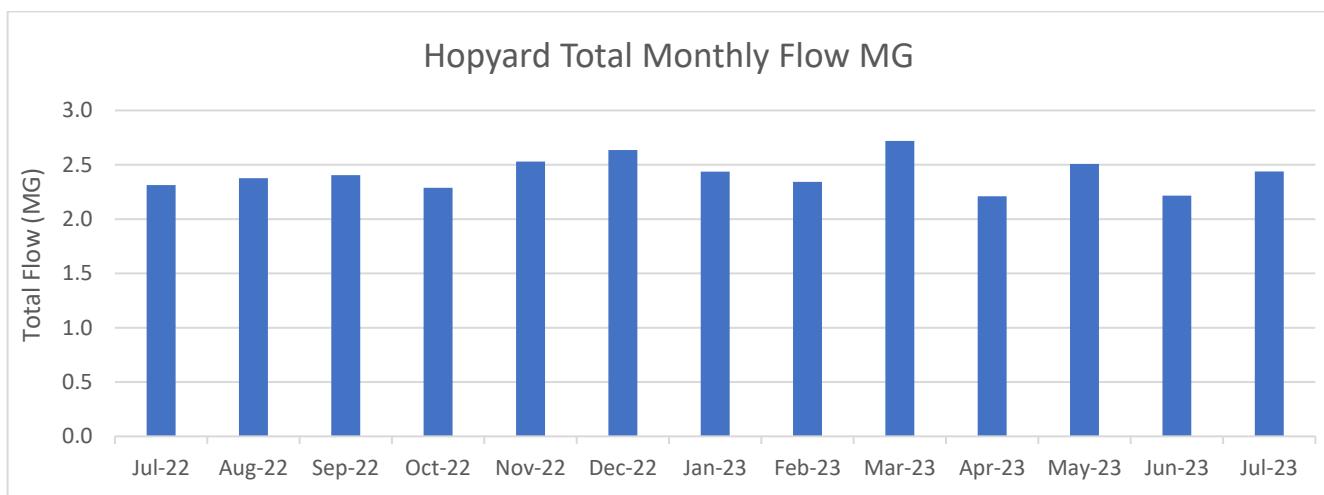
The Hopyard WWTP met the sewer service area's sanitation demand with an average daily discharge of 0.079 MGD and a total monthly discharge of 2.439 MG.

The following charts depict a graphical analysis of effluent quality monitoring and treatment plant daily and total monthly flows.

- A new mixer motor for SBR-1 has been ordered and received and awaiting installation.
- Operators performed preventative maintenance on blower equipment.
- Continuing efforts to reduce chemical feeds while maintaining final effluent quality.

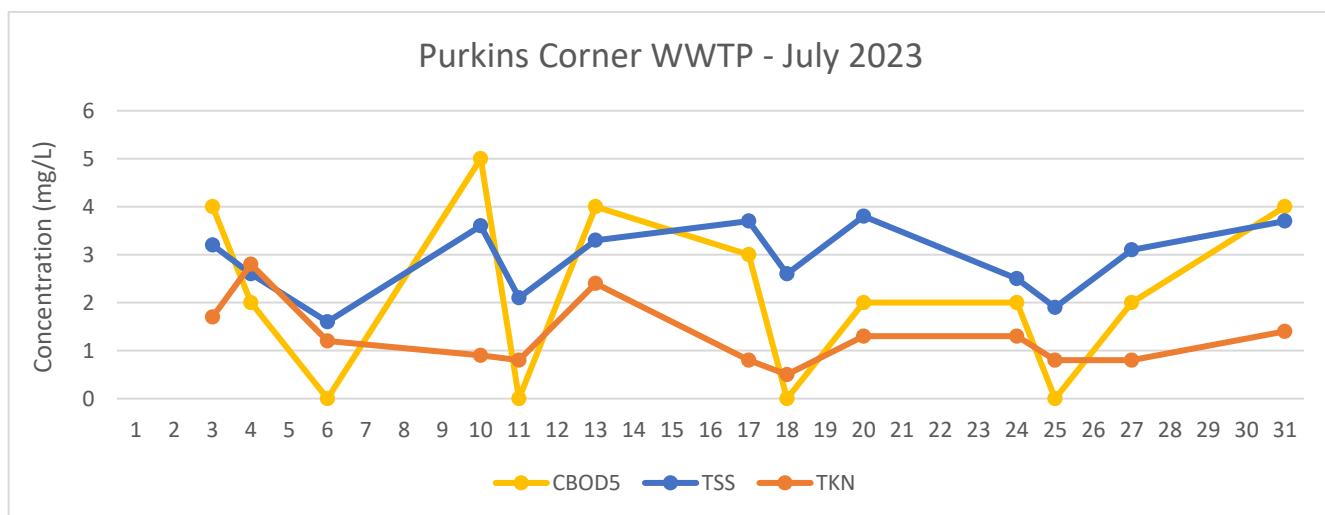
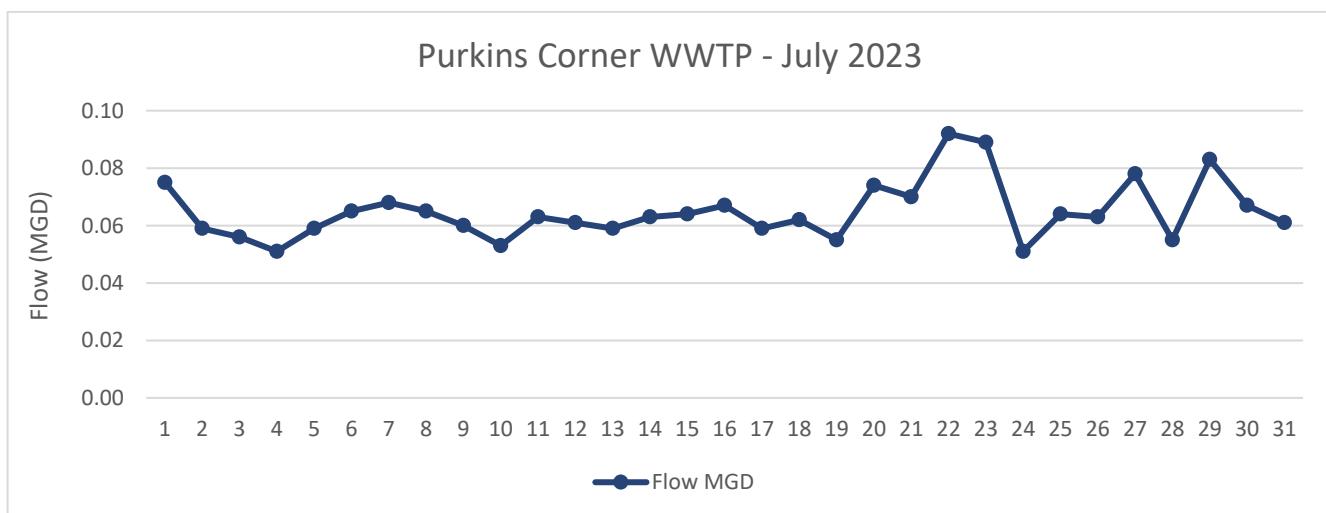
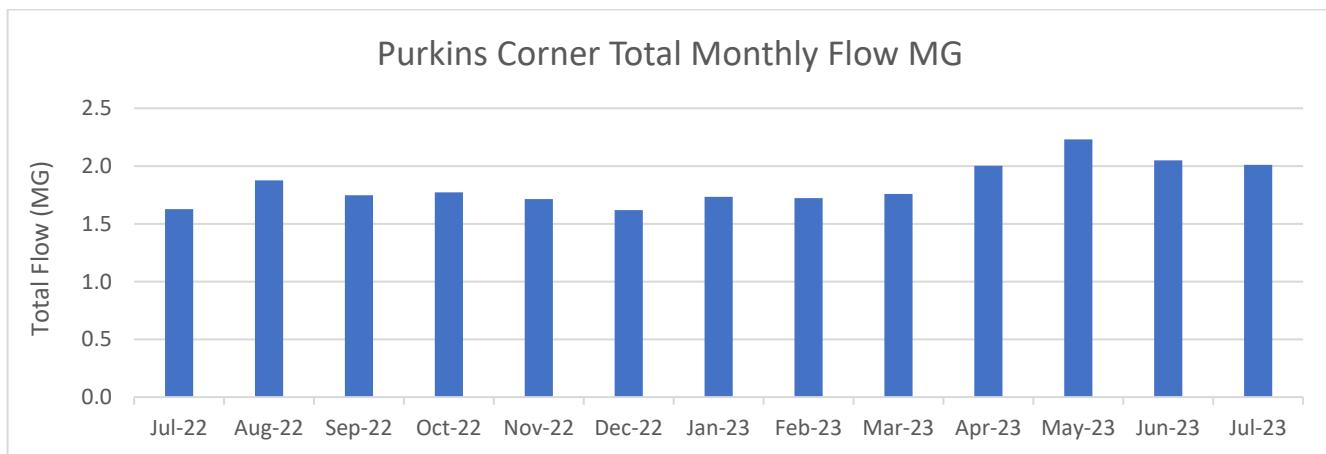
The Purkins Corner WWTP met the sewer service area's sanitation demand with an average daily discharge of 0.065 MGD and a total monthly discharge of 2.011 MG.

The following charts depict a graphical analysis of effluent quality monitoring and treatment plant daily and total monthly flows.

- Air leak identified by IES operators and repaired by KG maintenance staff. Which in turn positively affected air efficiency between each basin.
- Preventative maintenance items performed.
- New VPDES Permit was reissued to KG on July 28. The new permit has an effective date of August 1, 2023 with a five year term.

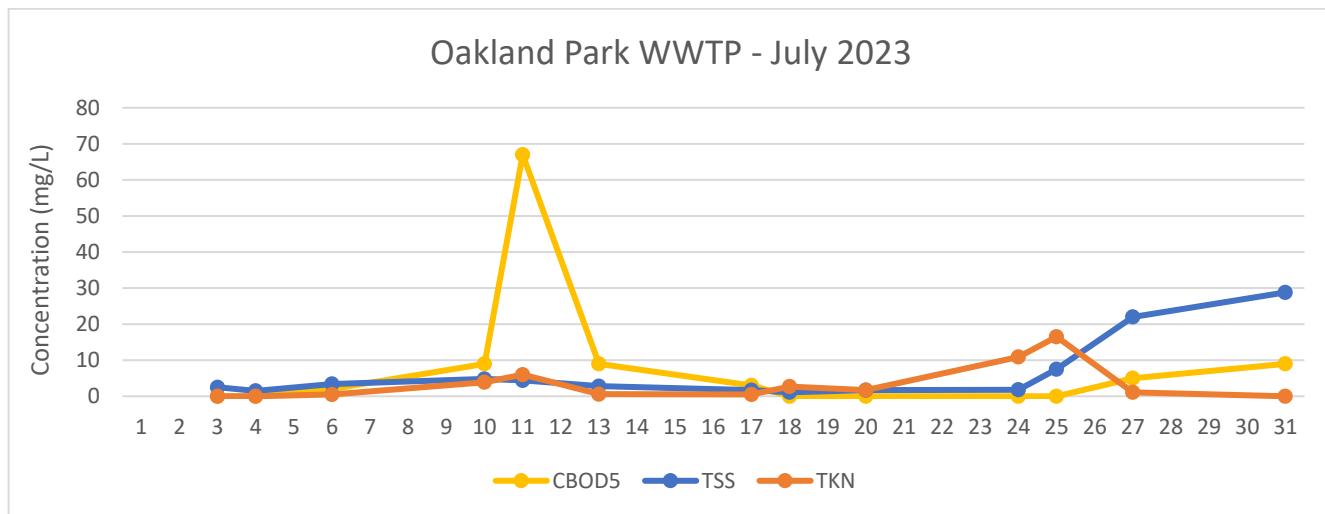
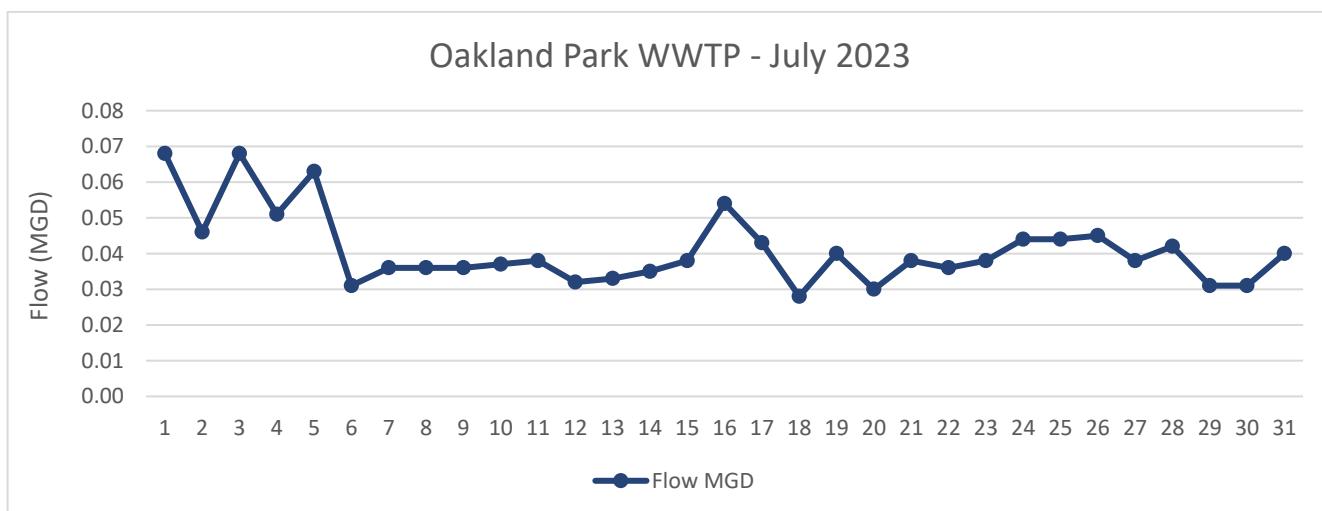
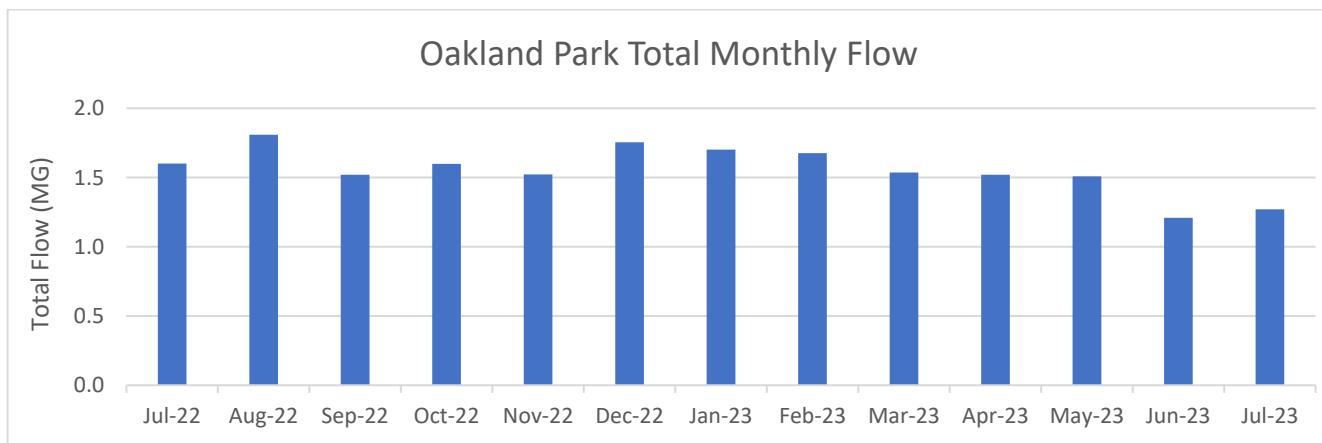
The Oakland Park WWTP met the sewer service area's sanitation demand with an average daily discharge of 0.041 MGD and a total monthly discharge of 1.270 MG.

The following charts depict a graphical analysis of effluent quality monitoring and treatment plant daily and total monthly flows.

- Further investigated flow equalization between both plants. KG maintenance installed solenoid valves to aid in dosing influent to each plant.
- Re-ran Alum feed lines due to clog and successfully replaced with smaller diameter hose to allow for a more fluid movement of chemical.

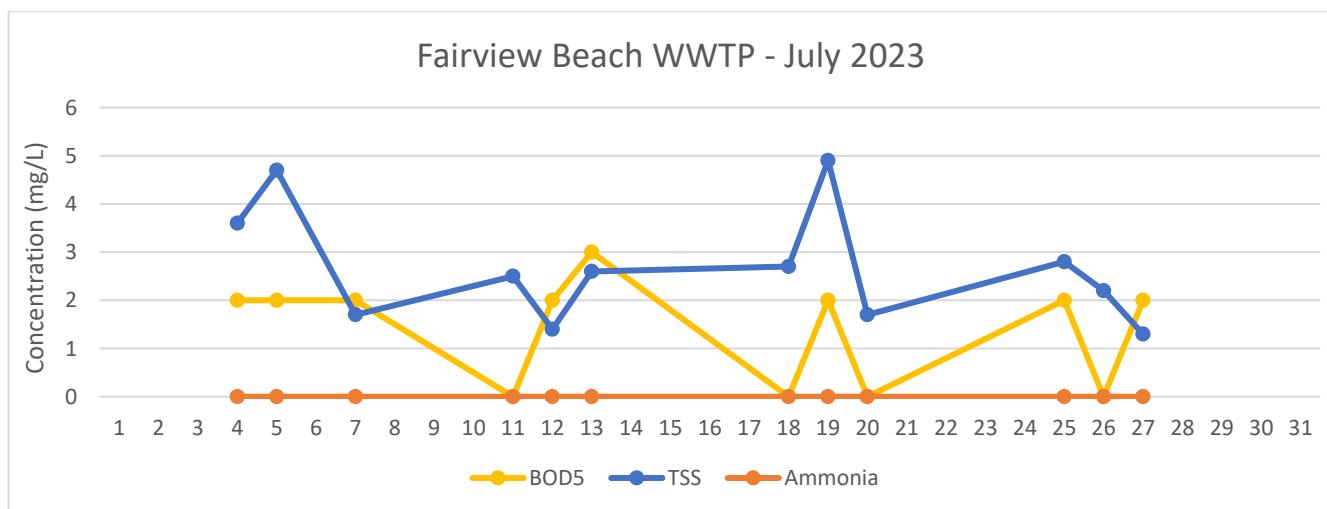
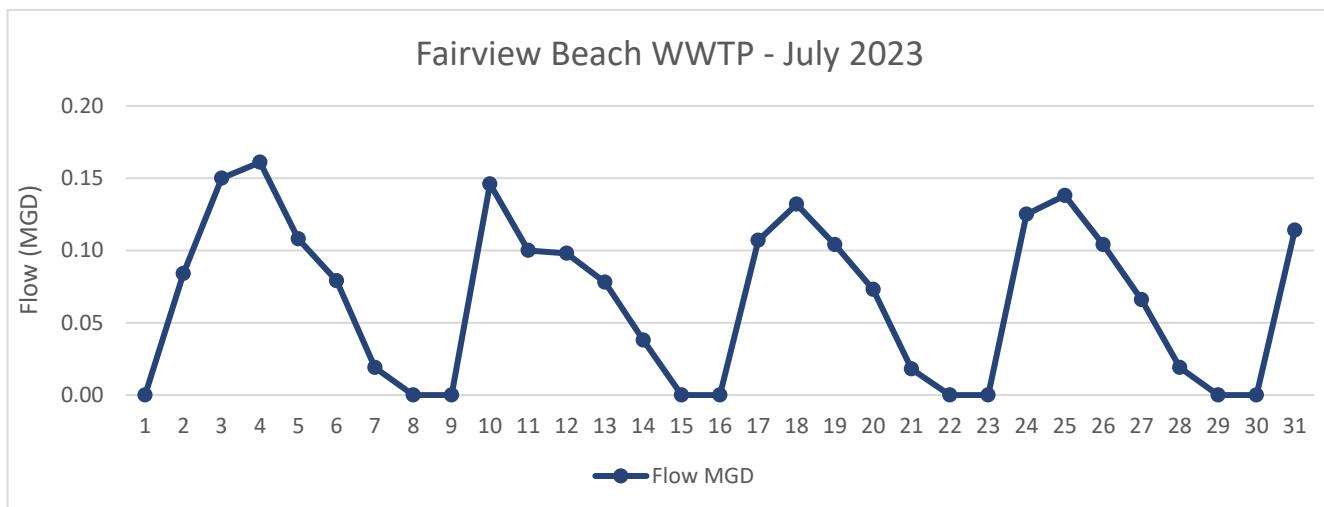
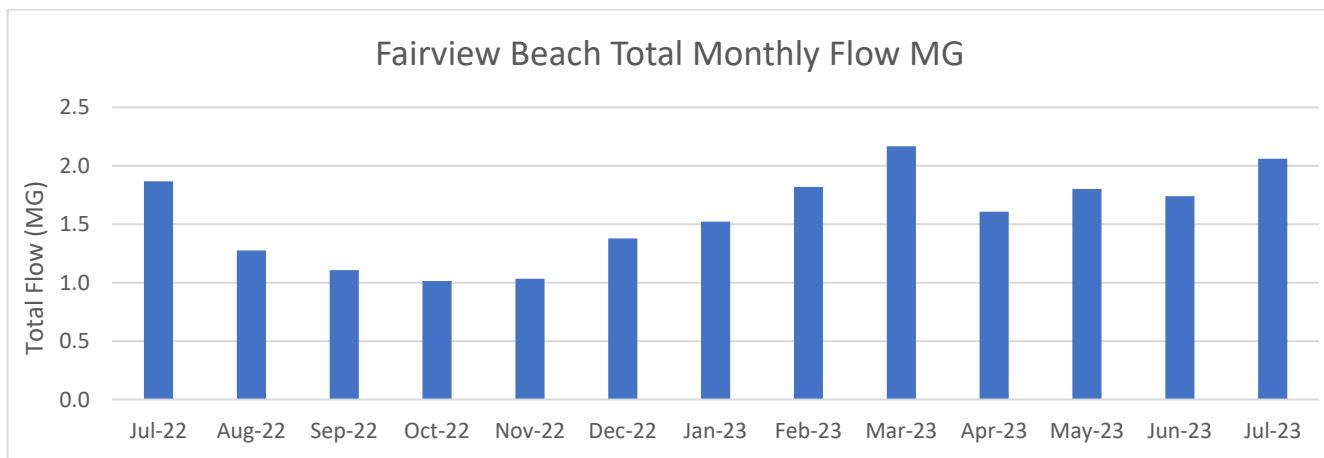
The Fairview Beach WWTP met the sewer service area's sanitation demand with an average daily discharge of 0.066 MGD and a total monthly discharge of 2.061 MG.

The following charts depict a graphical analysis of effluent quality monitoring and treatment plant daily and total monthly flows.

- Maintained effective operations of Biological and Chemical treatment to reduce nutrients in final effluent.
