UTILITY REPORT

FEBRUARY 2024

**King George County
Service Authority**

**Authored by:
Inboden Environmental
Services, Inc.**

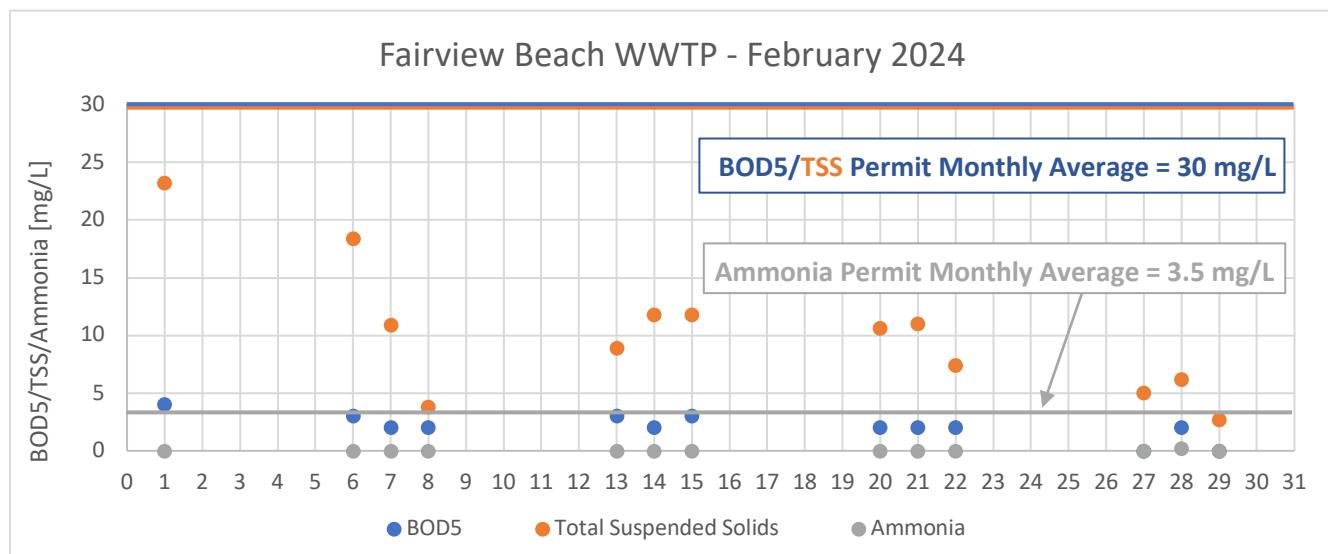
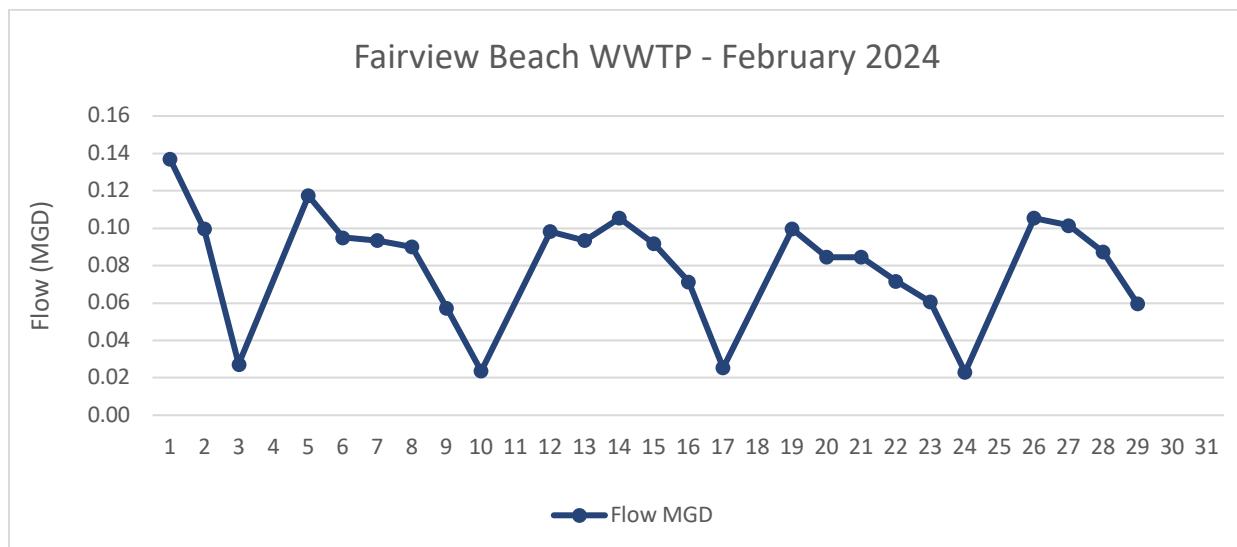
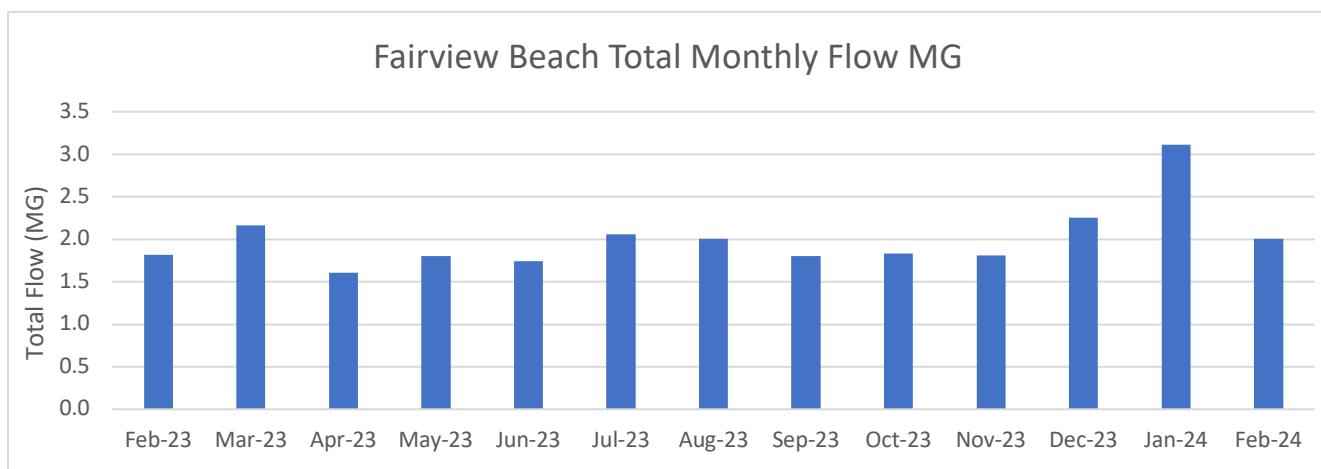
Data Trending:

The wastewater treatment facility operated well and maintained compliance with all permit-required sampling.

The Fairview Beach WWTP met the sewer service area's sanitation demand with an average daily discharge of 0.080 MGD for a total monthly discharge of 2.005 MG.

The following charts depict a graphical analysis of effluent quality monitoring and treatment plant daily and total monthly flows.

- DEQ performed a technical inspection.
- Working with KGCSA to use a larger tank to facilitate storage of more coagulant.
