UTILITY REPORT

MARCH 2024

**King George County
Service Authority**

**Authored by:
Inboden Environmental
Services, Inc.**

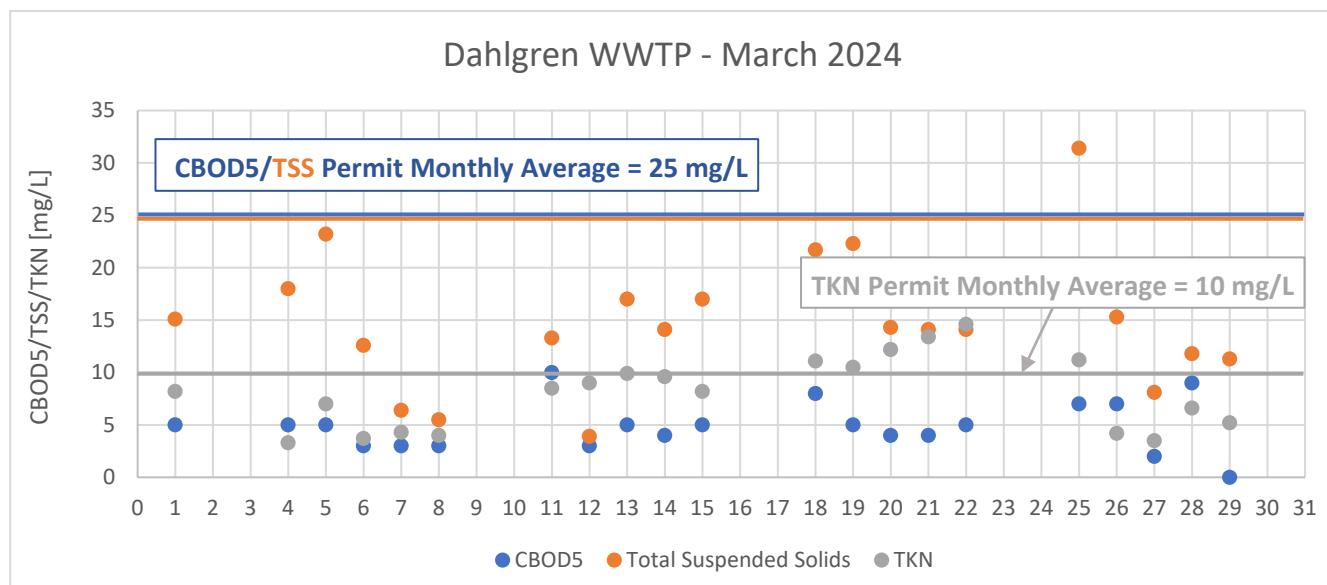
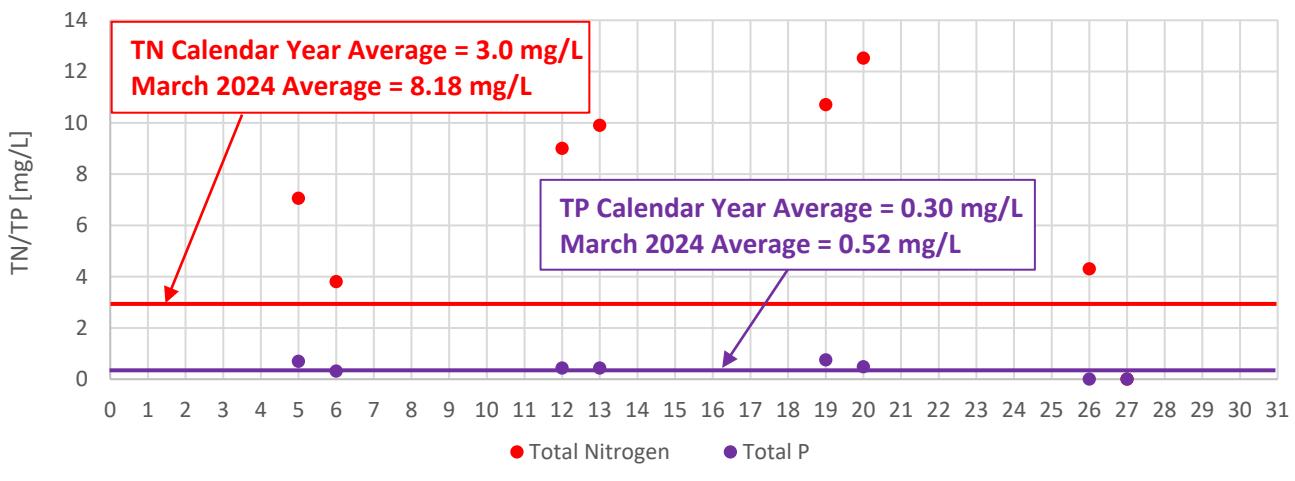
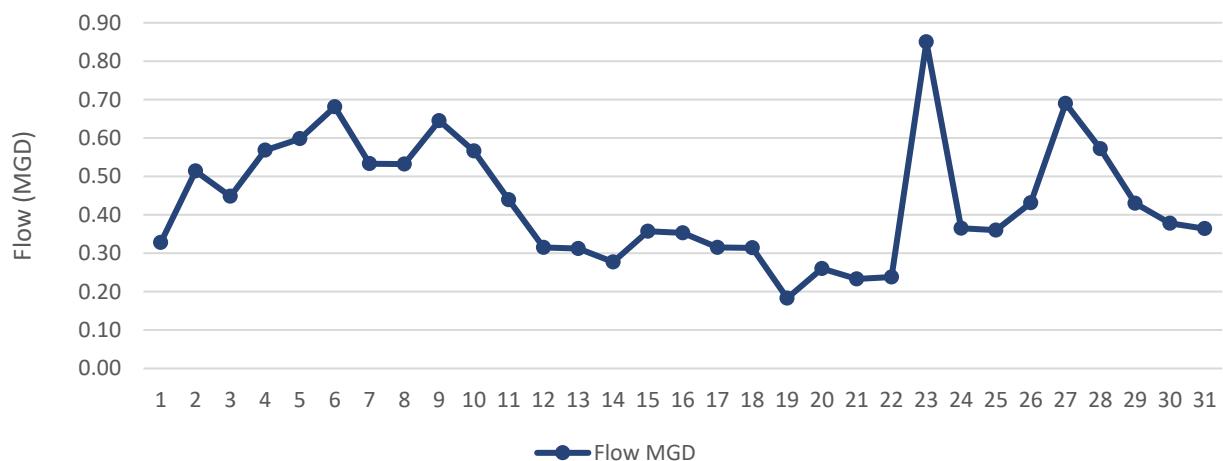
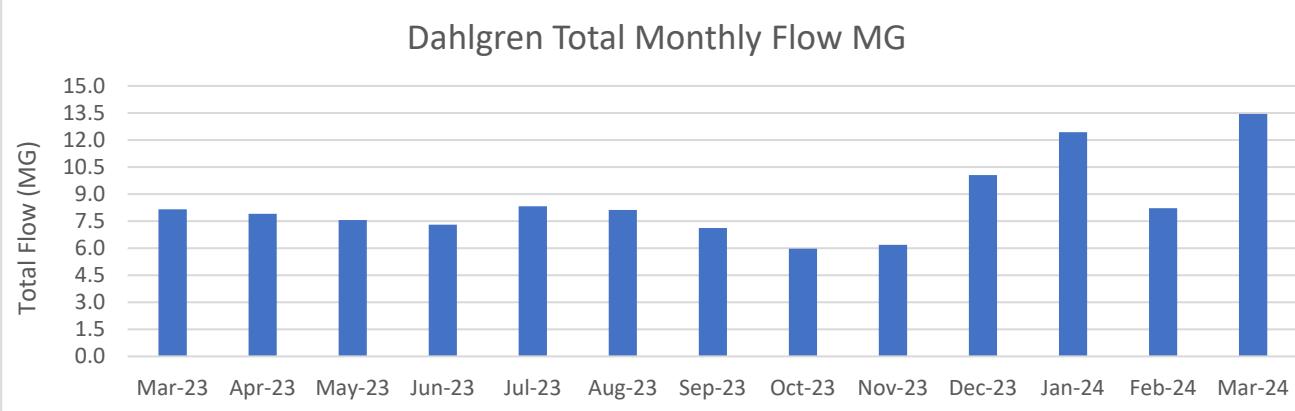
The following charts depict a graphical analysis of effluent quality monitoring and treatment plant daily and total monthly flows.

Dahlgren WWTP - March 2024

Dahlgren Total Monthly Flow MG

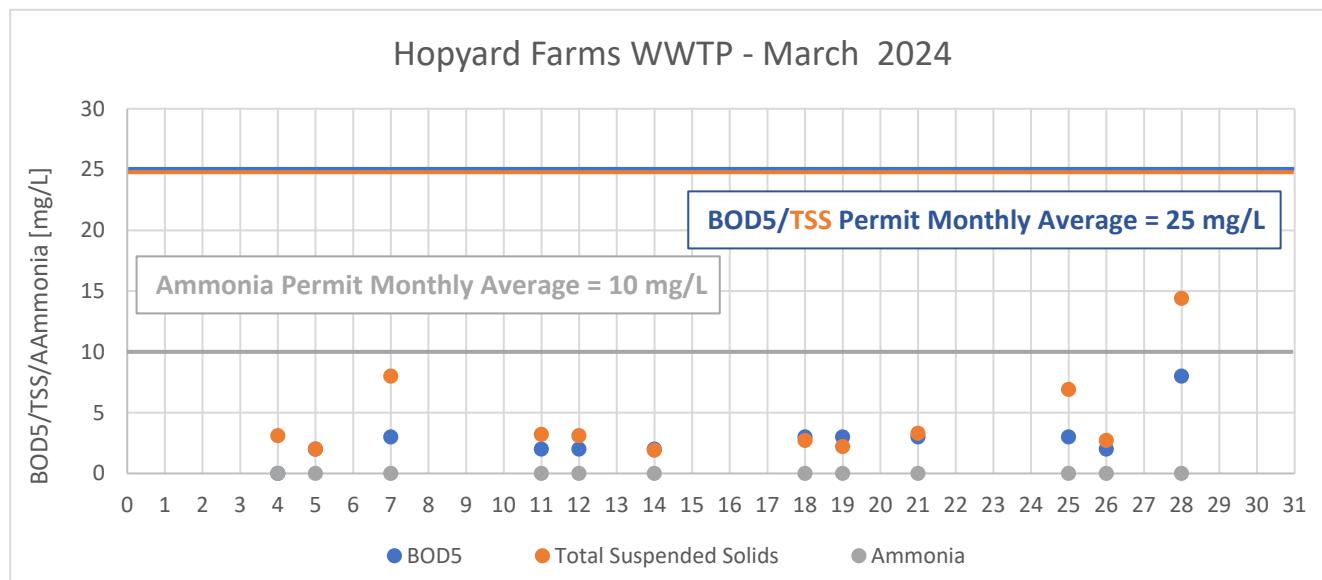
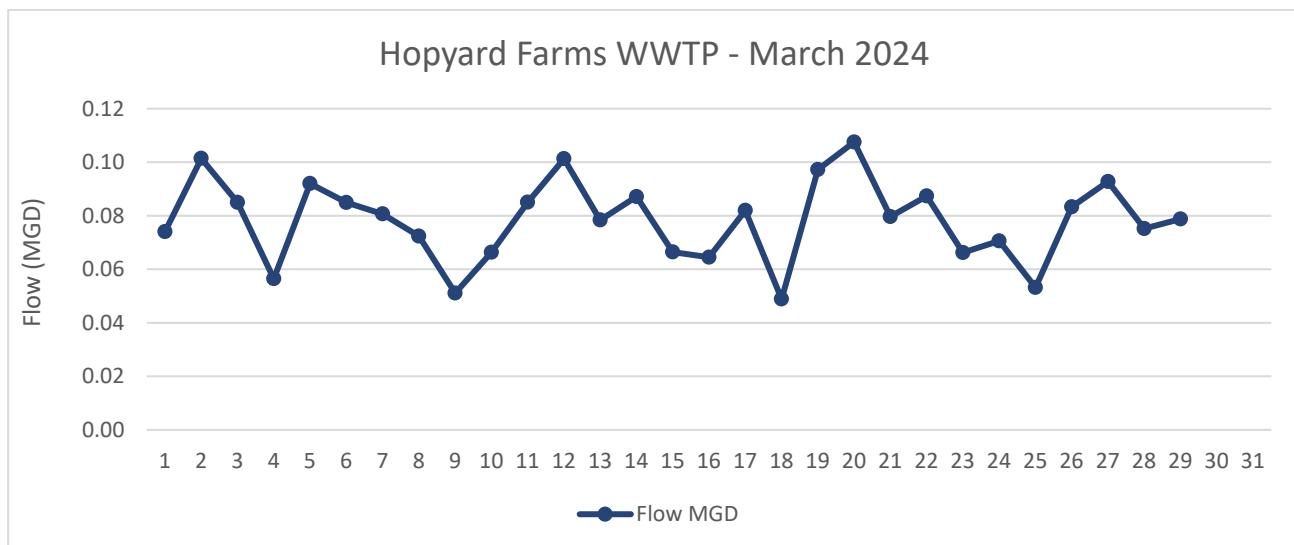
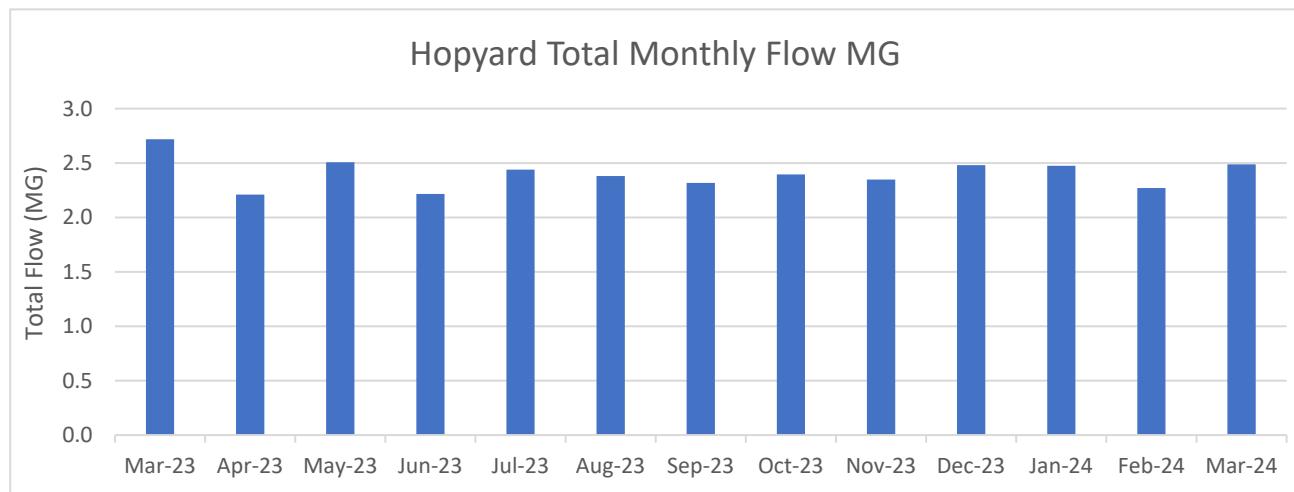
The following charts depict a graphical analysis of effluent quality monitoring and treatment plant daily and total monthly flows.

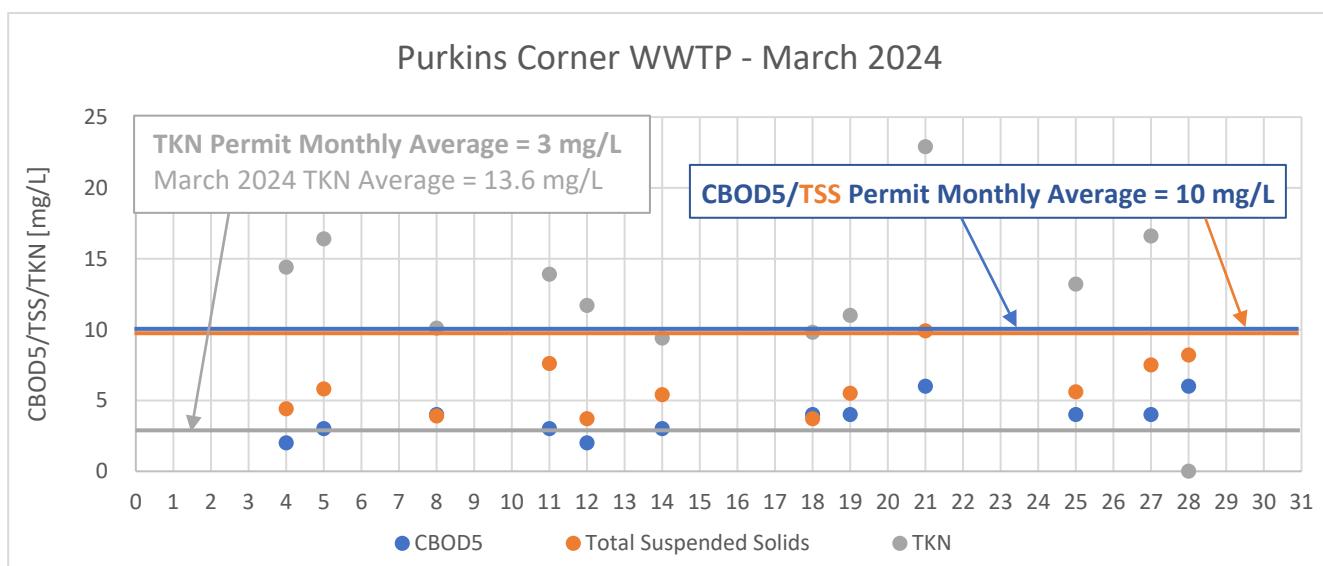
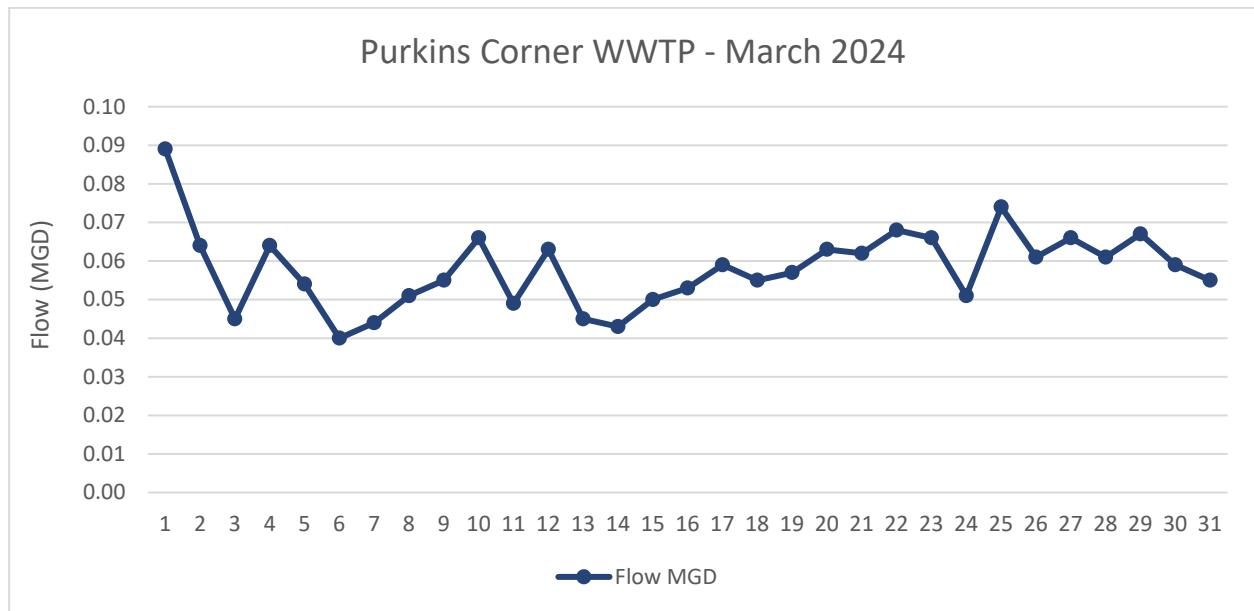
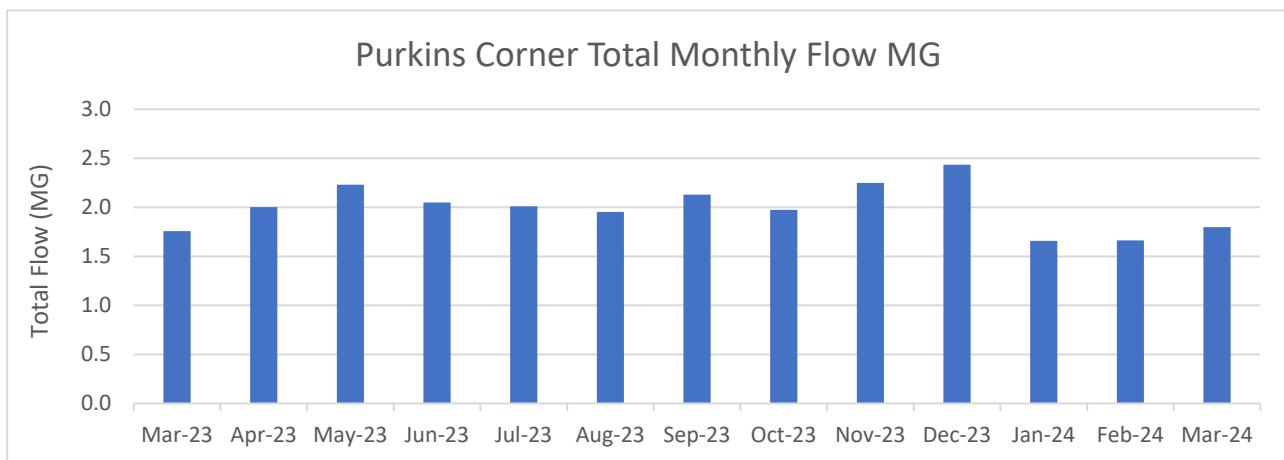
The wastewater treatment facility maintained compliance with permit-required sampling except for TKN. Inundation of FOG (fats/oils/grease) to the plant are being treated utilizing bioaugmentation to restore TKN removal. Treatment is improving.

The following charts depict a graphical analysis of effluent quality monitoring and treatment plant daily and total monthly flows.

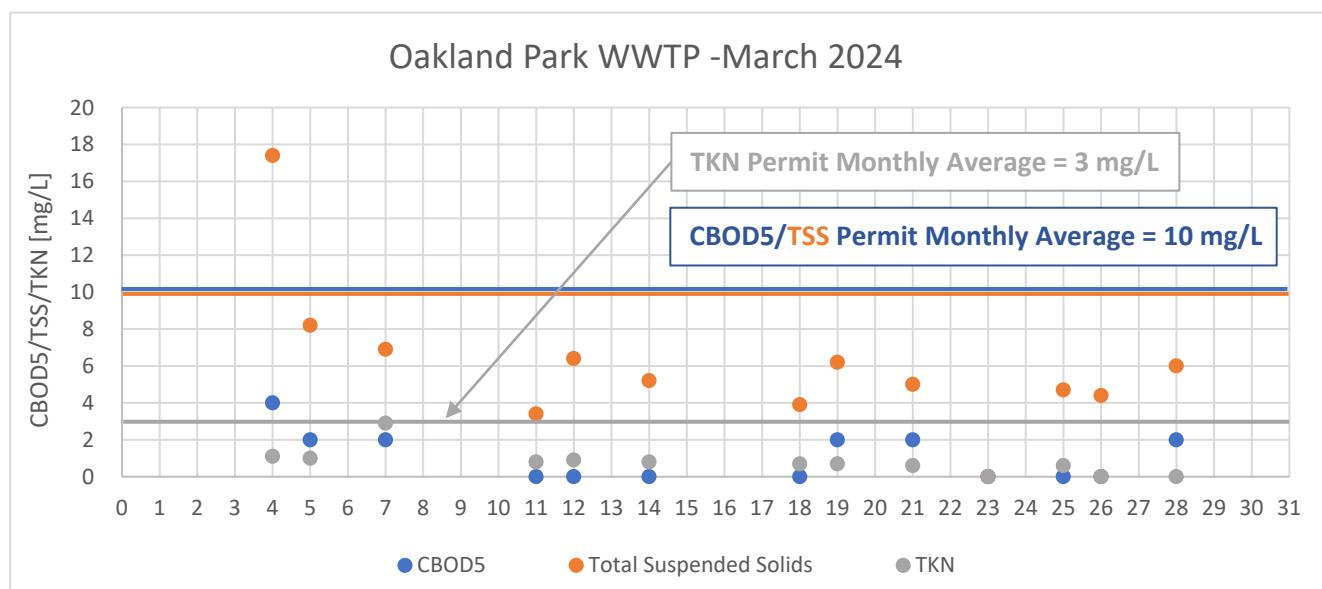
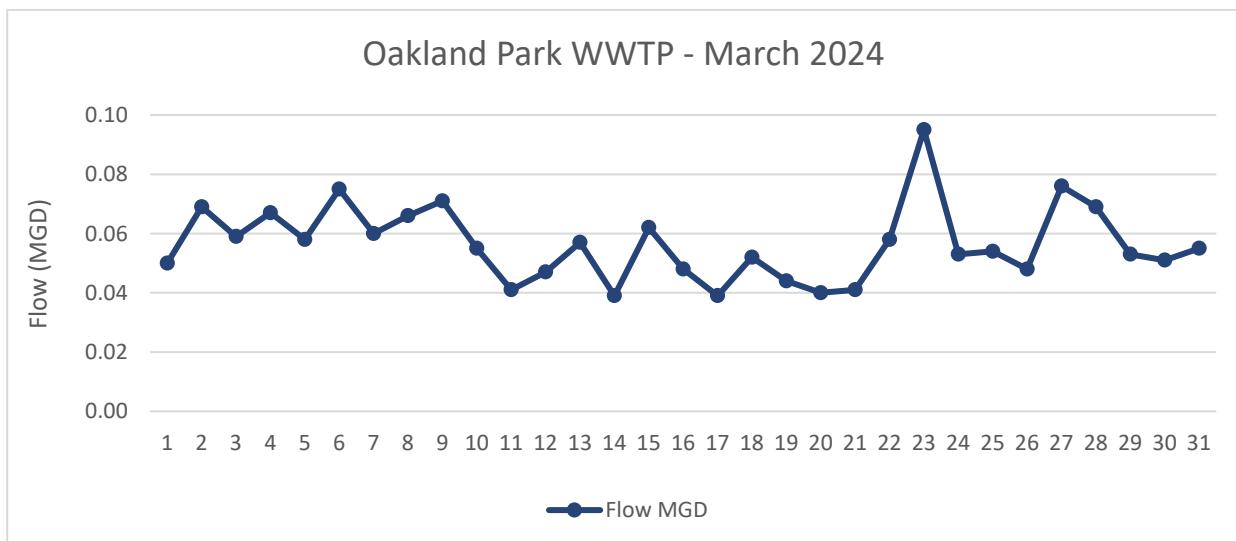
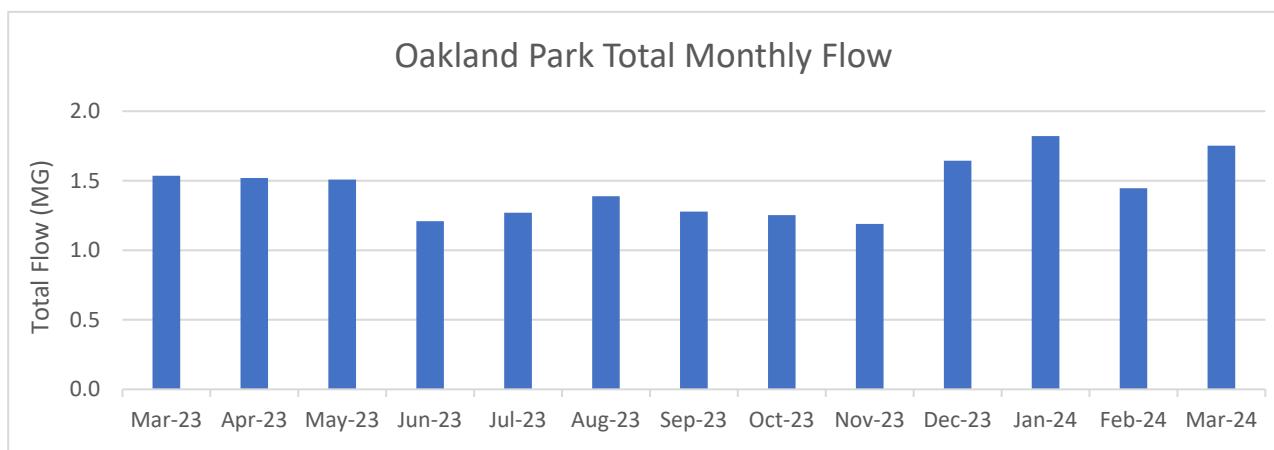
The following charts depict a graphical analysis of effluent quality monitoring and treatment plant daily and total monthly flows.

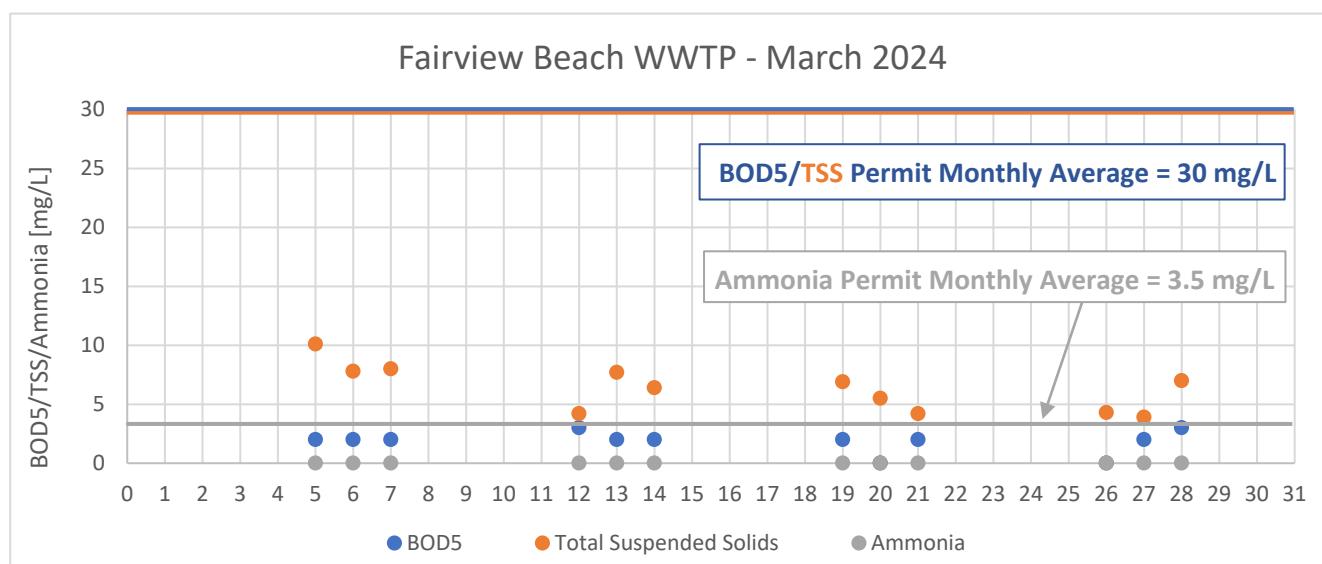
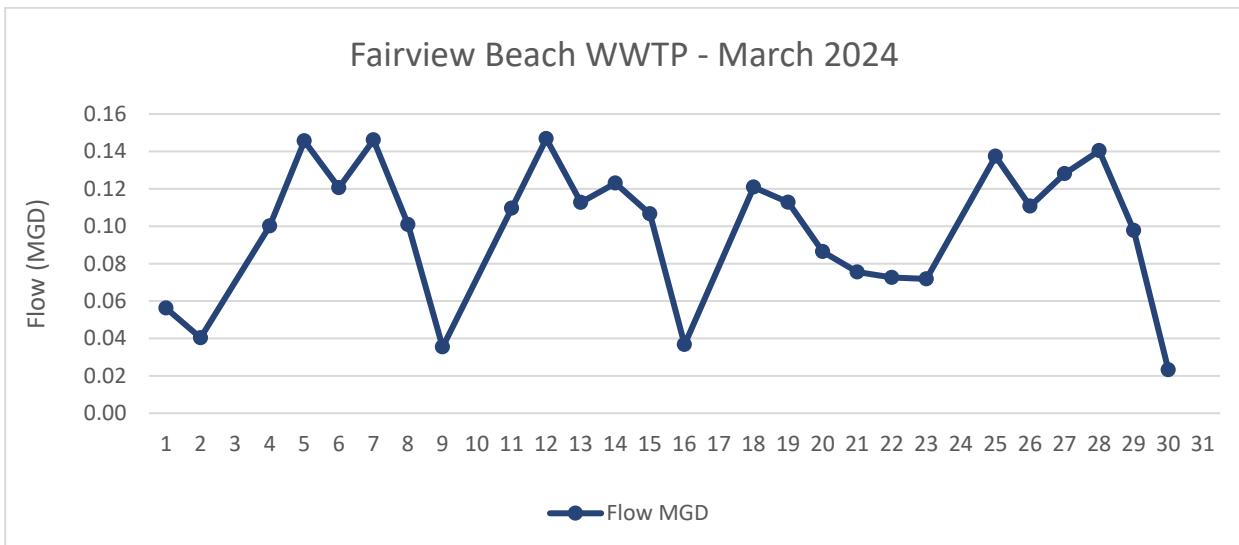
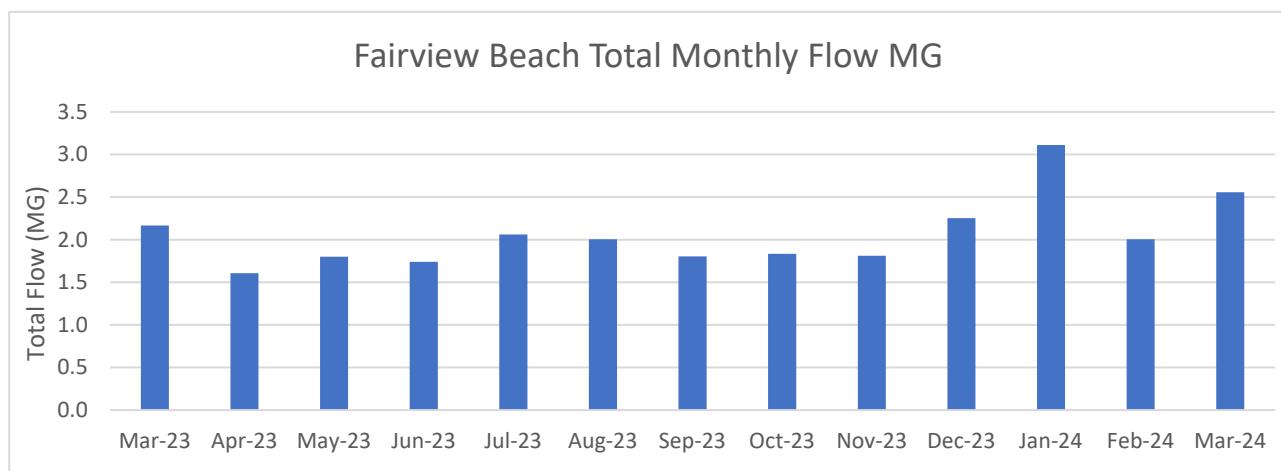
The following charts depict a graphical analysis of effluent quality monitoring and treatment plant daily and total monthly flows.
