UTILITY REPORT

JUNE 2024

**King George County
Service Authority**

**Authored by:
Inboden Environmental
Services, Inc.**

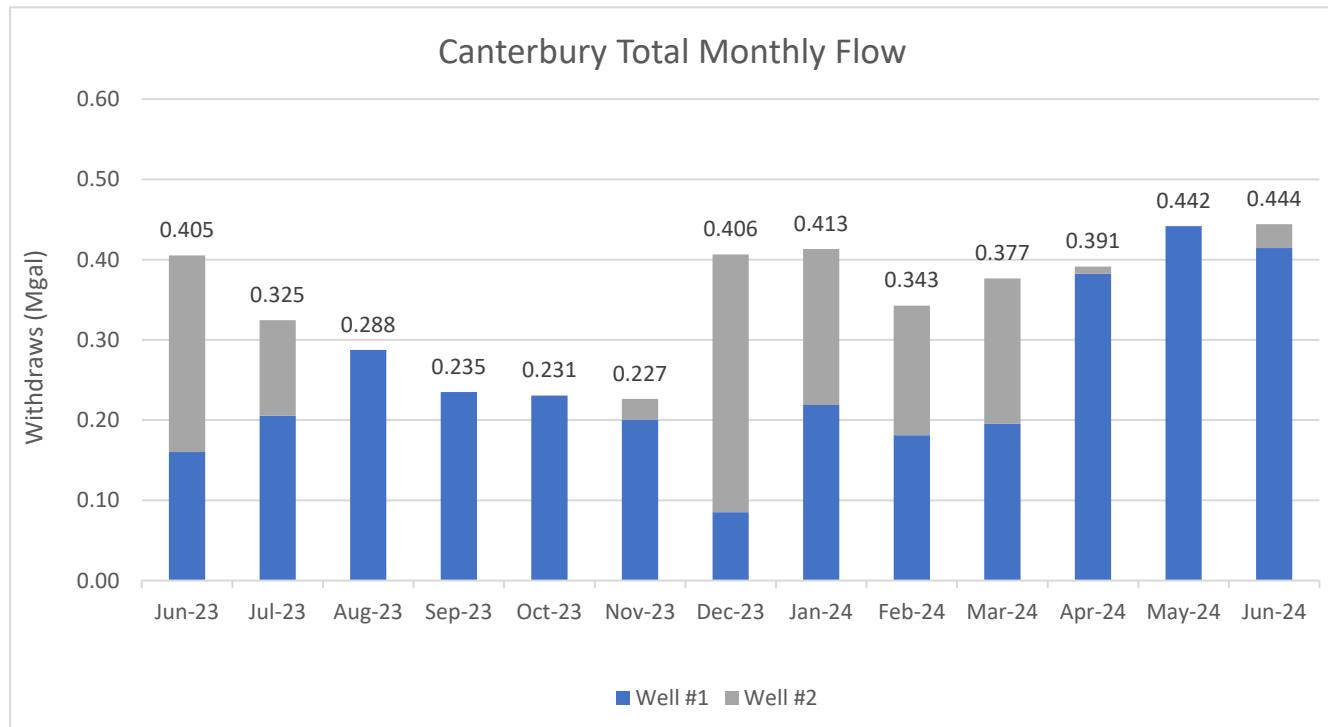
Canterbury Subdivision – PWSID 6099085

System Production:

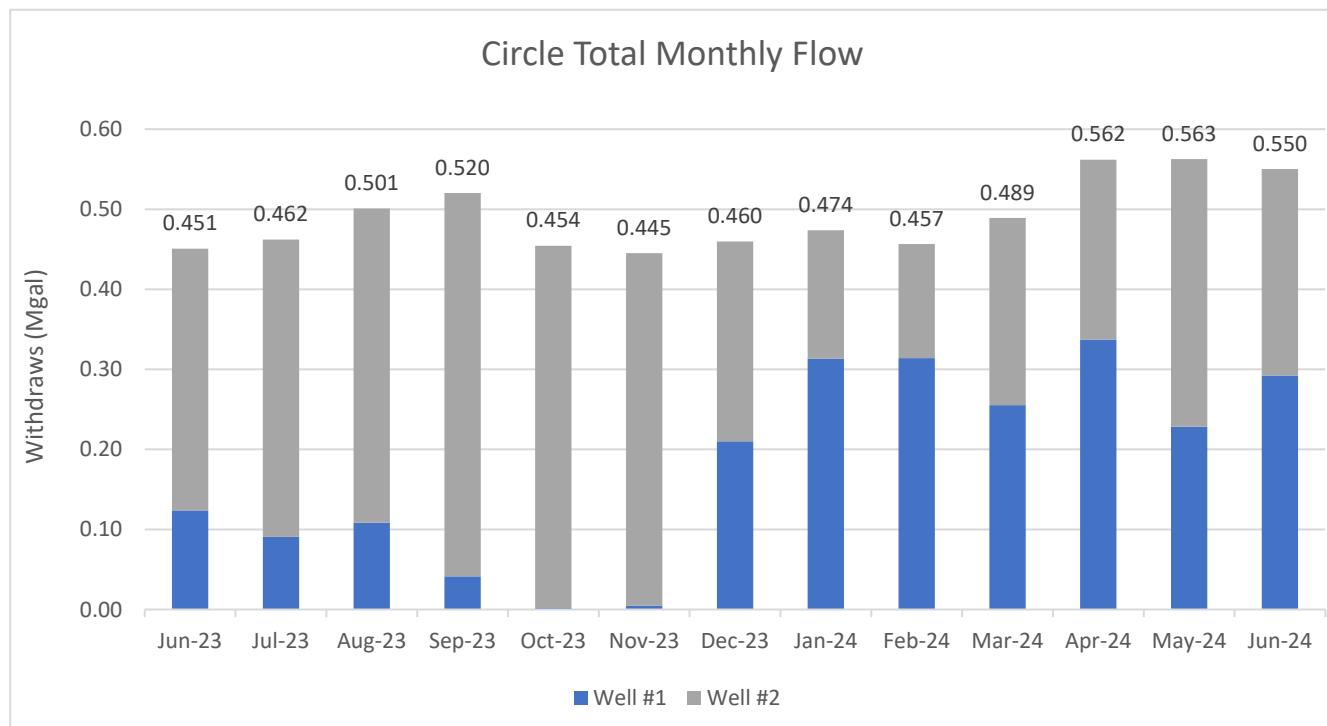
Circle – PWSID 6099100

System Production:

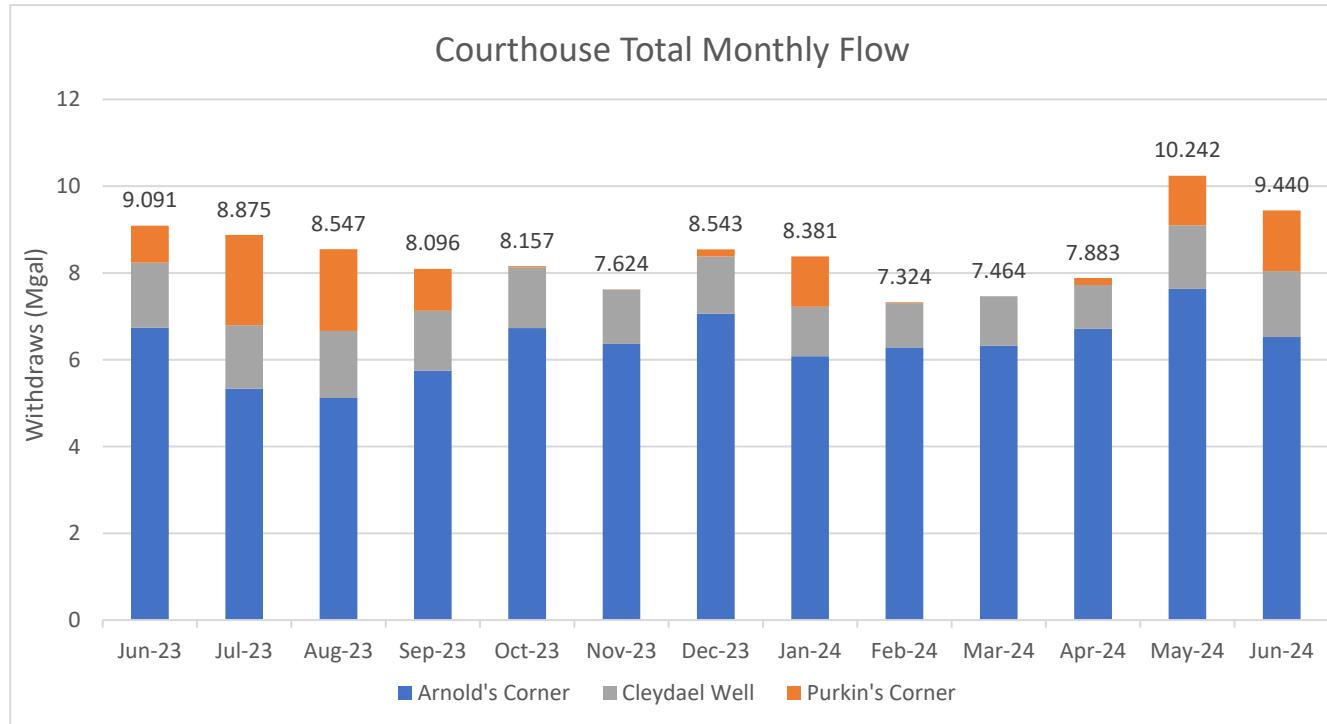
KGC Courthouse – PWSID 6099050

System Production:

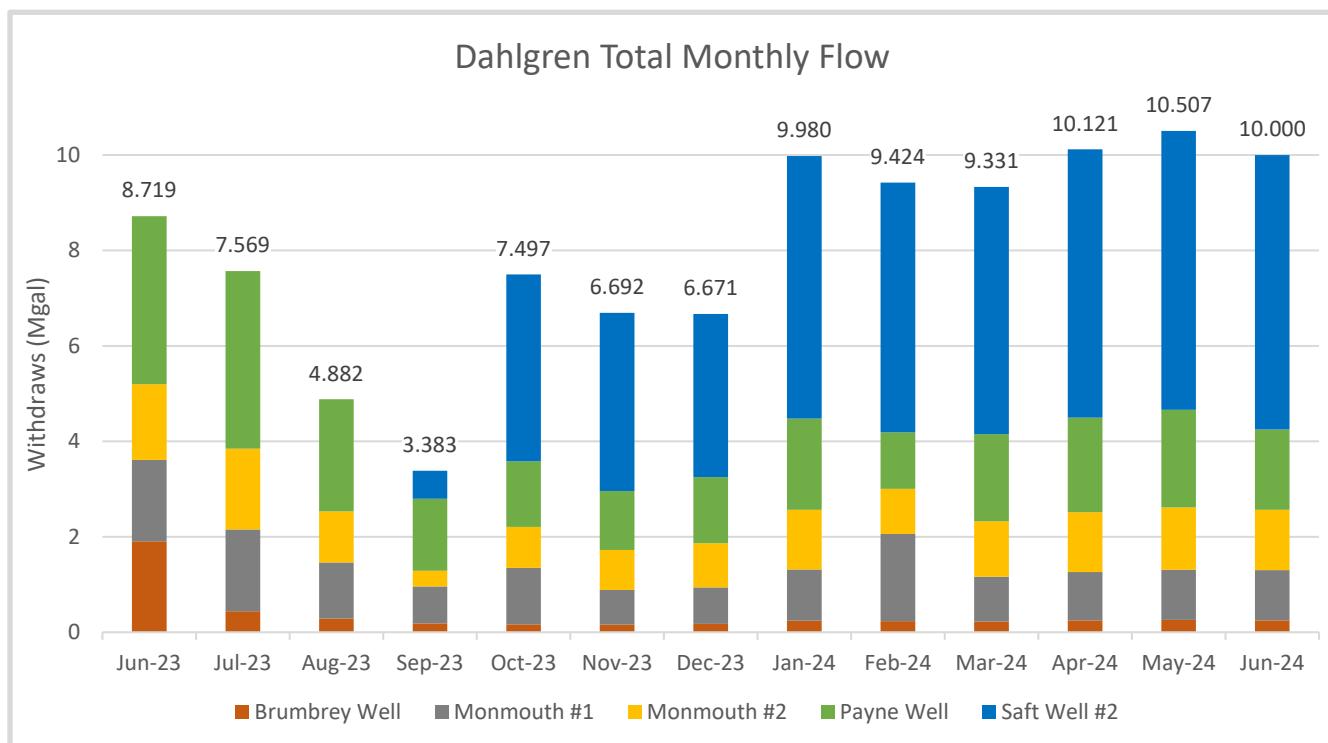
Dahlgren – PWSID 6099295

System Production:

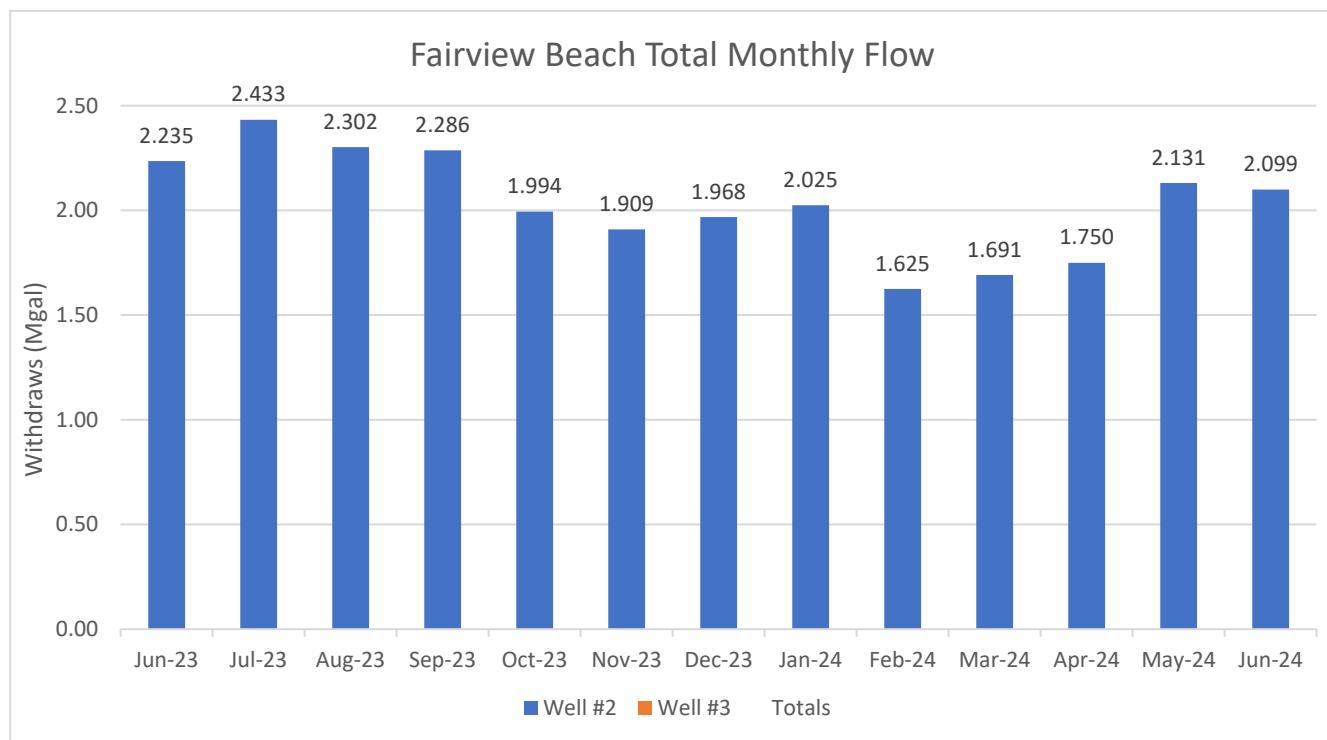
Fairview Beach – PWSID 6099250

System Production:

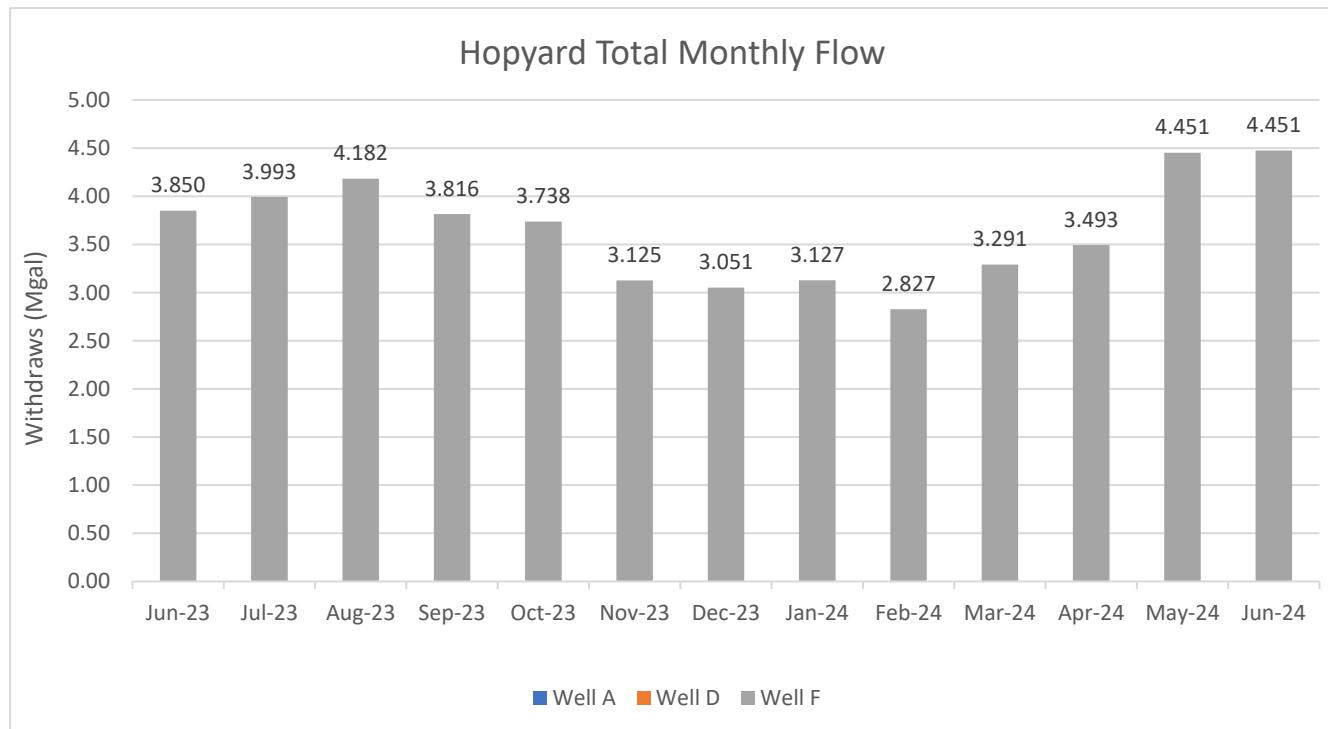
Hopyard Farm – PWSID 6099283

System Production:

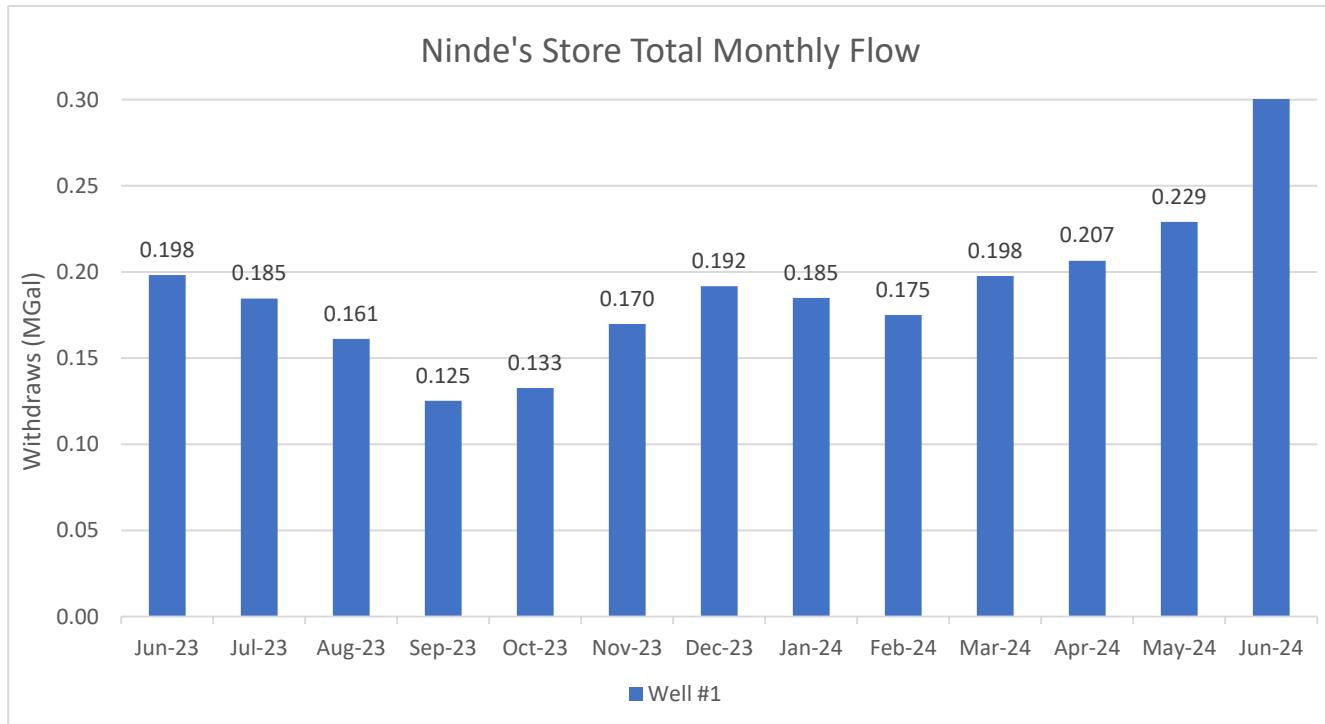
Ninde's Store – PWSID 6099300

System Production:

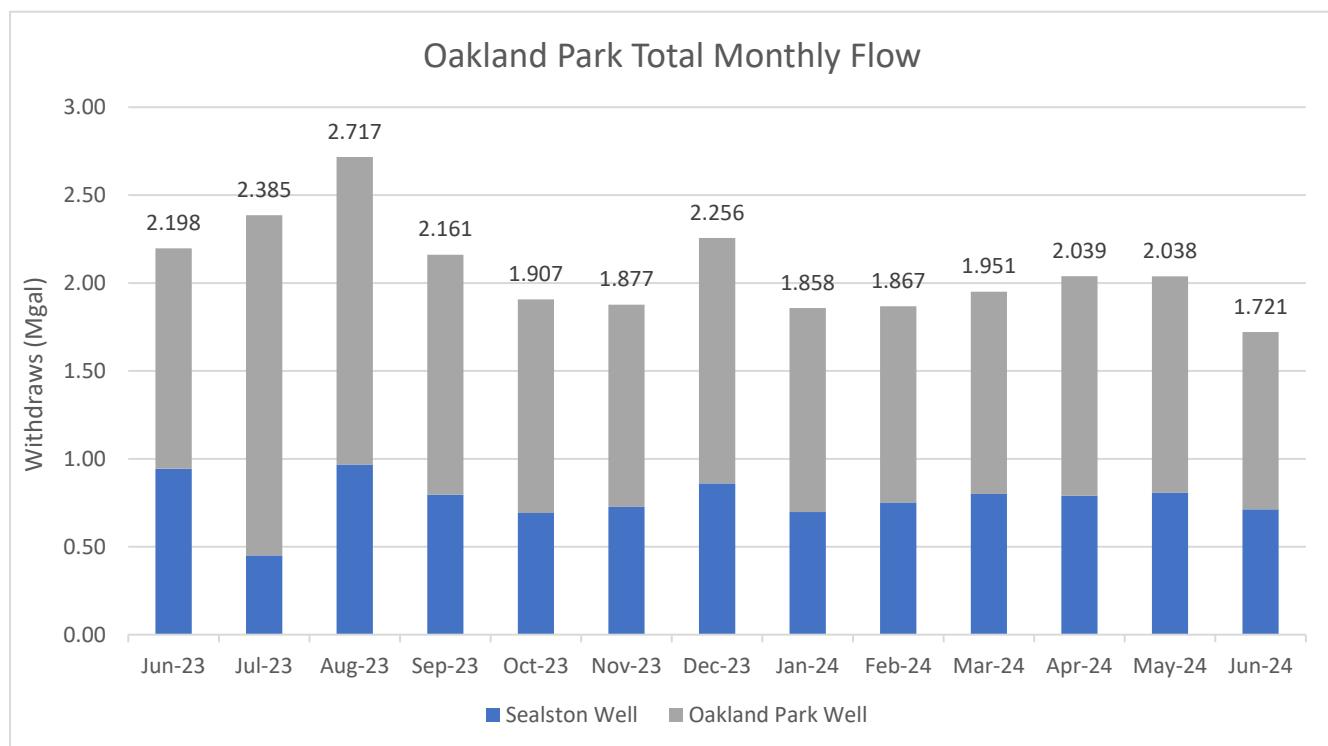
Oakland Park – PWSID 6099350

System Production:

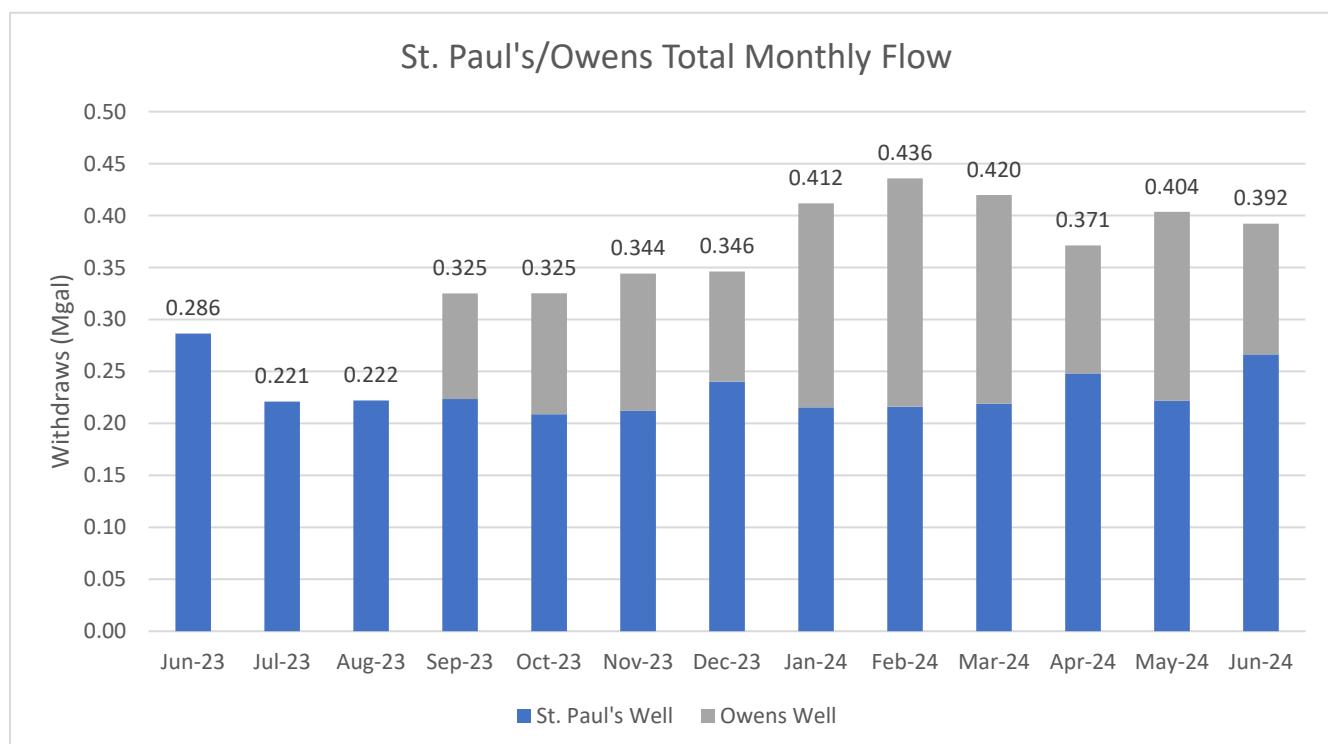
St. Paul's/Owens – PWSID 6099550

System Production:

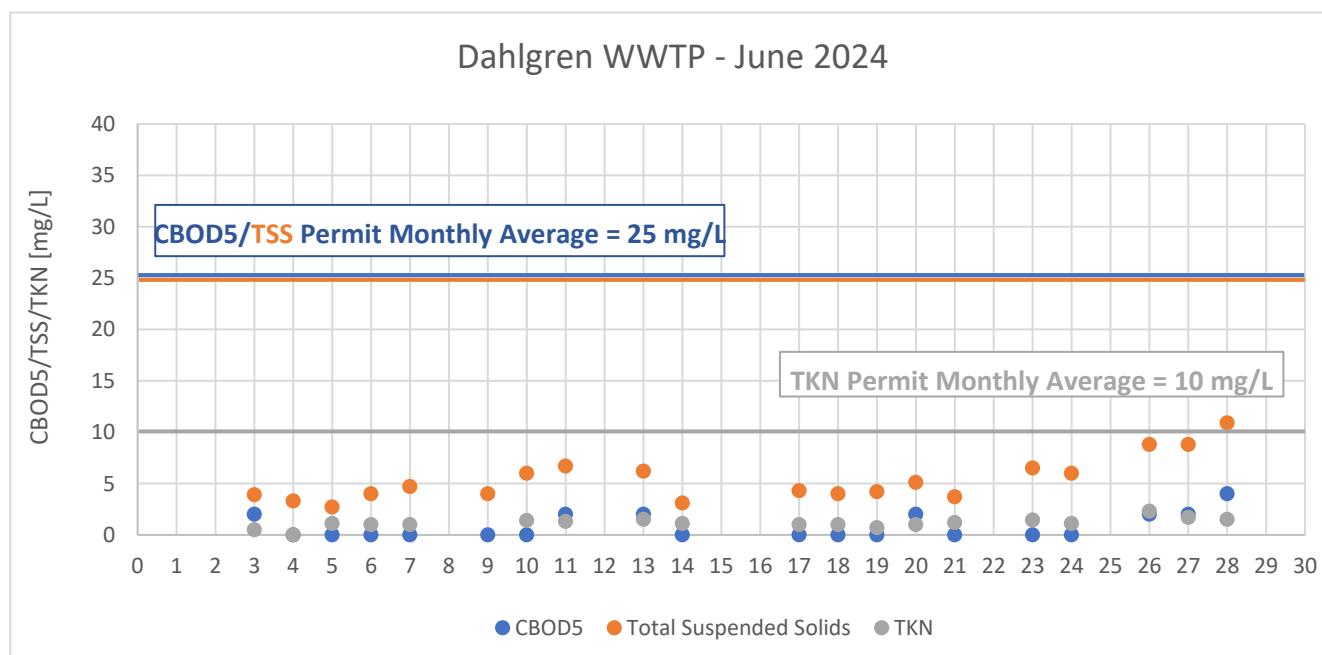
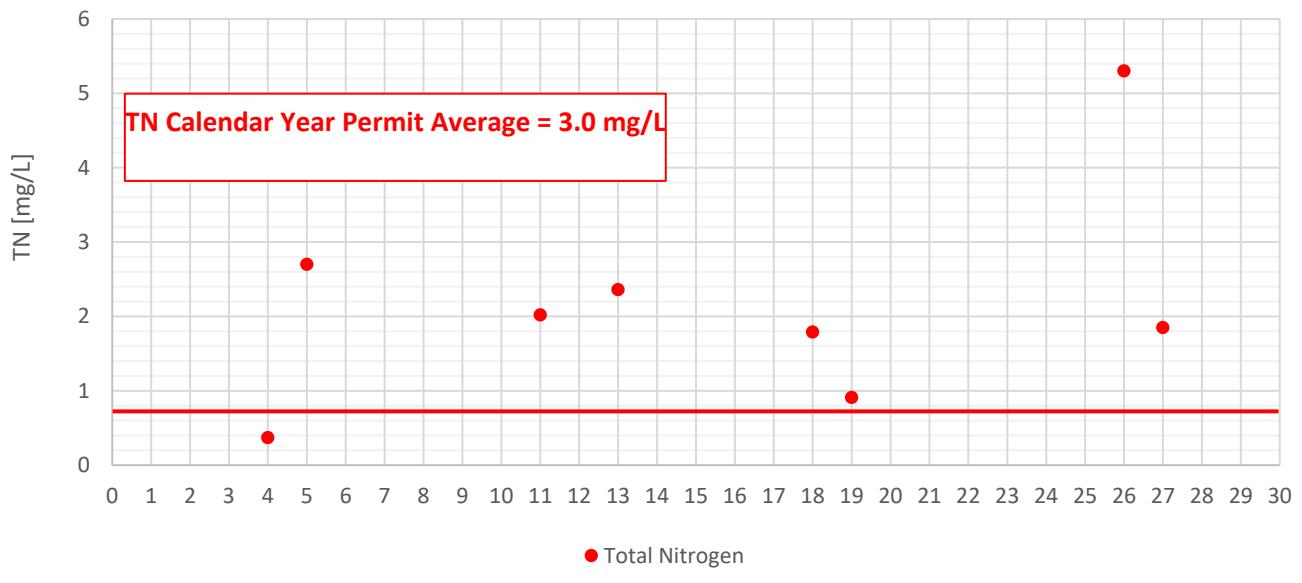
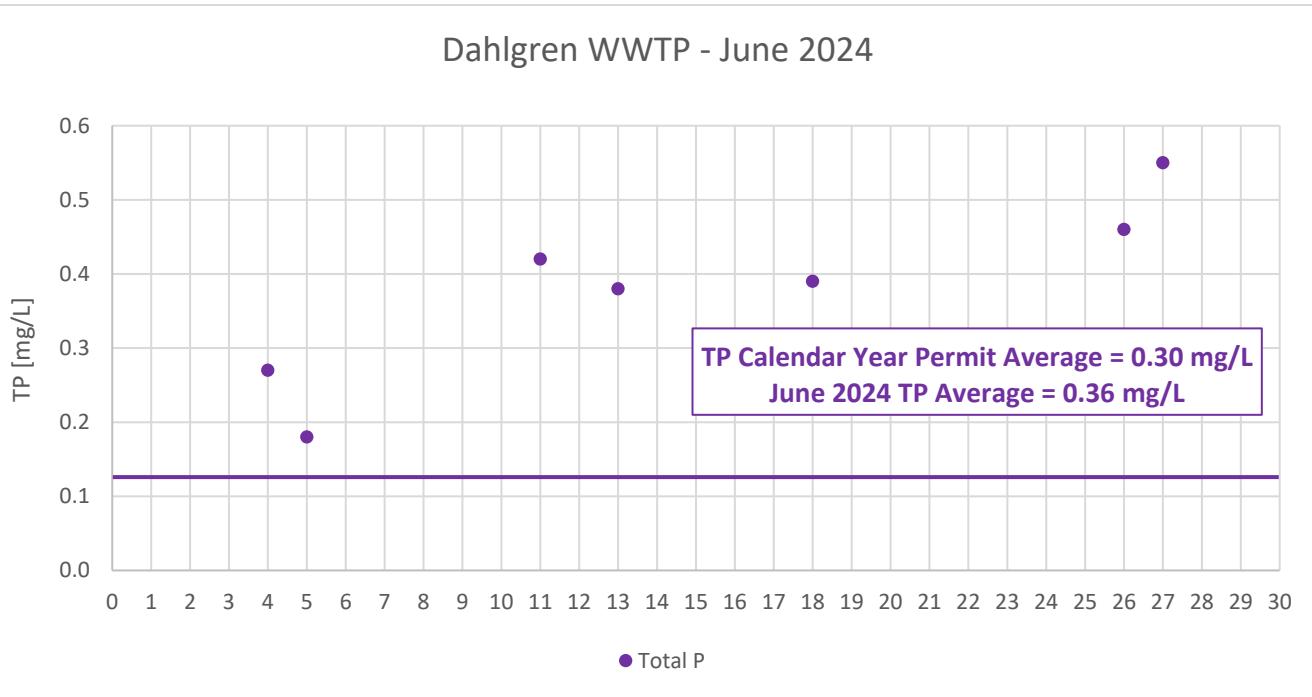
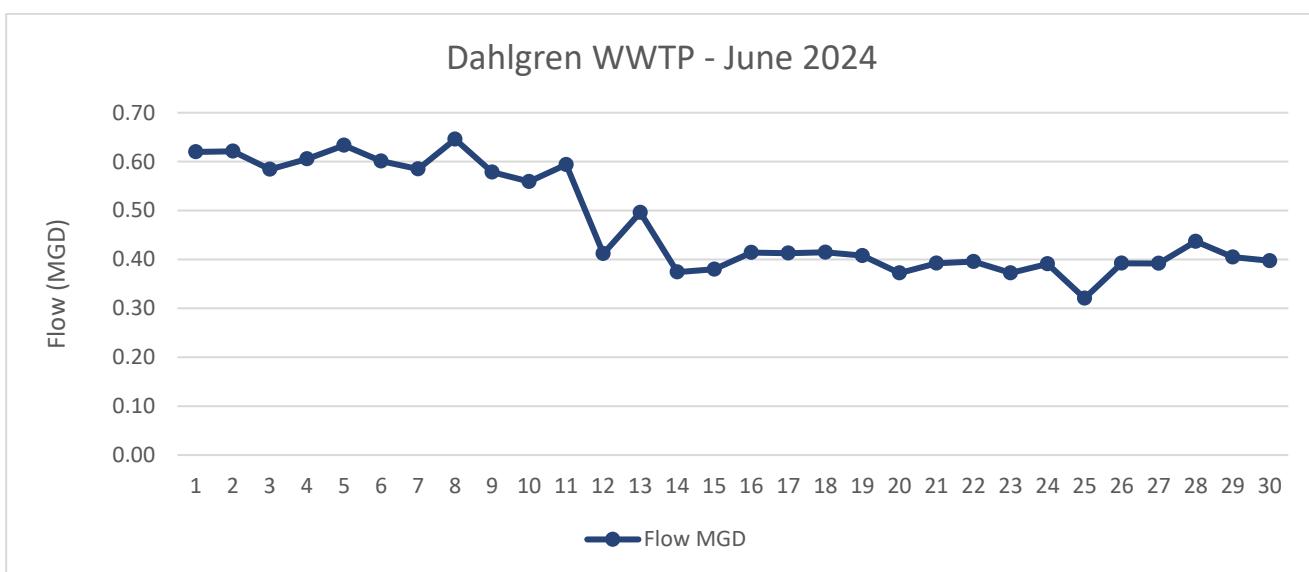
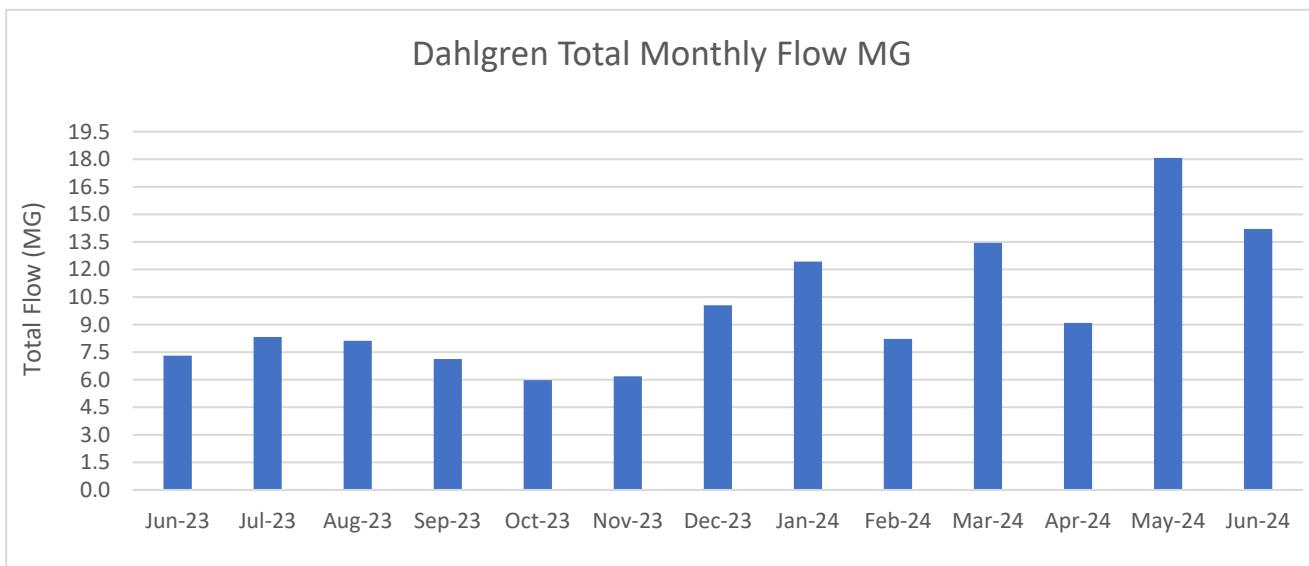
Dahlgren WWTP - June 2024

The Dahlgren WWTP met the sewer service area's sanitation demand with an average daily discharge of 0.473 MGD for a total monthly discharge of 14.204 MG.

The following charts depict a graphical analysis of effluent quality monitoring and treatment plant daily and total monthly flows.

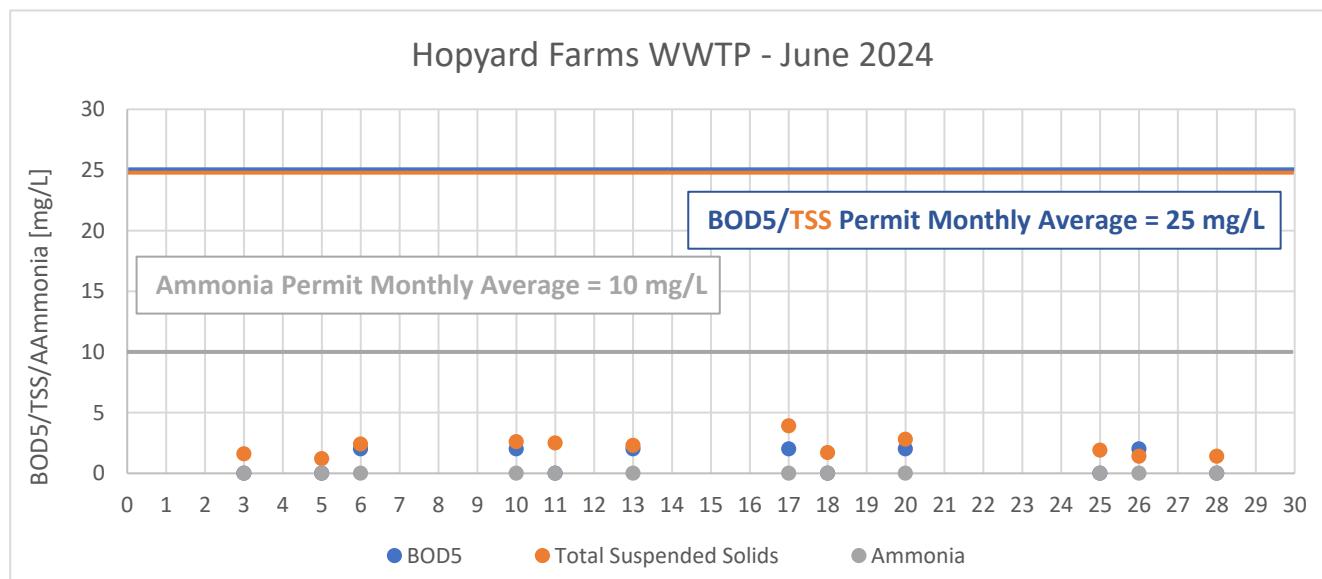
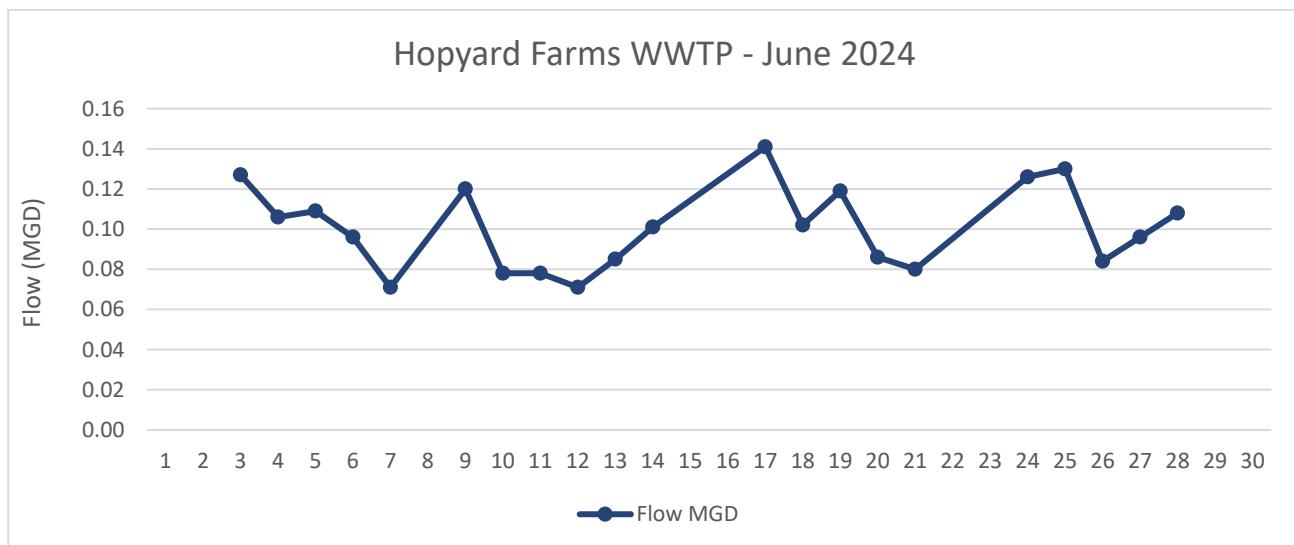
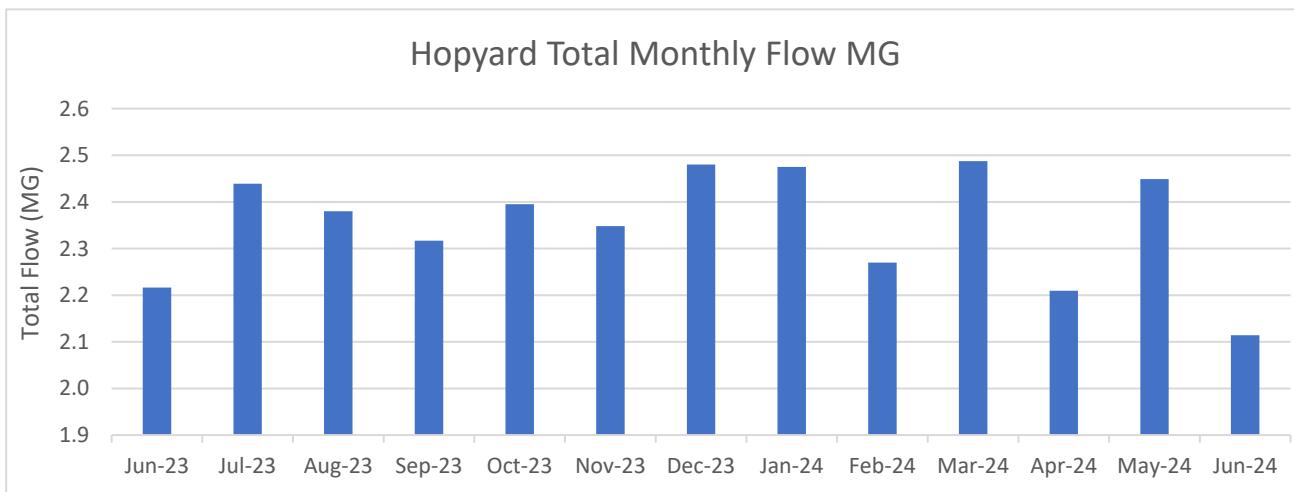
The Hopyard Farms WWTP met the sewer service area's sanitation demand with an average daily discharge of 0.101 MGD for a total monthly discharge of 2.114 MG.

The following charts depict a graphical analysis of effluent quality monitoring and treatment plant daily and total monthly flows.

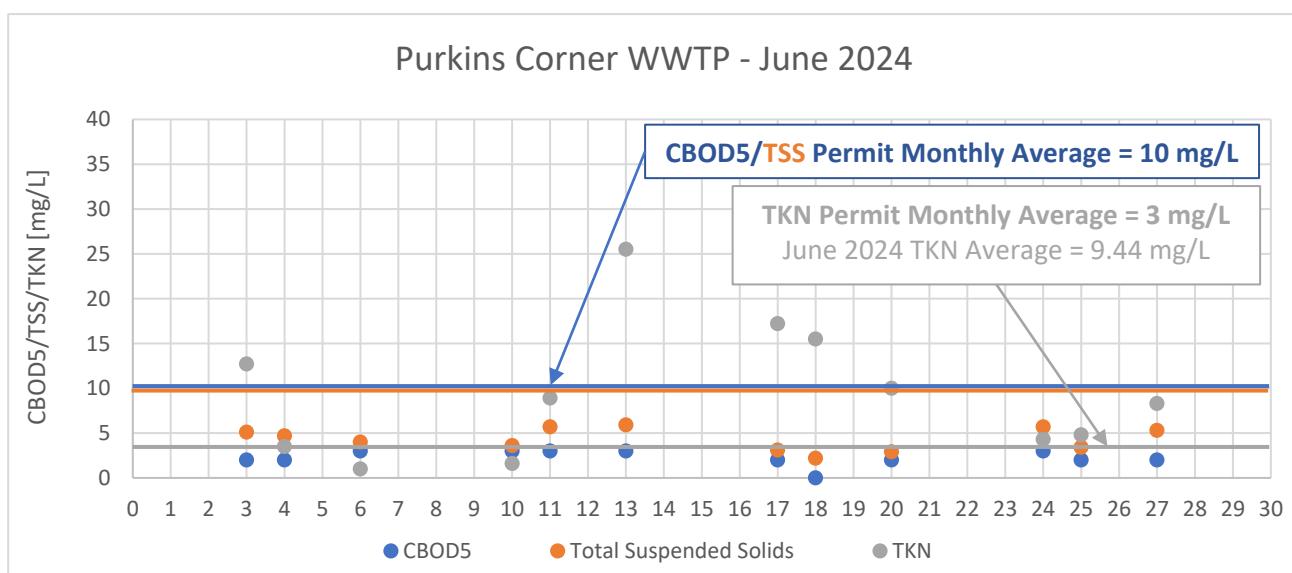
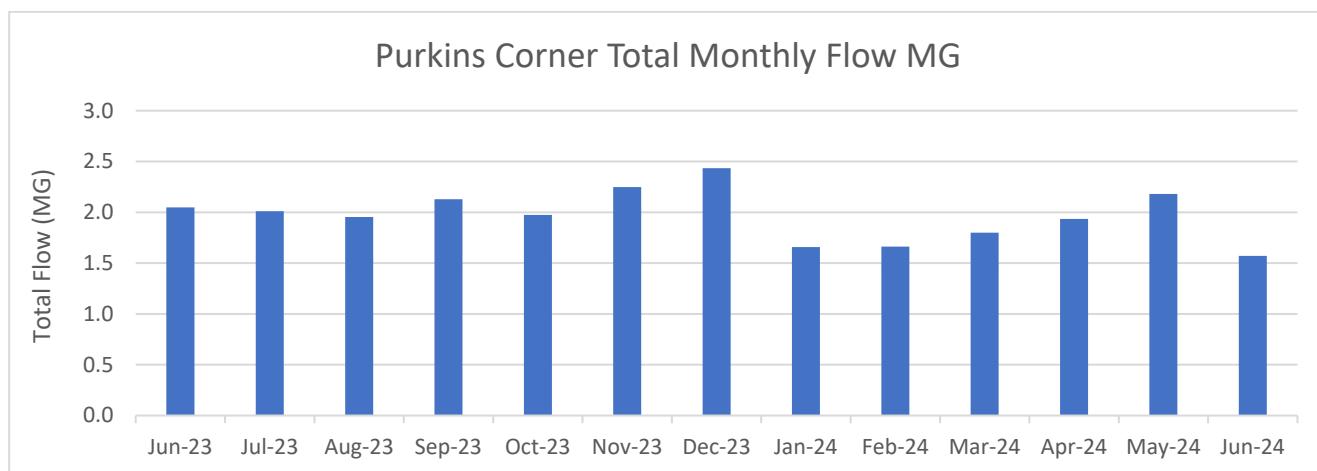
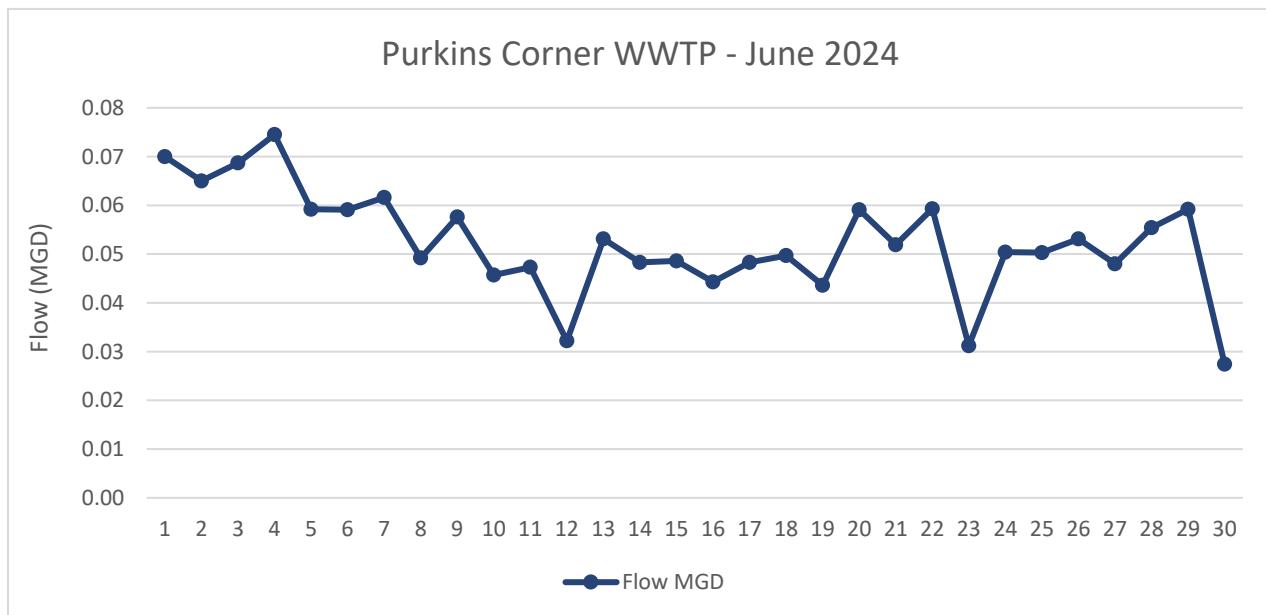
The wastewater treatment facility maintained compliance with permit-required sampling except for TKN. It was determined that the TKN exceedance was due to influent concentration values being higher than the plant's treatment capabilities coupled with a mixer that has failed. A replacement mixer has been ordered.

The Purkins Corner WWTP met the sewer service area's sanitation demand with an average daily discharge of 0.052 MGD for a total monthly discharge of 1.571 MG.

The following charts depict a graphical analysis of effluent quality monitoring and treatment plant daily and total monthly flows.

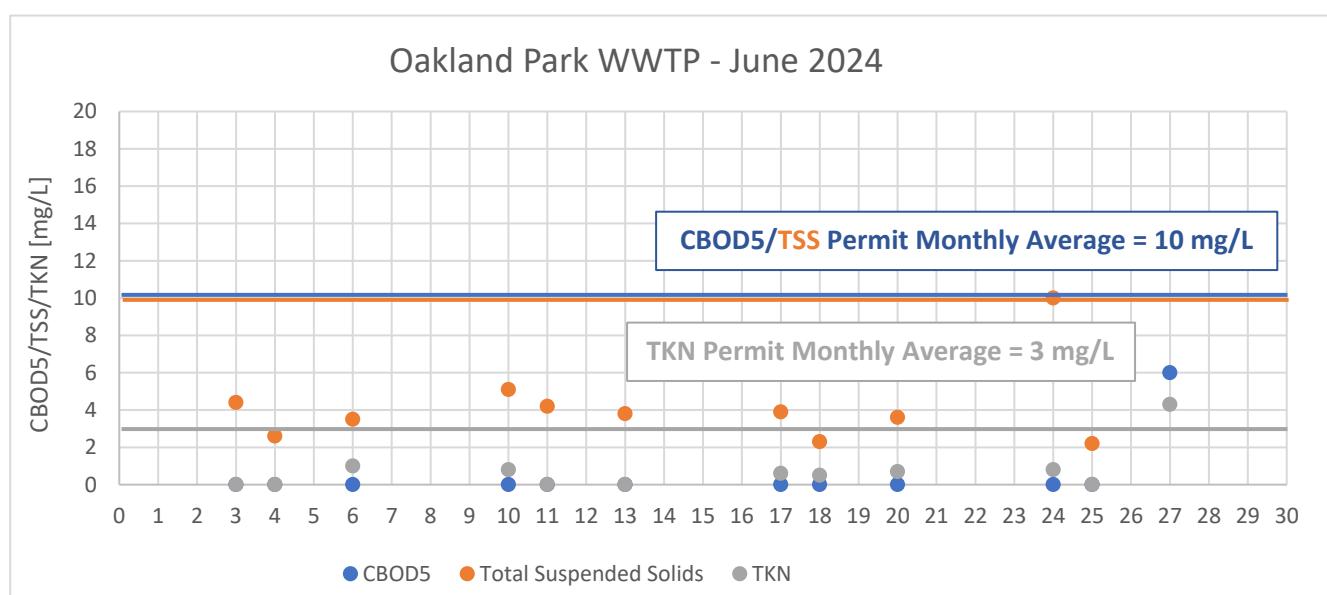
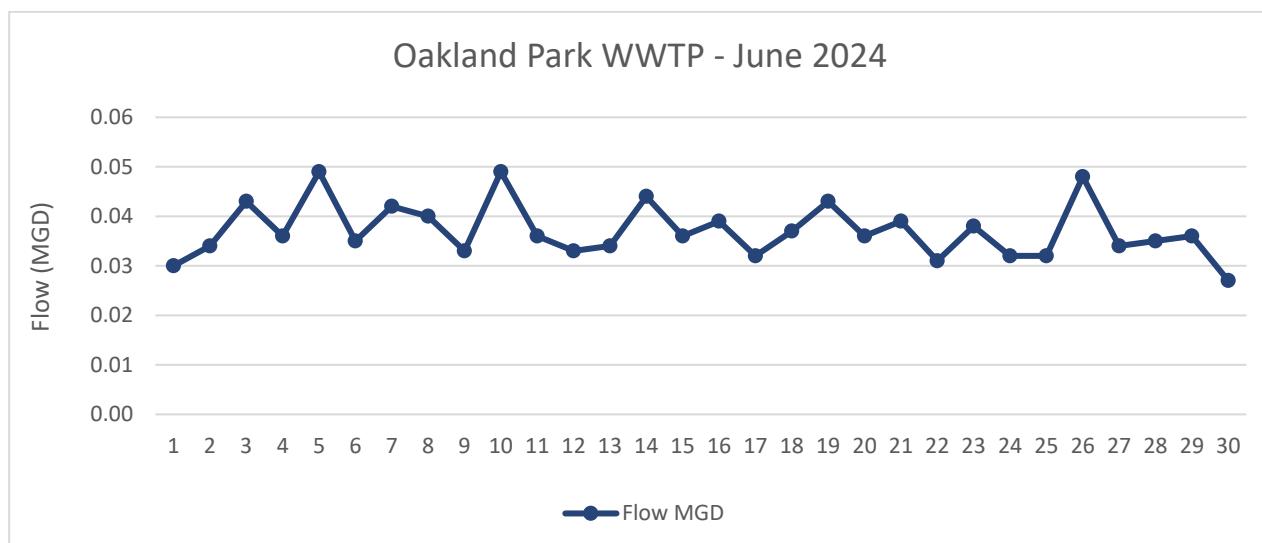
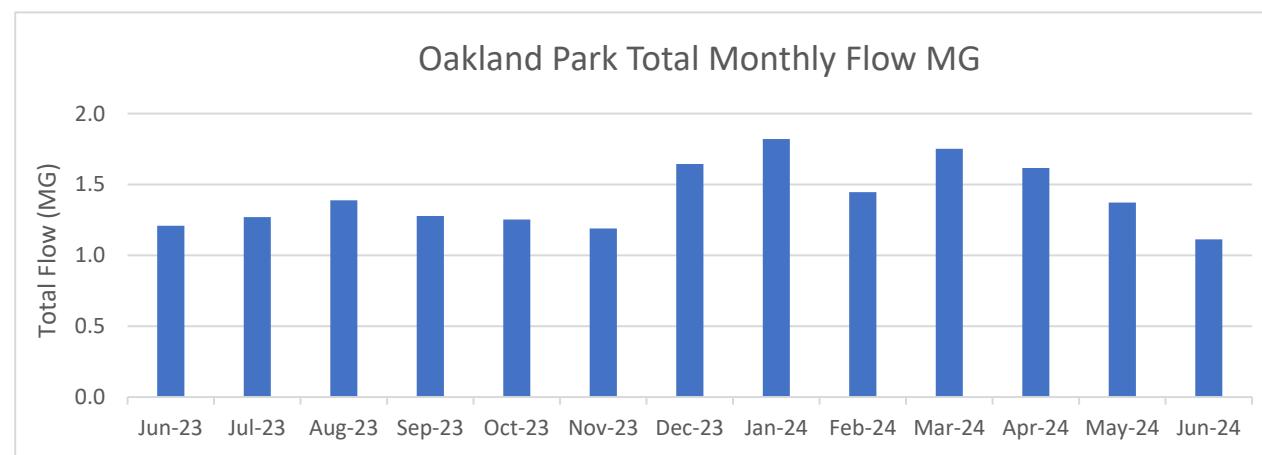
The wastewater treatment facility maintained compliance with all permit-required sampling with the exception of D.O. It was determined that the low D.O. values were caused by collecting the samples early in the morning during a period of no forward flow.

The Oakland Park WWTP met the sewer service area's sanitation demand with an average daily discharge of 0.037 MGD for a total monthly discharge of 1.113 MG.

The following charts depict a graphical analysis of effluent quality monitoring and treatment plant daily and total monthly flows.

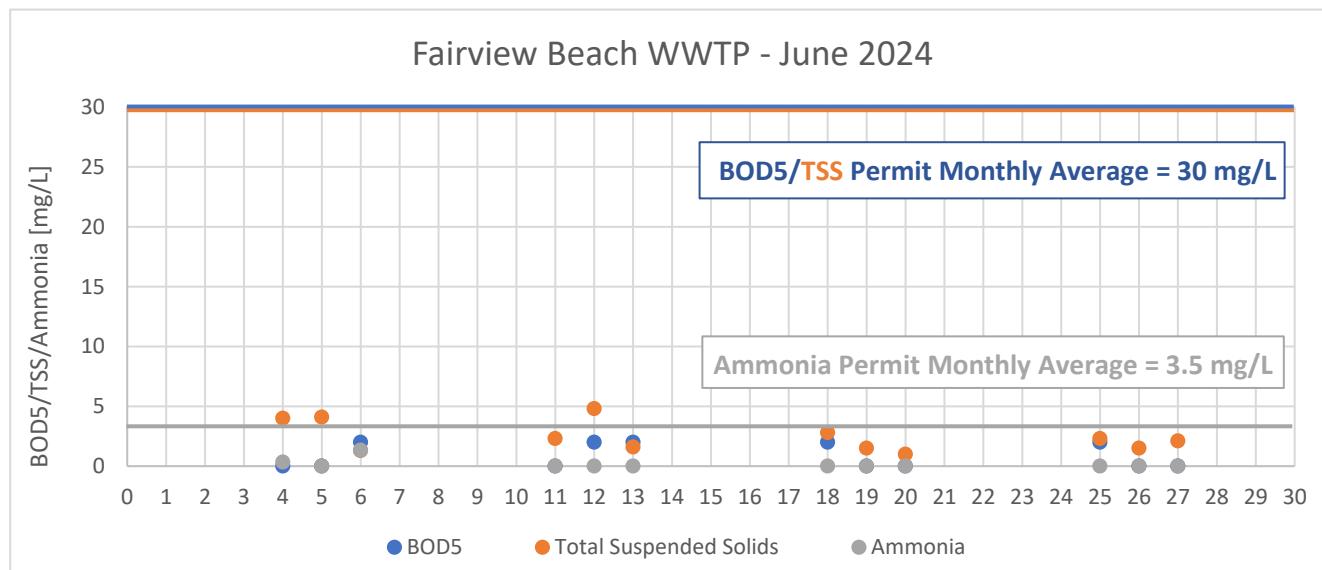
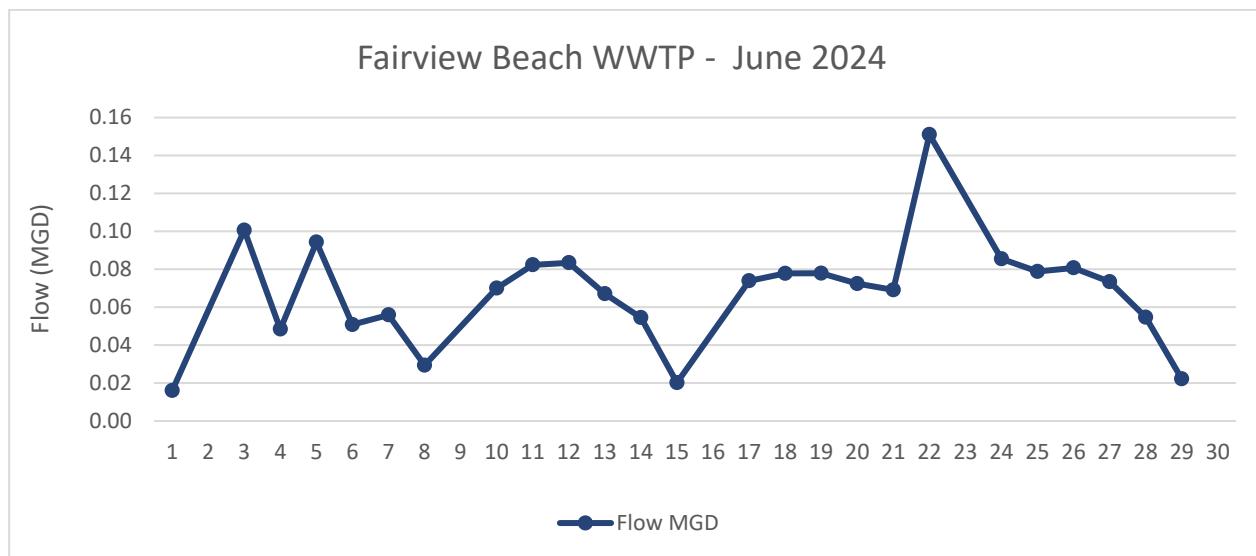
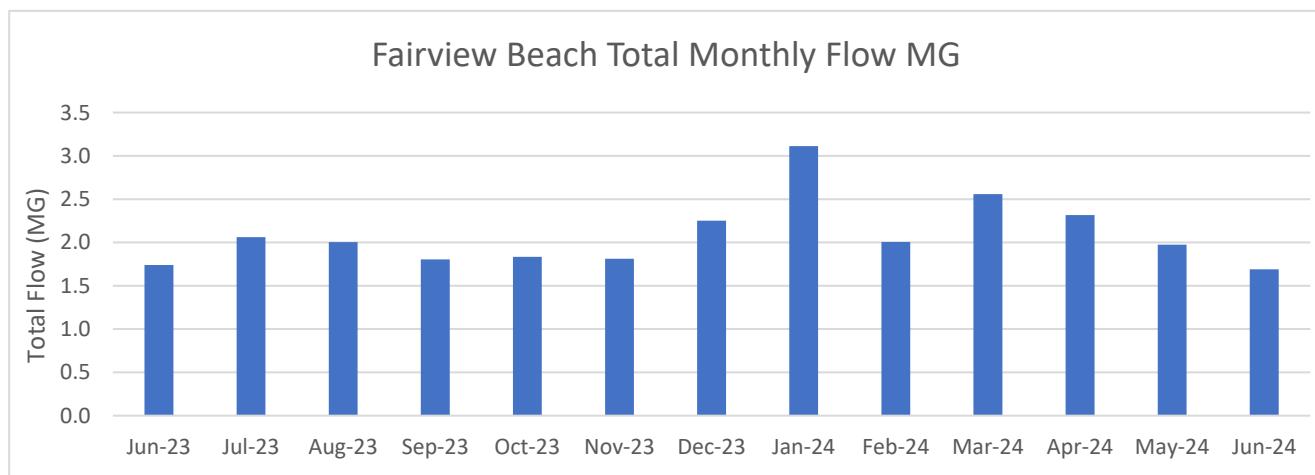
The Fairview Beach WWTP met the sewer service area's sanitation demand with an average daily discharge of 0.102 MGD for a total monthly discharge of 2.539 MG (25 days with flow).

The following charts depict a graphical analysis of effluent quality monitoring and treatment plant daily and total monthly flows.
