UTILITY REPORT

AUGUST 2024

**King George County
Service Authority**

**Authored by:
Inboden Environmental
Services, Inc.**

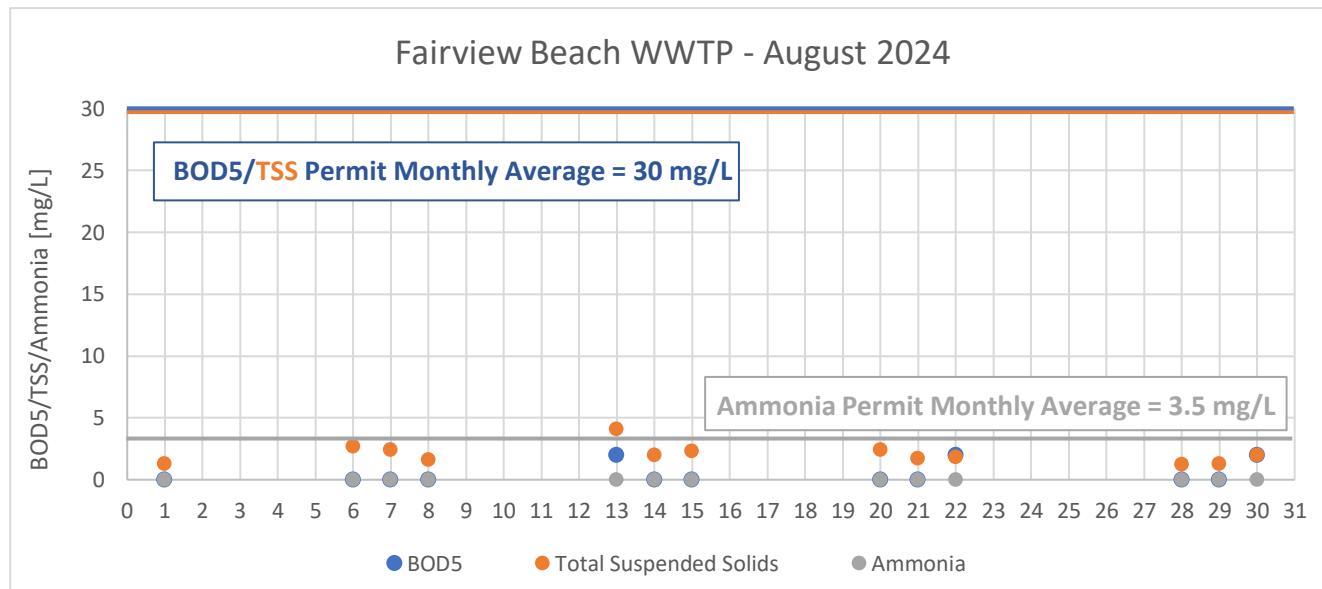
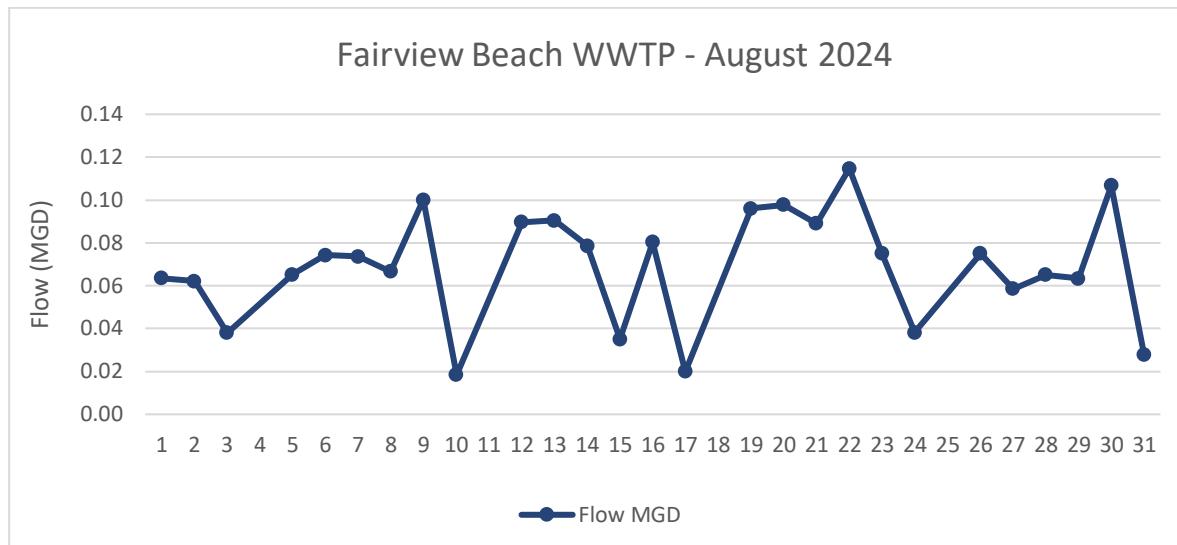
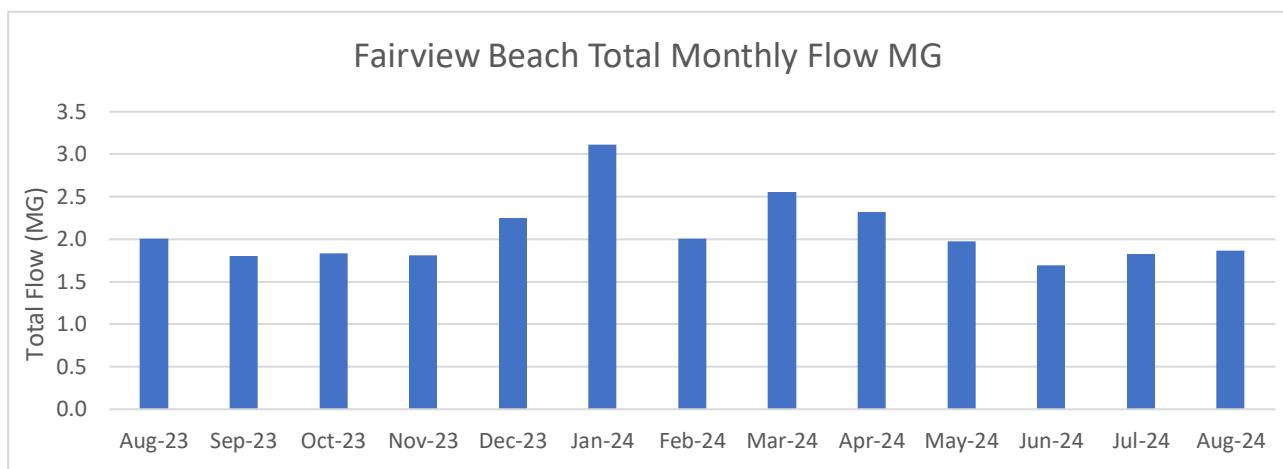
The Fairview Beach WWTP met the sewer service area's sanitation demand with an average daily discharge of 0.069 MGD for a total monthly discharge of 1.864 MG (27 days with flow).

The following charts depict a graphical analysis of effluent quality monitoring and treatment plant daily and total monthly flows.
