UTILITY REPORT

OCTOBER 2024

King George County
Service Authority

Authored by:
Inboden Environmental
Services, Inc.

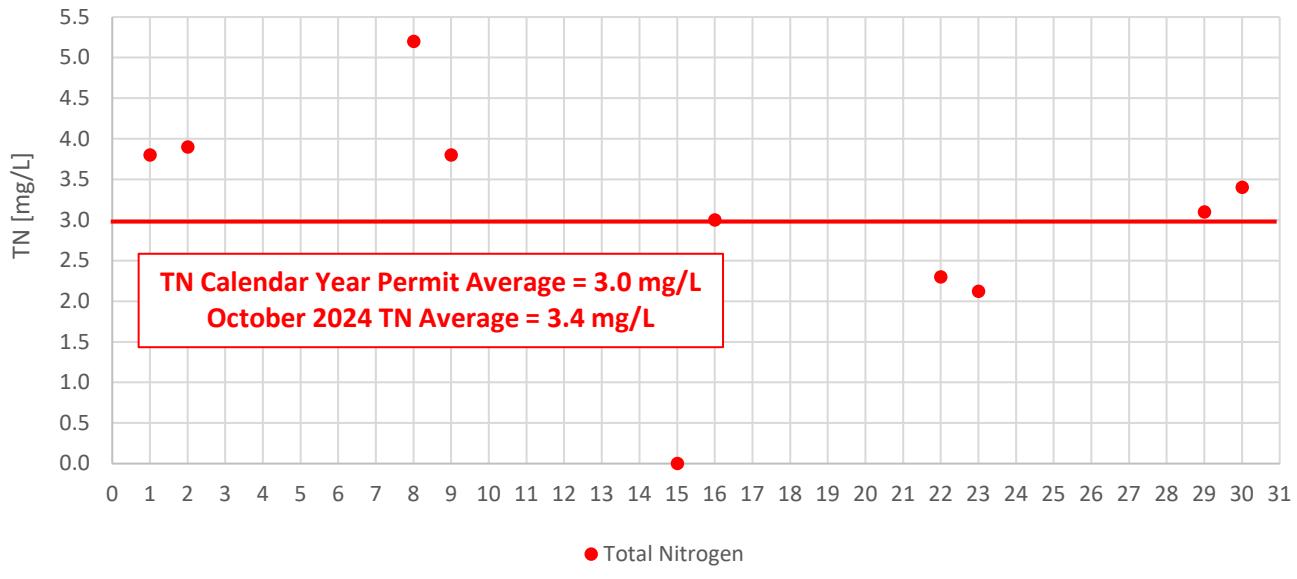
Dahlgren WWTP Total Nitrogen - October 2024

The following charts depict a graphical analysis of effluent quality monitoring and treatment plant daily and total monthly flows.

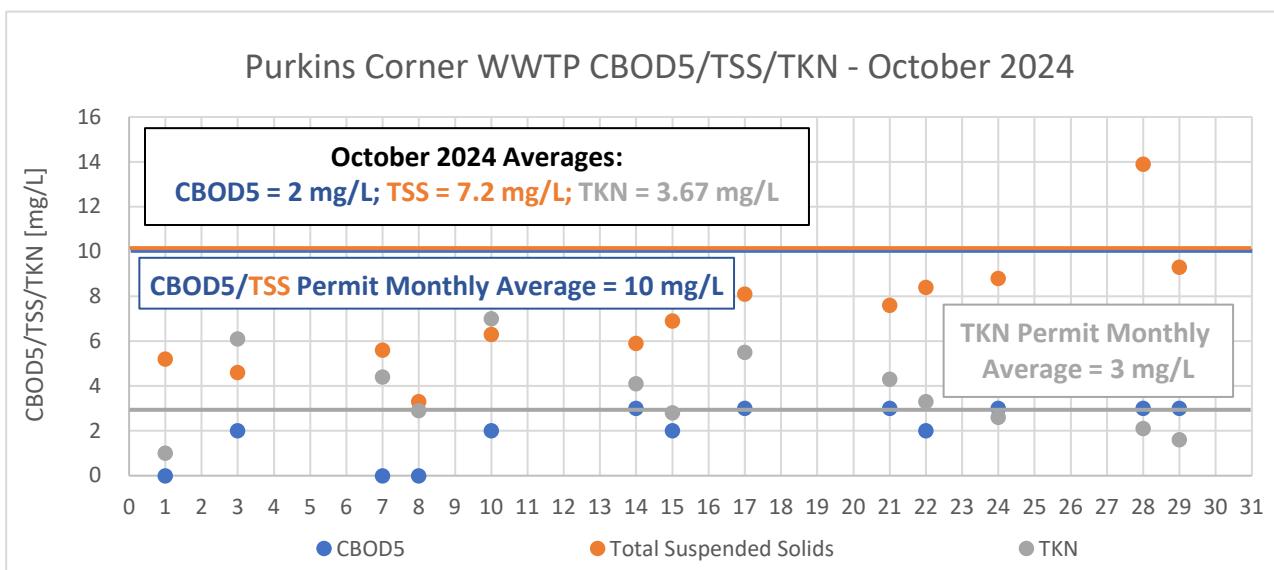
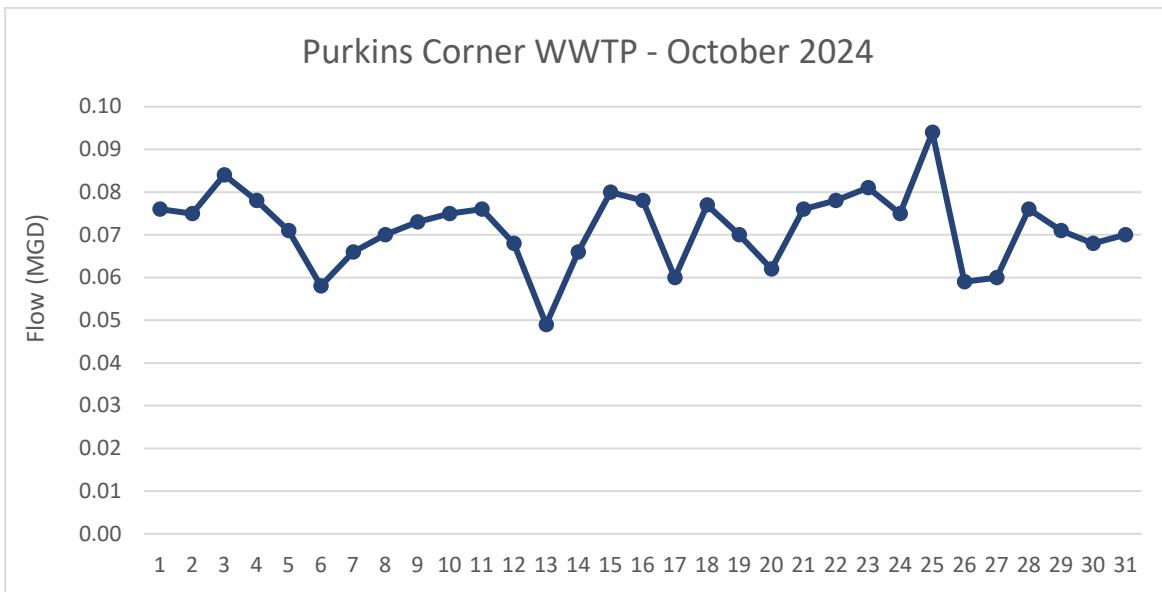
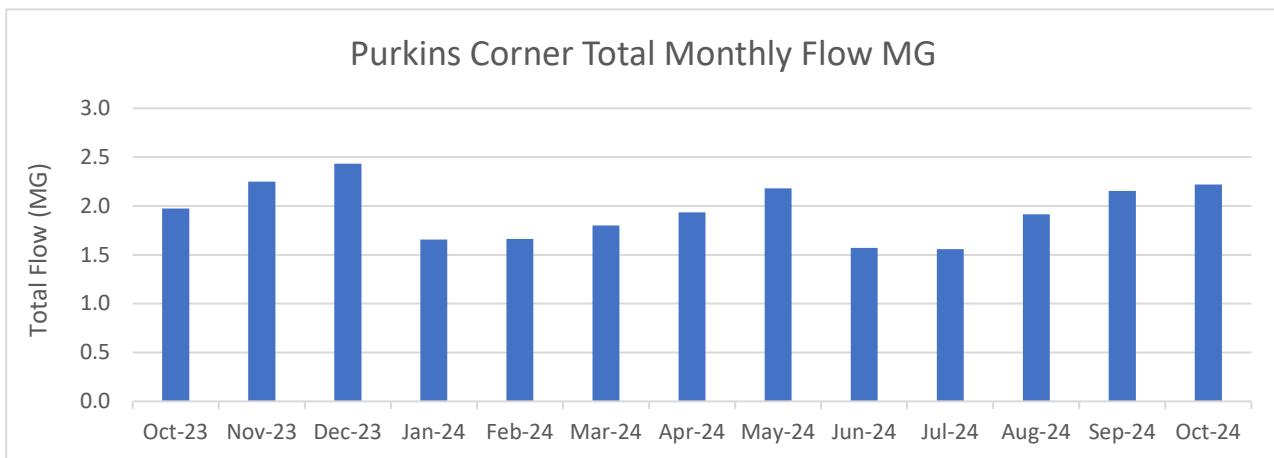
- During the October monitoring period, TKN exceeded the weekly permit limit (4.5 mg/L) at 4.77 mg/L, and the monthly permit limit (3.0 mg/L) at 3.67 mg/L. The elevated TKN concentrations were due to a failed anoxic tank mixer on the B side of the plant. A temporary mixer was put in place, but it was not as effective as the original. This required the WWTP staff to feed influent into the aeration zone, limiting denitrification. A replacement mixer was delivered and installed on November 4th.

The following charts depict a graphical analysis of effluent quality monitoring and treatment plant daily and total monthly flows.

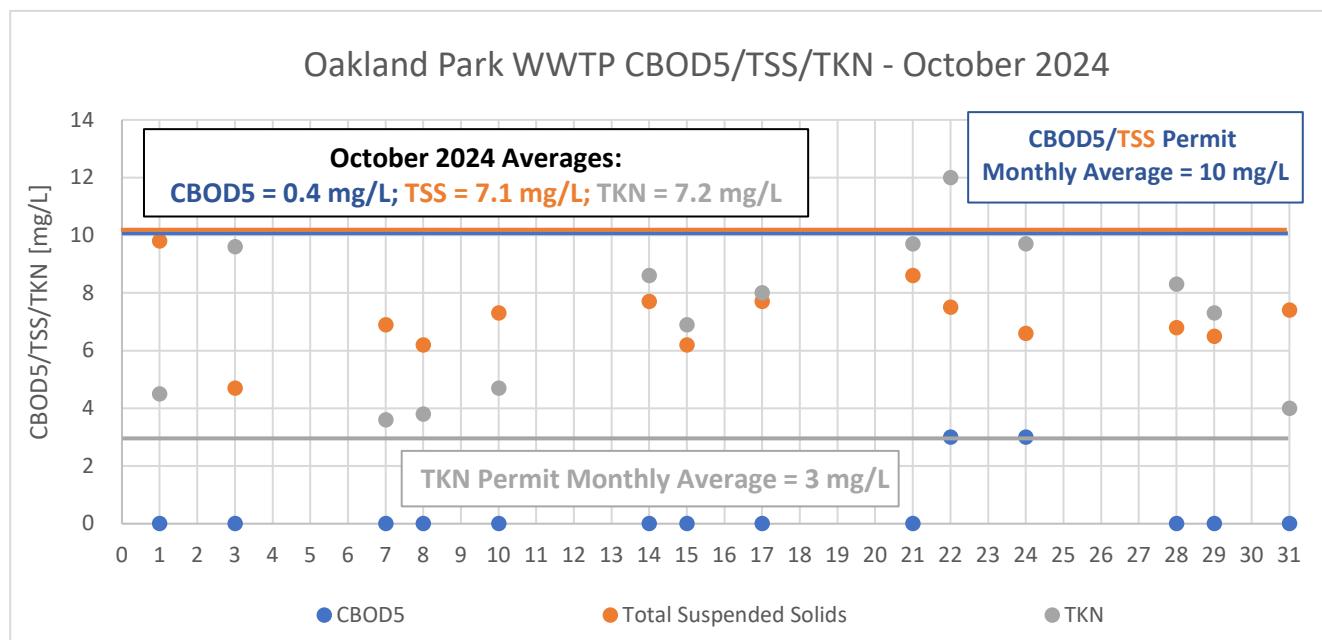
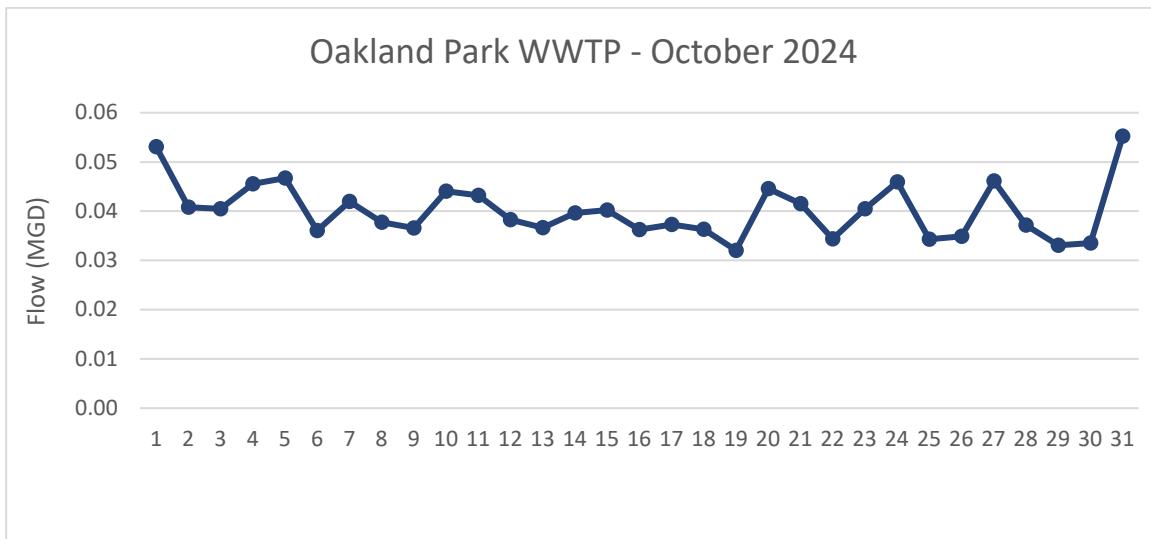
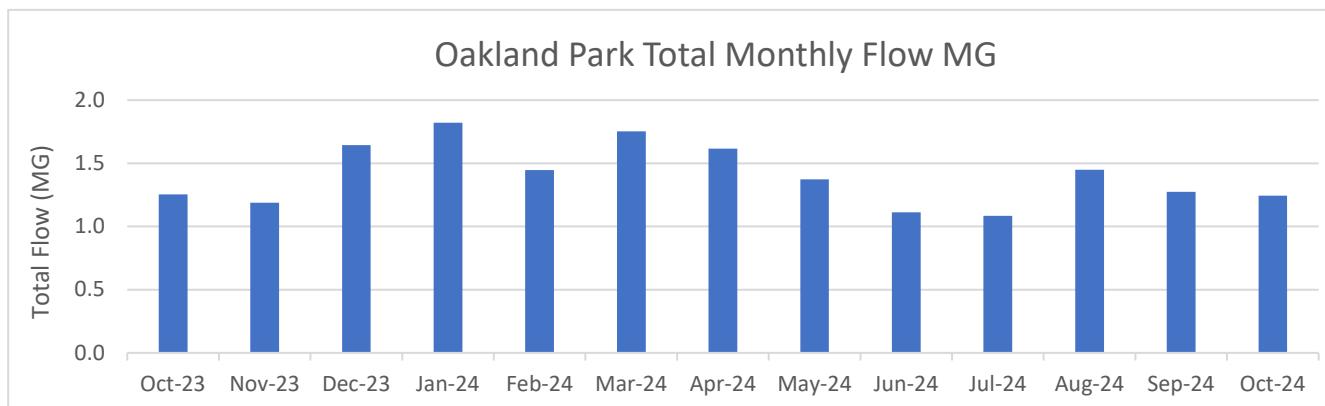
- During the October monitoring period, TKN exceeded the weekly permit limit (4.5 mg/L) twice at 7.83 and 10.47 mg/L, and the monthly permit limit (3.0 mg/L) at 7.19 mg/L. The elevated TKN was due to a clogged RAS line in Plant A and a ruptured BioCarb feed line. Both lines have since been unclogged/repaired.

The following charts depict a graphical analysis of effluent quality monitoring and treatment plant daily and total monthly flows.
