# UTILITY REPORT

**FEBRUARY 2025**

**King George County  
Service Authority**

**Authored by:  
Inboden Environmental  
Services, Inc.**

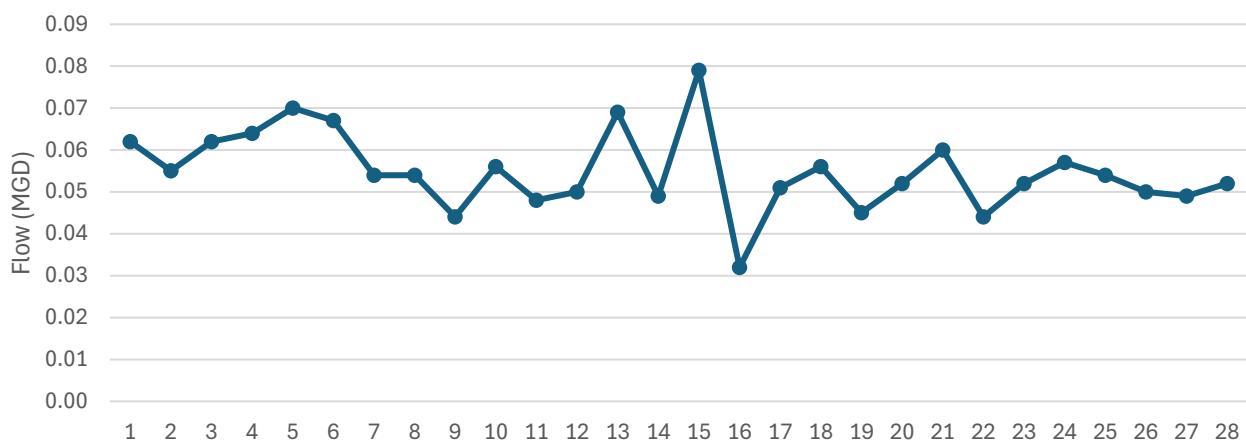
### Purkins Corner WWTP Flow - February 2025

The Purkins Corner WWTP met the sewer service area's sanitation demand with an average daily discharge of 0.055 MGD for a total monthly discharge of 1.537 MG.
