UTILITY REPORT

JULY 2025

**King George County
Service Authority**

**Authored by:
Inboden Environmental
Services, Inc.**

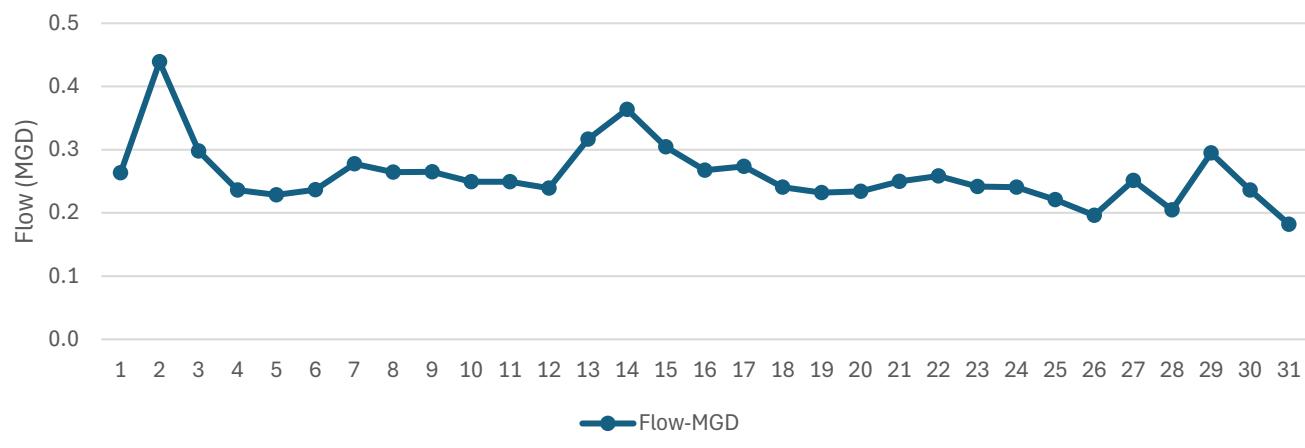
Dahlgren WWTP Flow - July 2025

The Dahlgren WWTP met the sewer service area's sanitation demand with an average daily discharge of 0.260 MGD for a total monthly discharge of 8.056 MG.

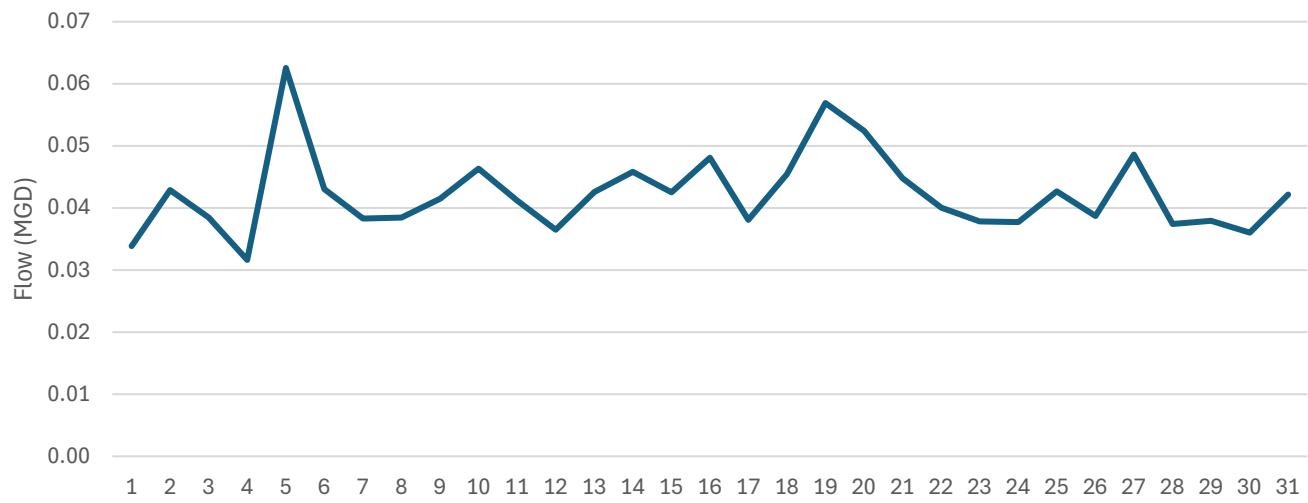
Oakland Park WWTP - July 2025

The Oakland Park WWTP met the sewer service area's sanitation demand with an average daily discharge of 0.042 MGD for a total monthly discharge of 1.311 MG.

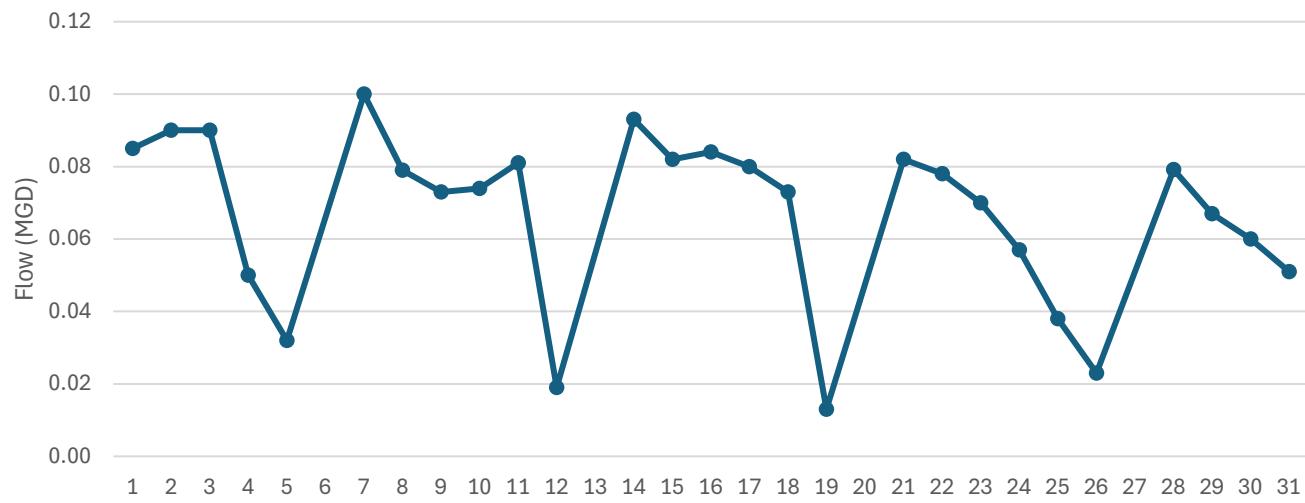
Fairview Beach WWTP - June 2025

The Fairview Beach WWTP met the sewer service area's sanitation demand with an average daily discharge of 0.067 MGD for a total monthly discharge of 1.803 MG (27 days with flow).
