UTILITY REPORT

SEPTEMBER 2025

**King George County
Service Authority**

**Authored by:
Inboden Environmental
Services, Inc.**

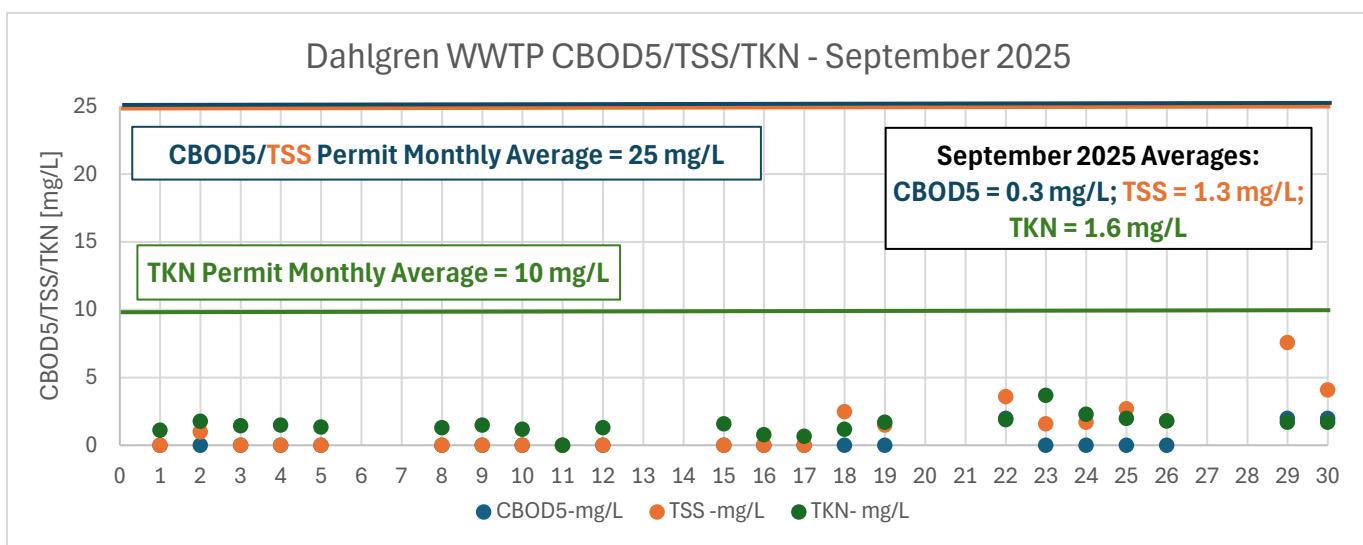
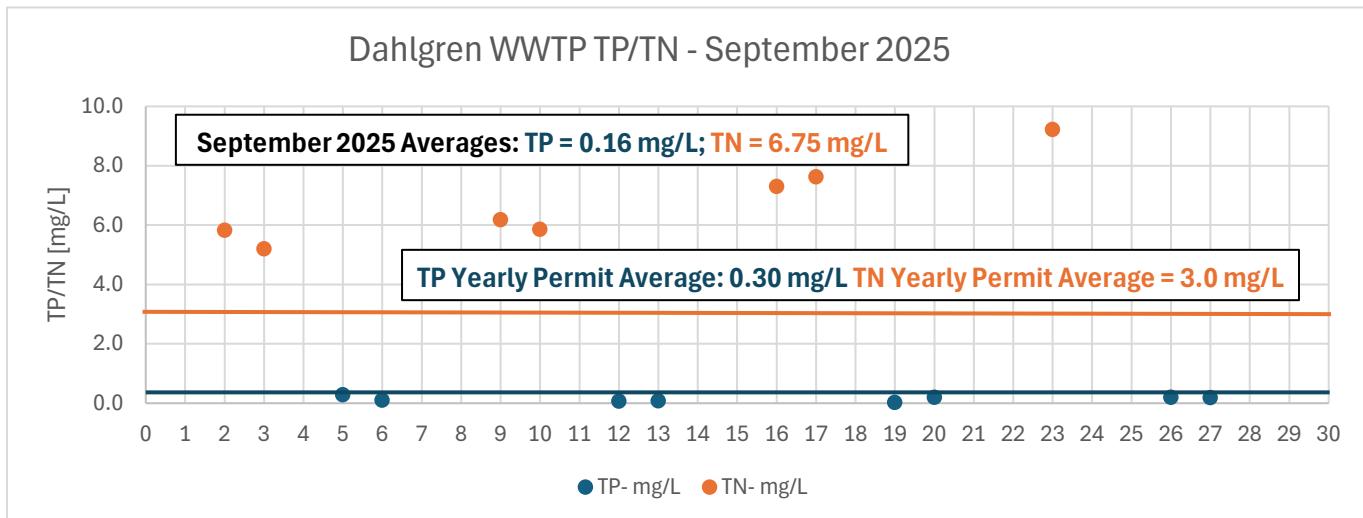
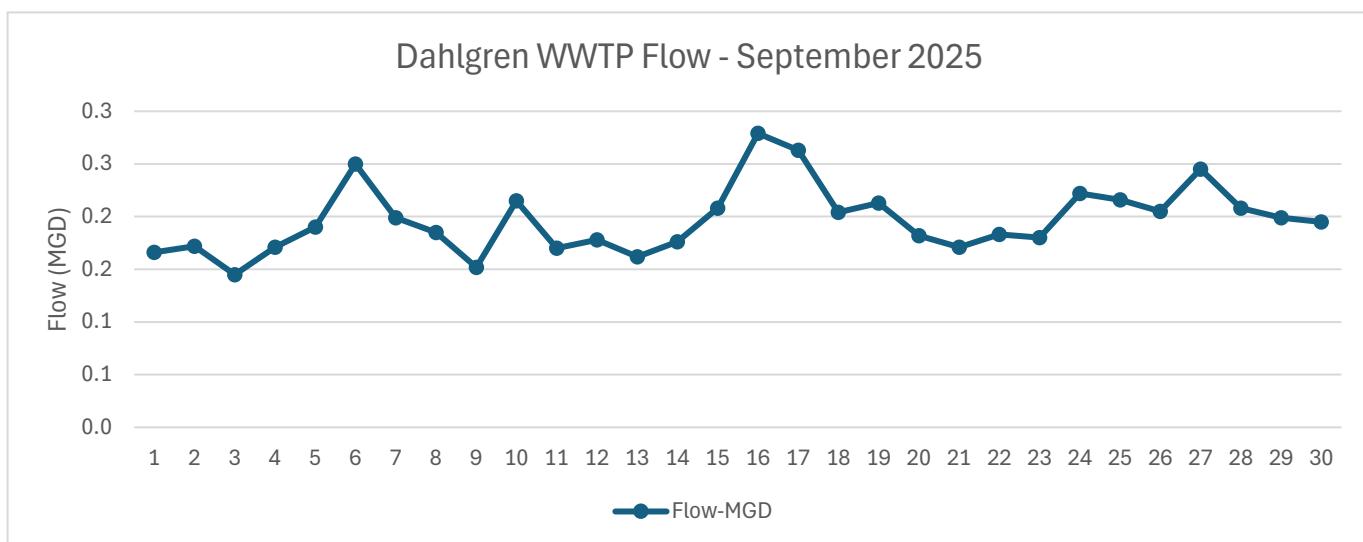
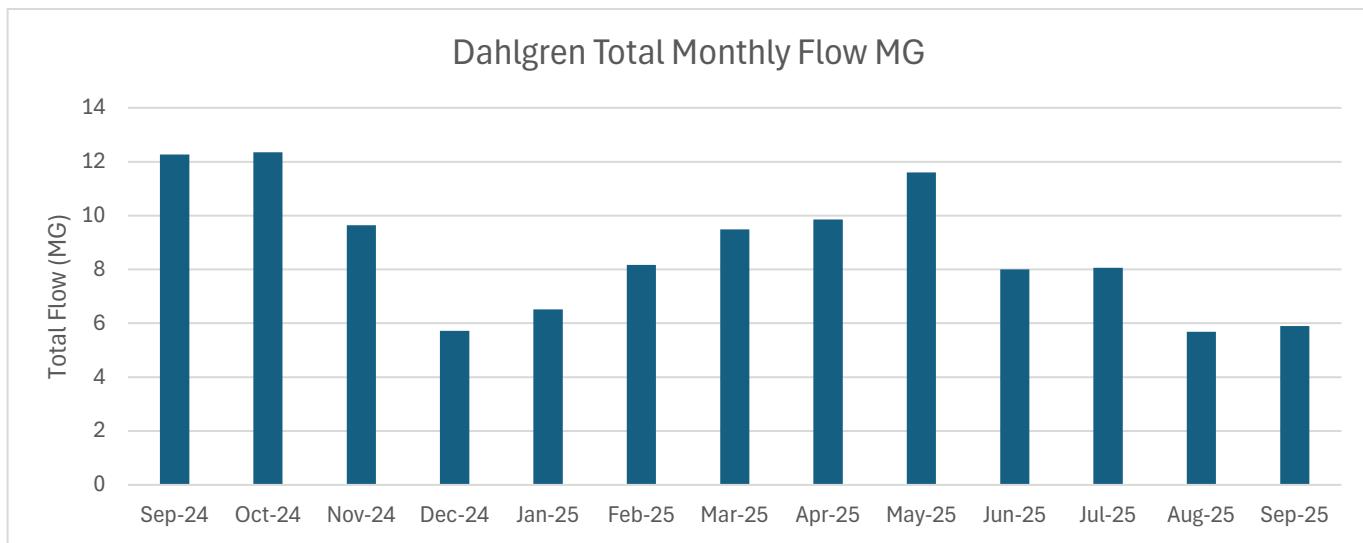
The Dahlgren WWTP met the sewer service area's sanitation demand with an average daily discharge of 0.197 MGD for a total monthly discharge of 5.904 MG.

The following charts depict a graphical analysis of effluent quality monitoring and treatment plant daily and total monthly flows.

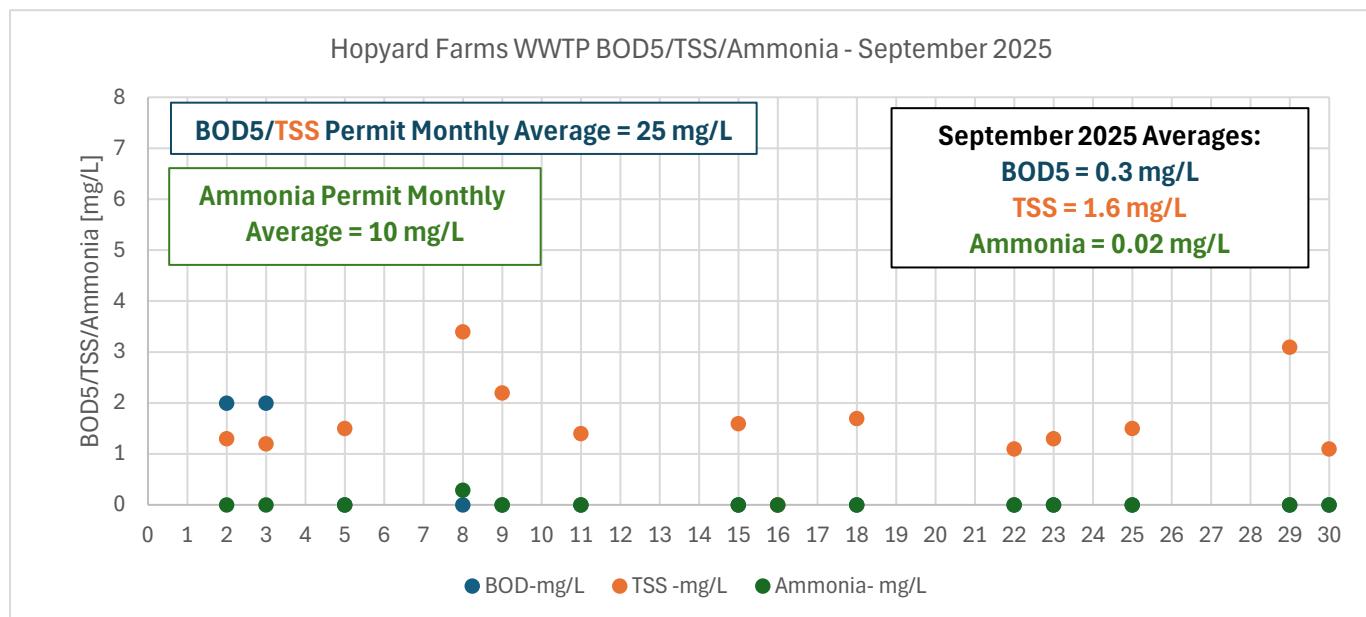
The Hopyard Farms WWTP met the sewer service area's sanitation demand with an average daily discharge of 0.093 MGD for a total monthly discharge of 2.412 MG (26 days with flow).

The following charts depict a graphical analysis of effluent quality monitoring and treatment plant daily and total monthly flows.

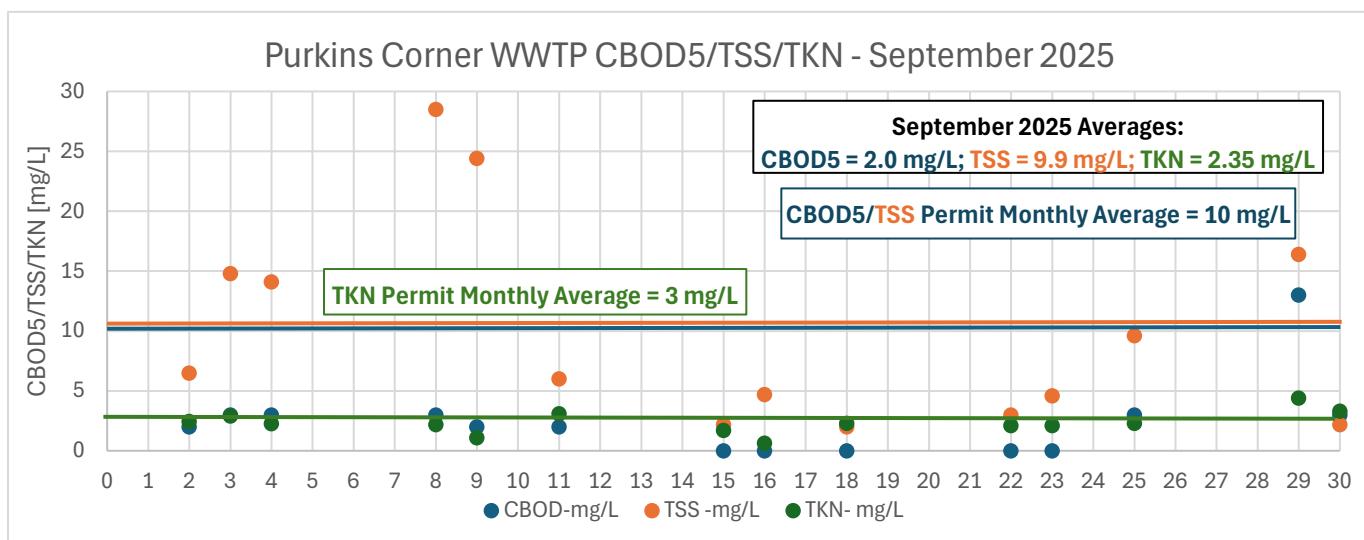
Purkins Corner WWTP Flow - September 2025

The Purkins Corner WWTP met the sewer service area's sanitation demand with an average daily discharge of 0.063 MGD for a total monthly discharge of 1.885 MG.

During this monitoring period, the facility experienced elevated E. coli concentrations, which brought the geometric mean to 229n/CML, exceeding the permit limit of 126n/CML. Additionally, TSS the weekly average for the week of September 7th exceeded the permit limit of 15mg/L, with 19.6mg/L. Upon investigation, it is believed the cause of the elevated E. coli concentrations was the daily cleaning of the effluent channel being conducted immediately prior to sample collection. To prevent future occurrences, the operator has been instructed to avoid cleaning the effluent trough immediately prior to sample collection. This measure ensures that sampling reflects true effluent conditions.
