# UTILITY REPORT

**King George County  
Service Authority**

**Authored by:**  
**Inboden Environmental  
Services, Inc.**

# INTRODUCTION

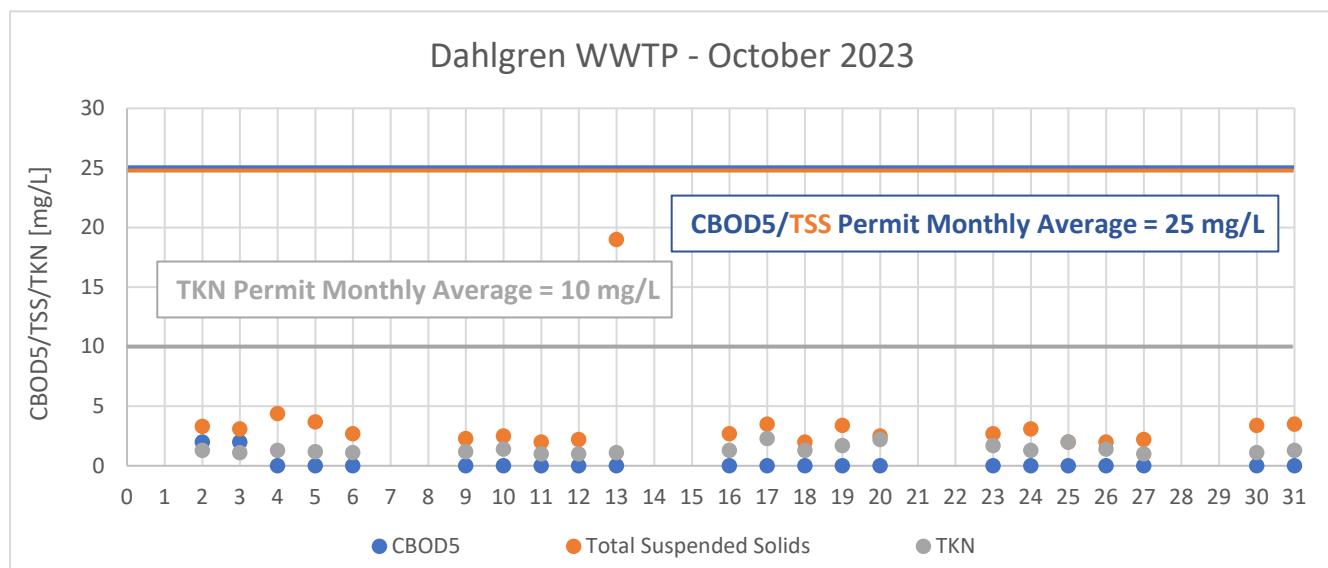
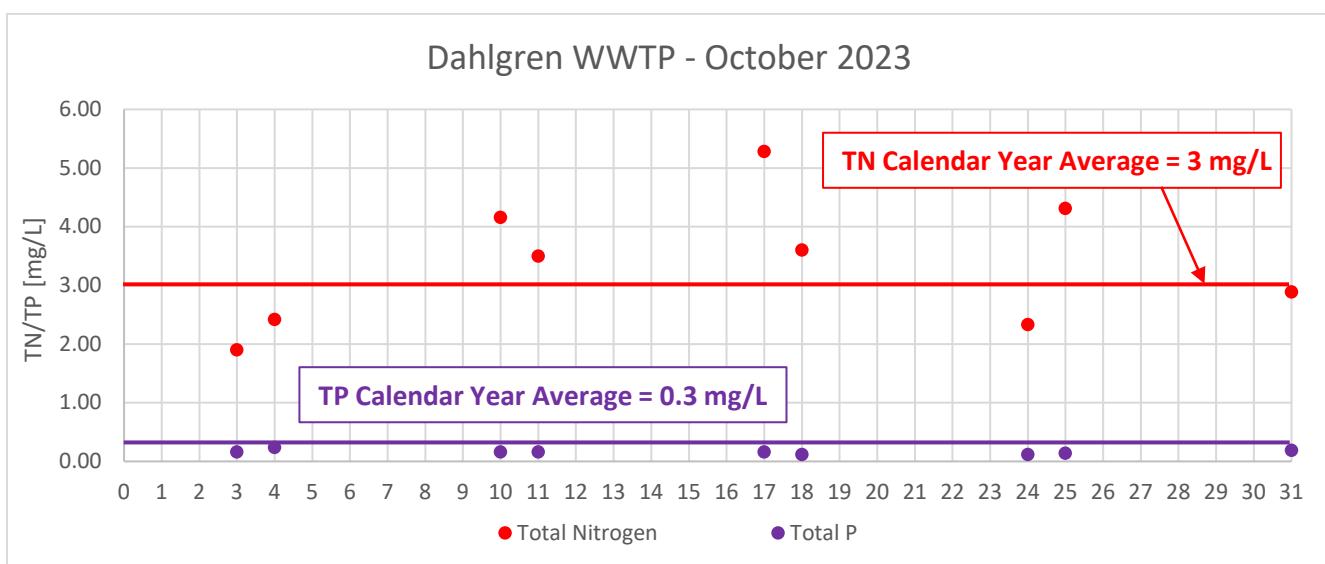
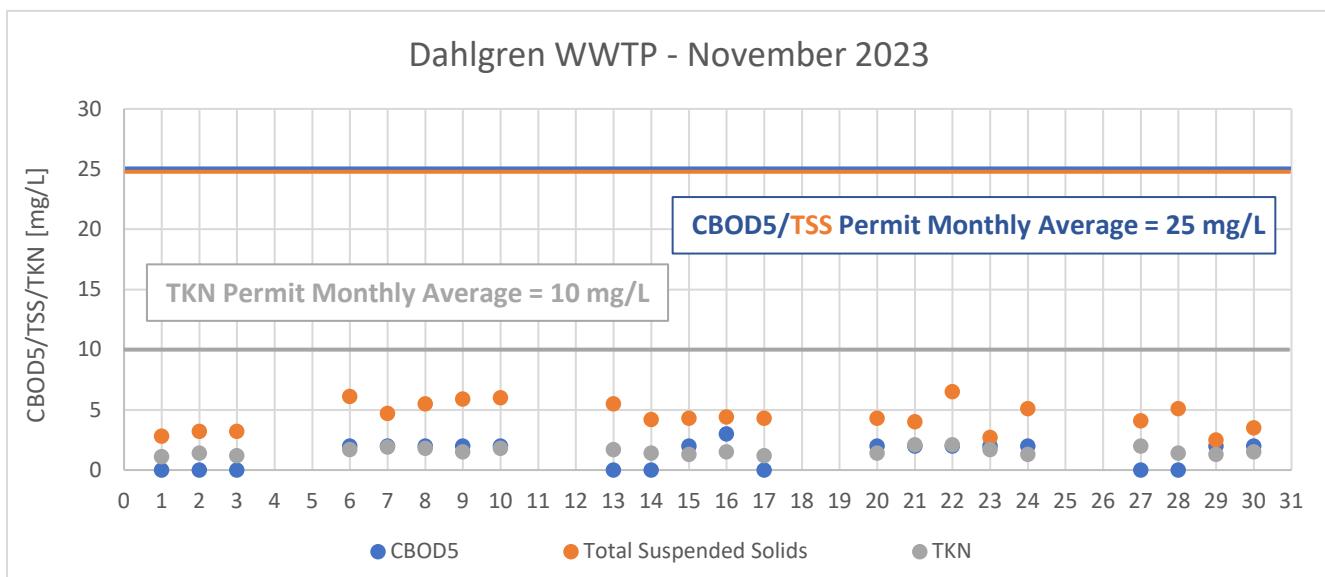
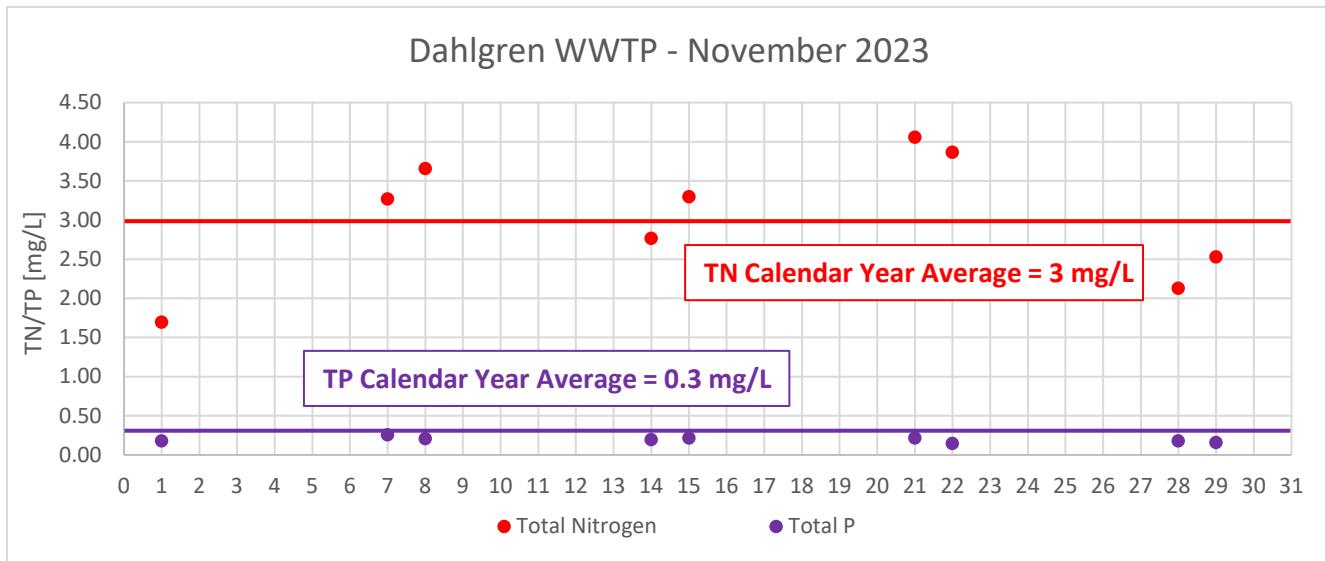
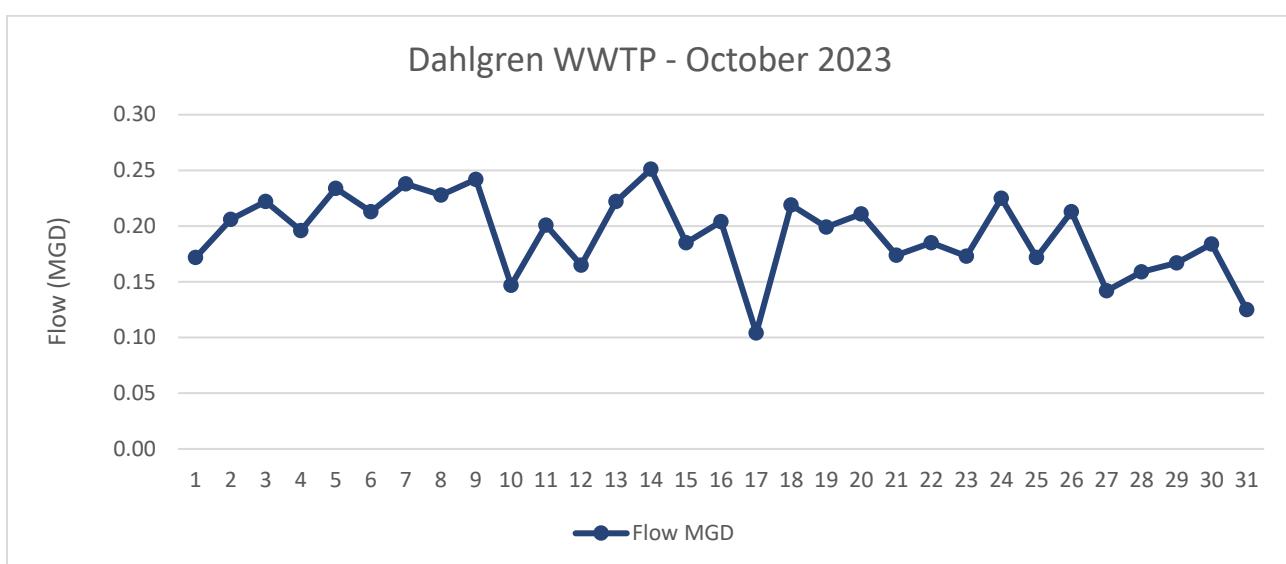
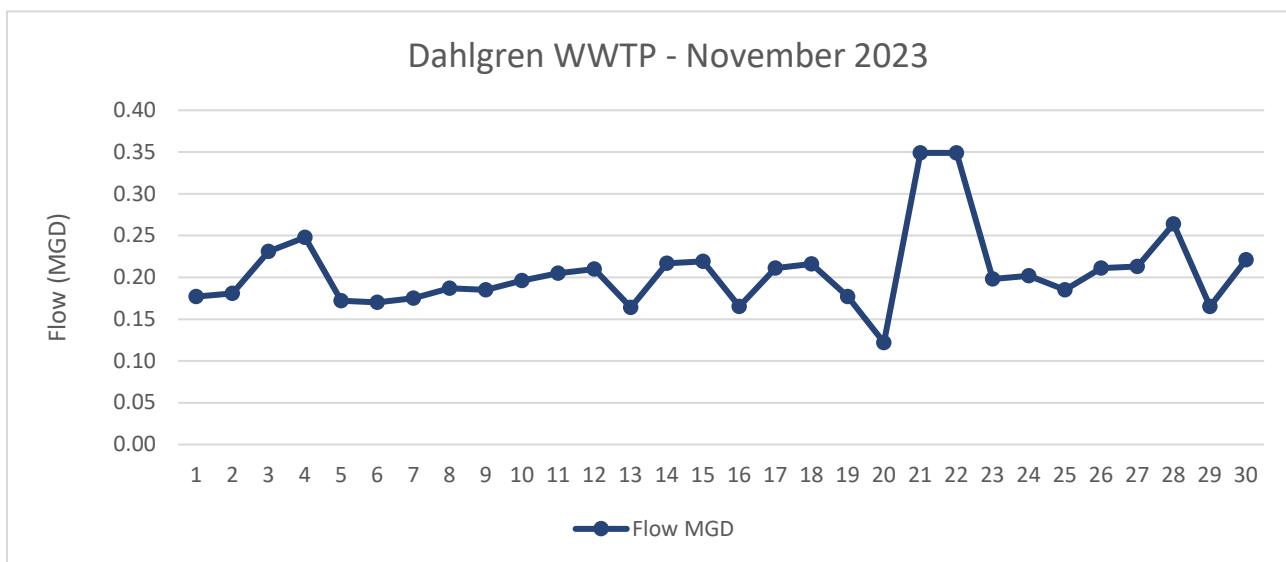
## Data Trending:

The following charts depict a graphical analysis of effluent quality monitoring and treatment plant daily and total monthly flows.

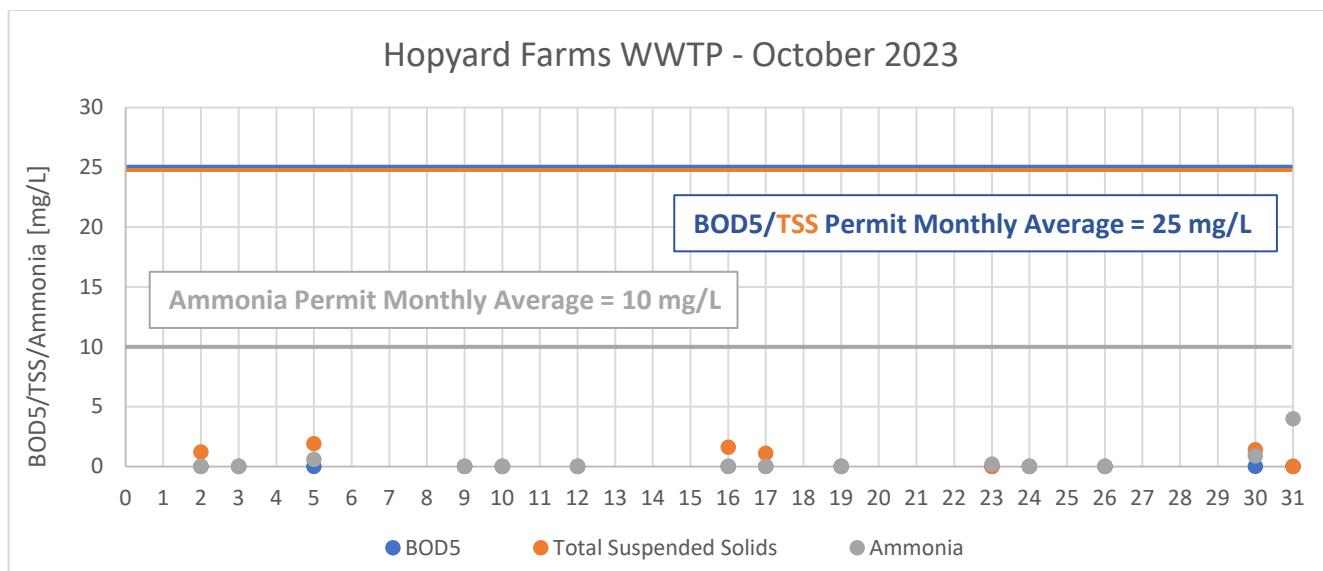
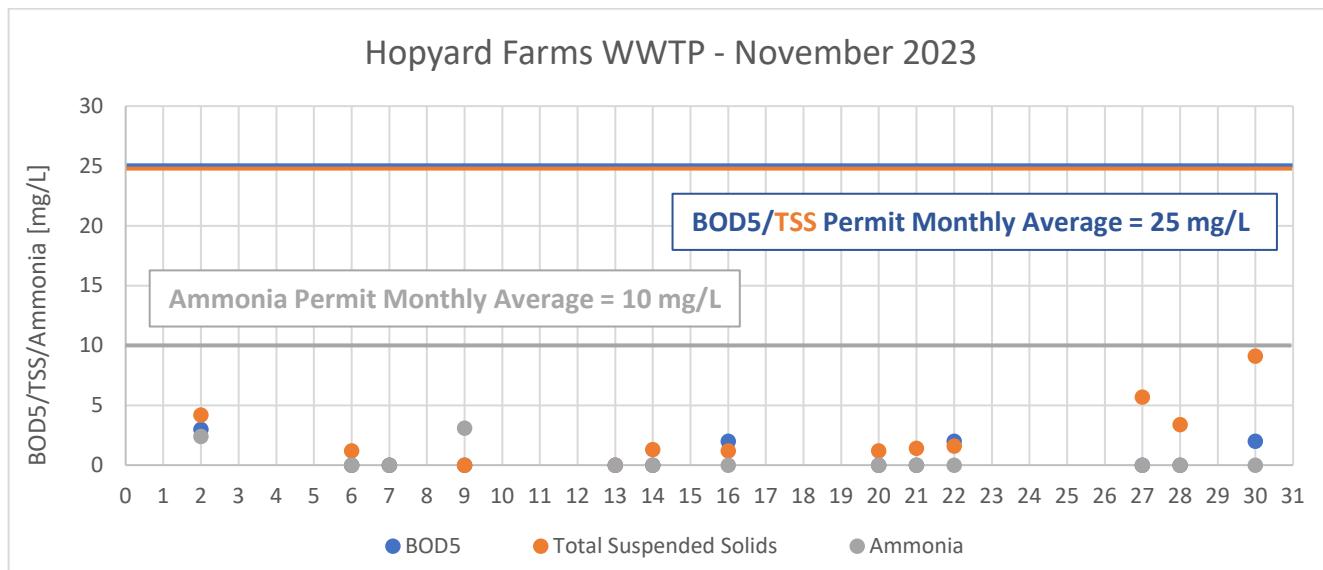
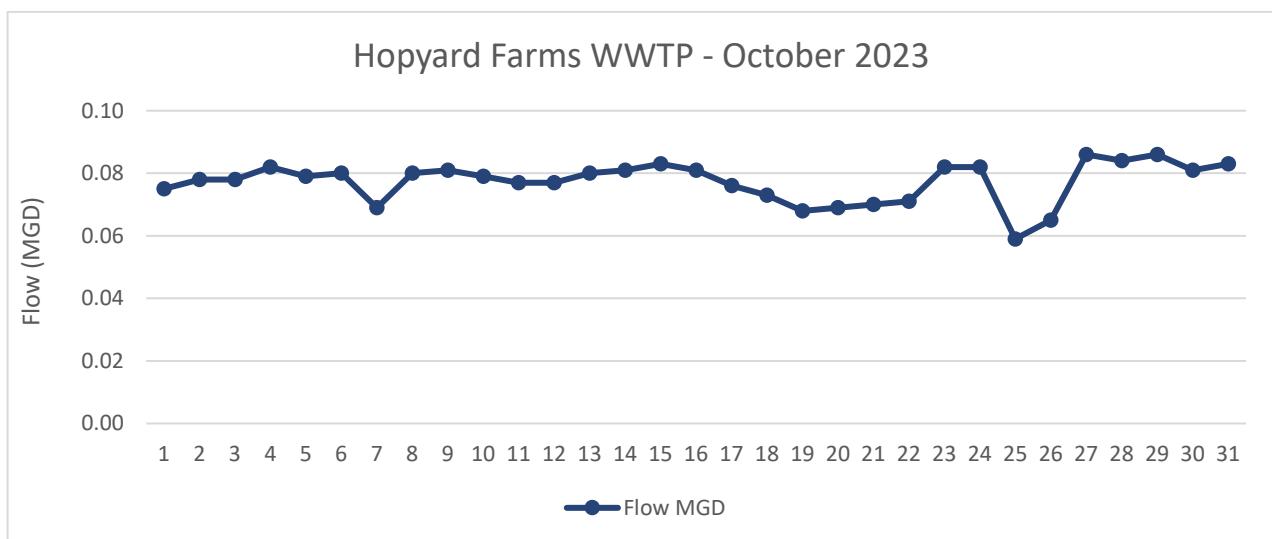
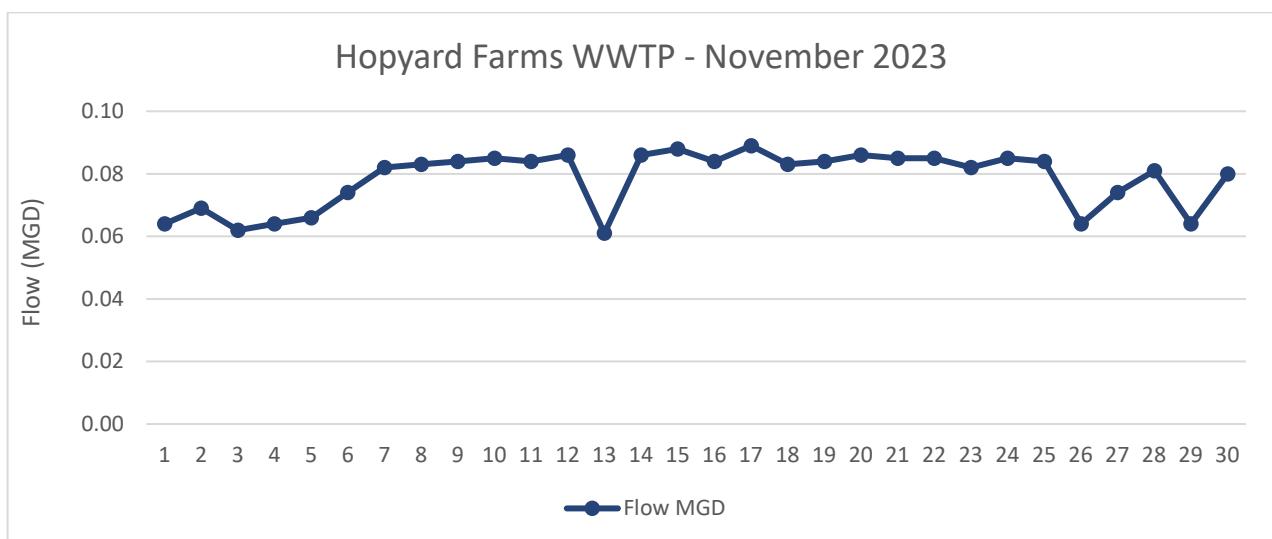
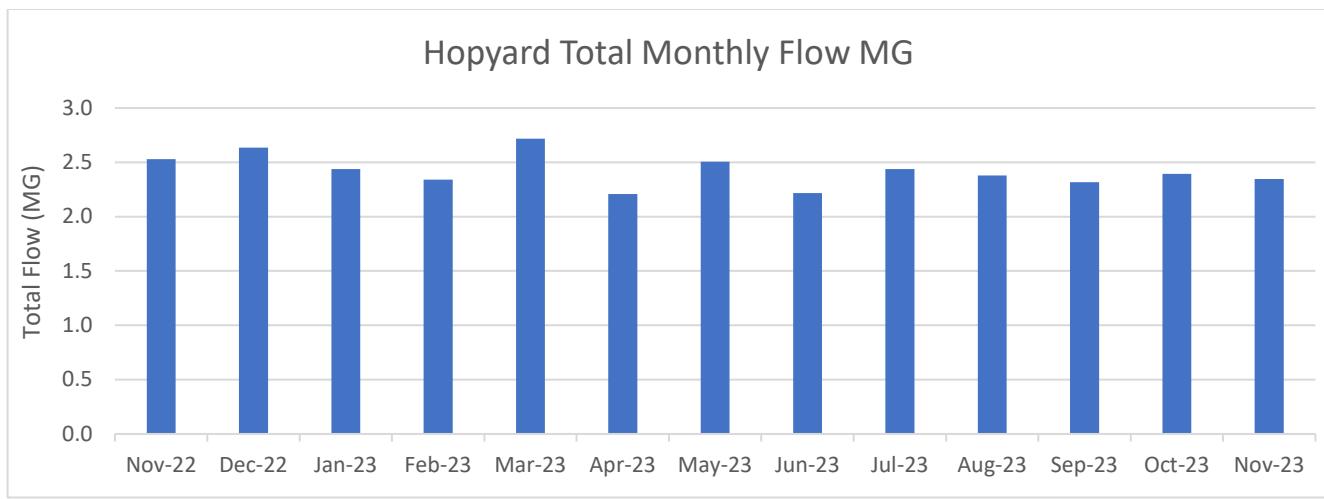
## Data Trending:

The following charts depict a graphical analysis of effluent quality monitoring and treatment plant daily and total monthly flows.

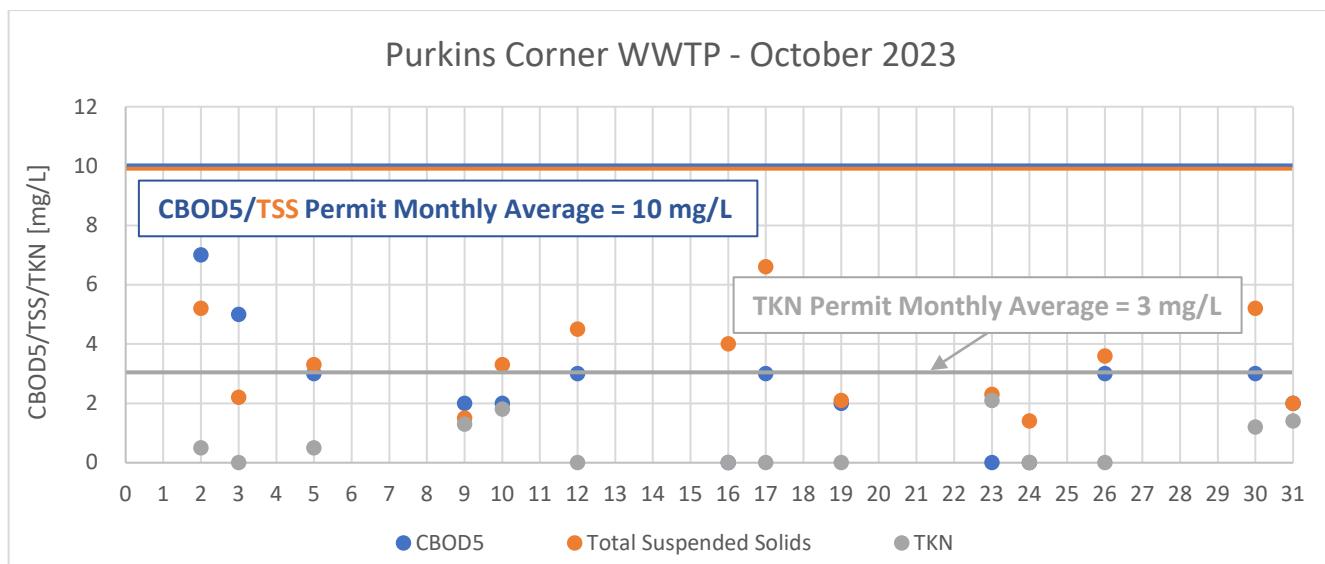
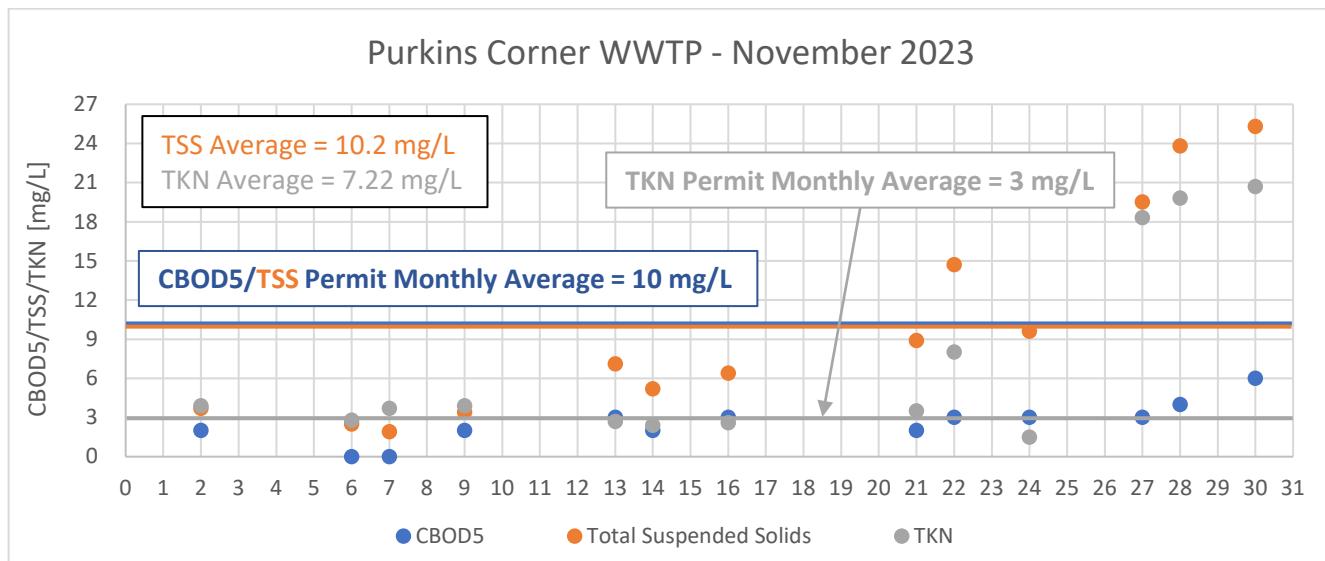
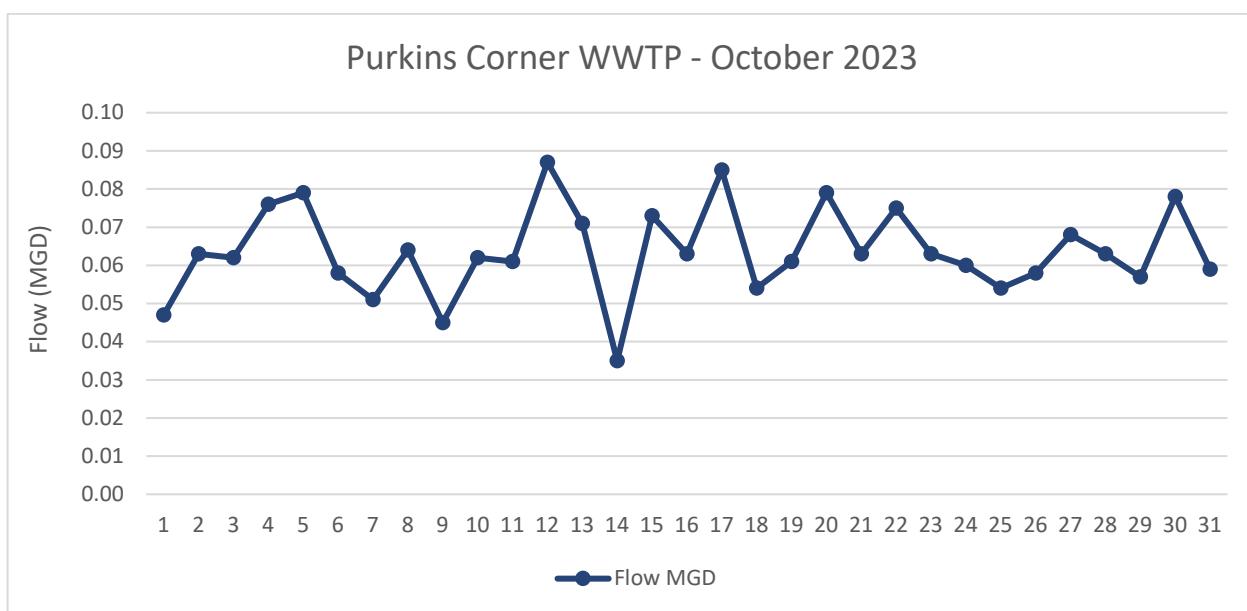
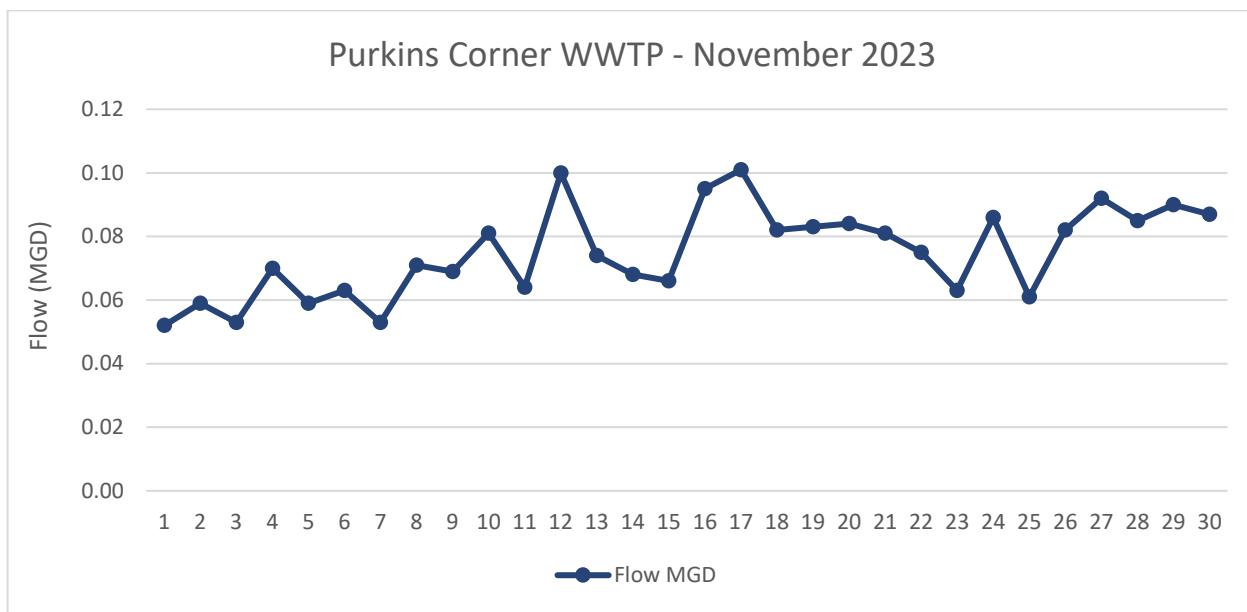
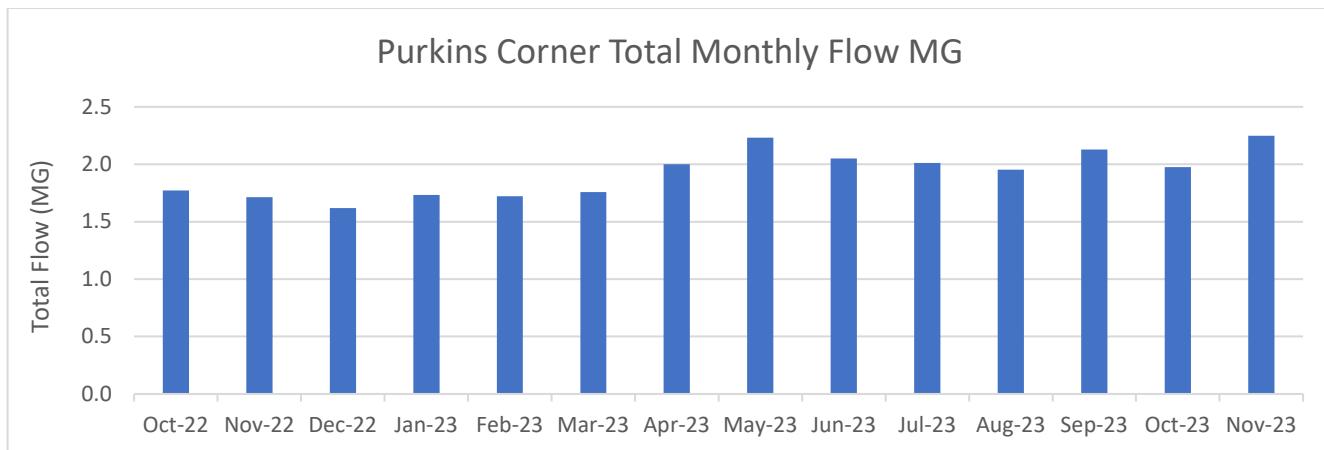
## Data Trending:

The following charts depict a graphical analysis of effluent quality monitoring and treatment plant daily and total monthly flows.

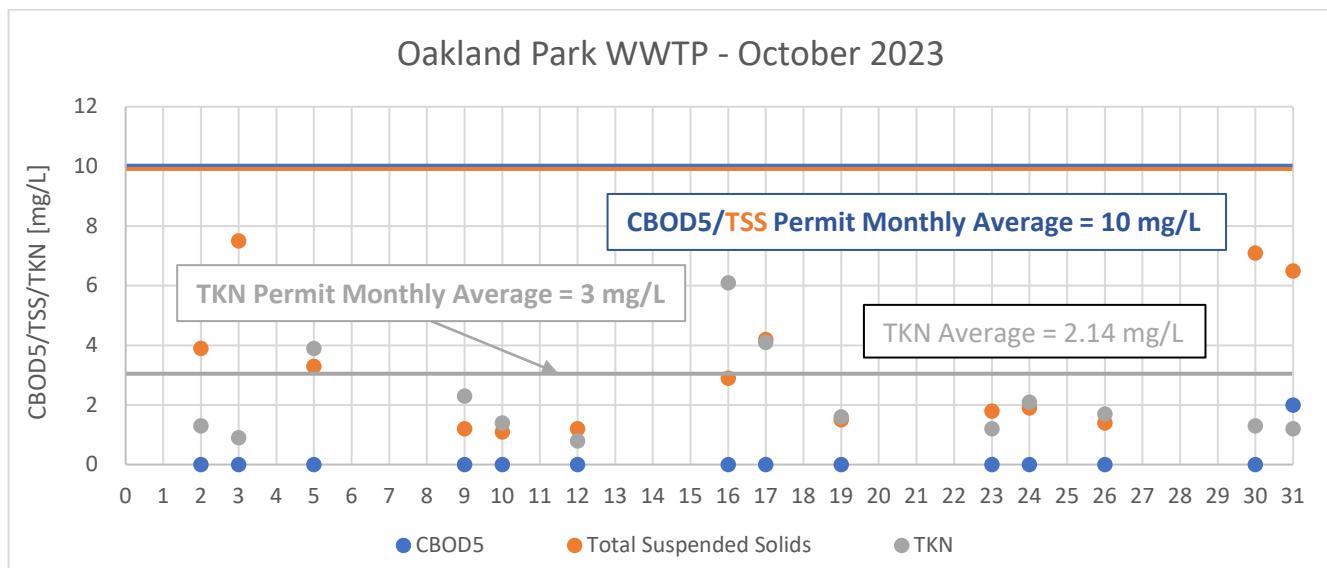
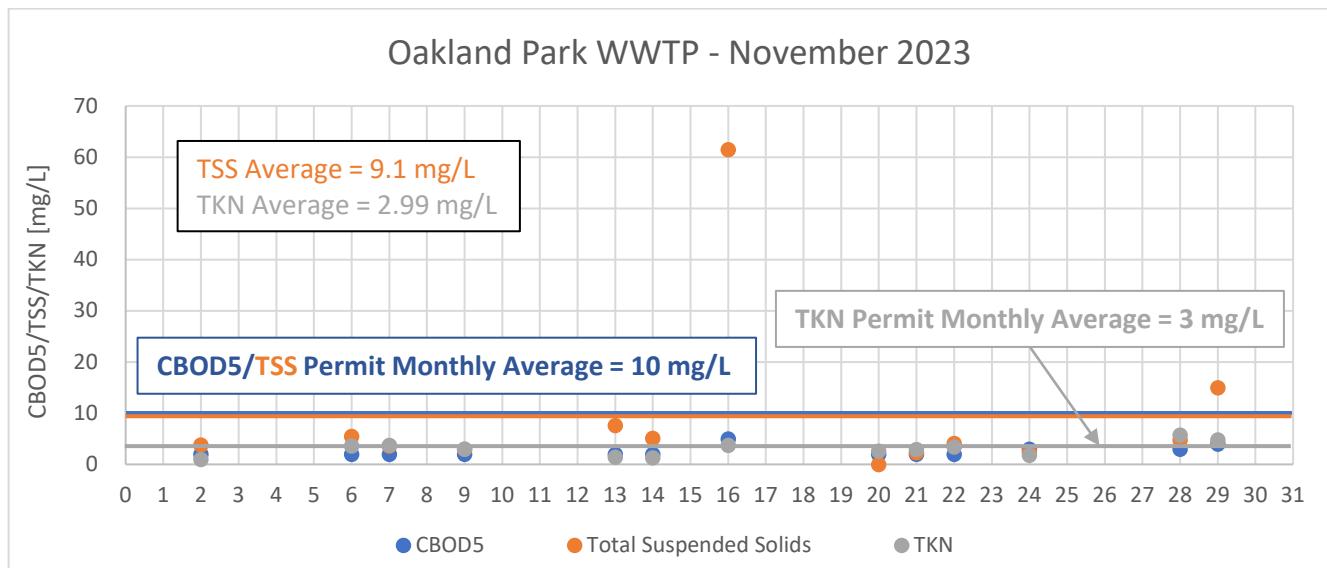
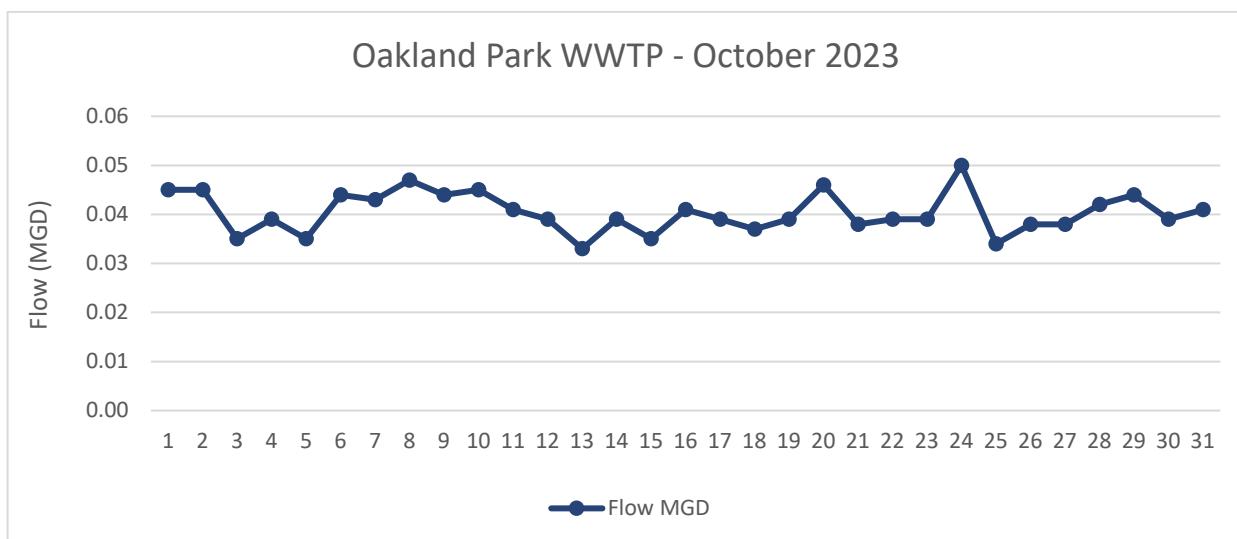
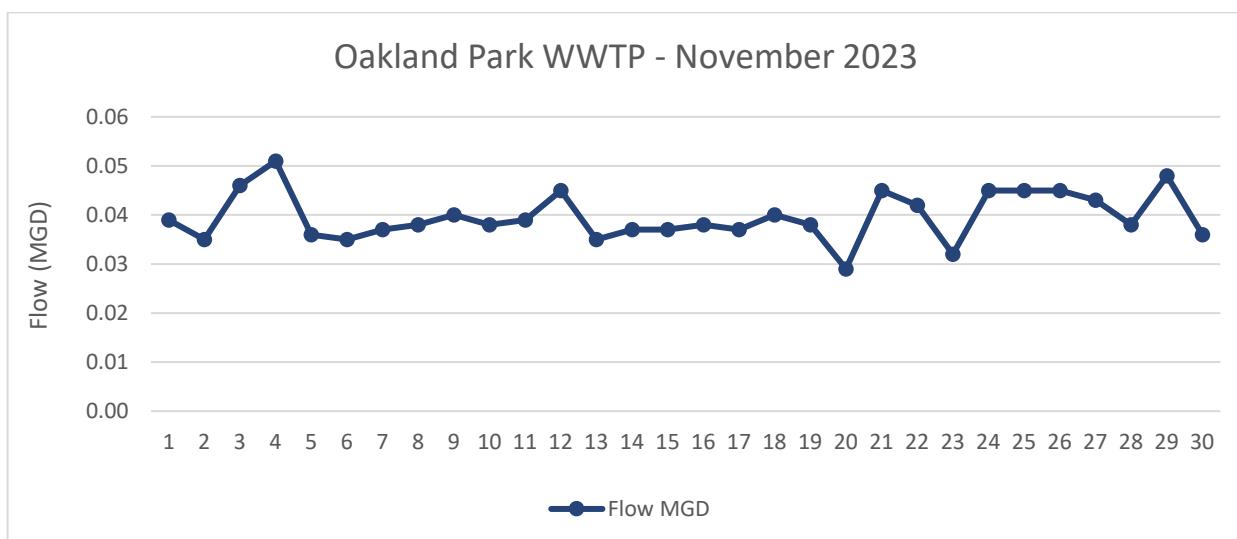
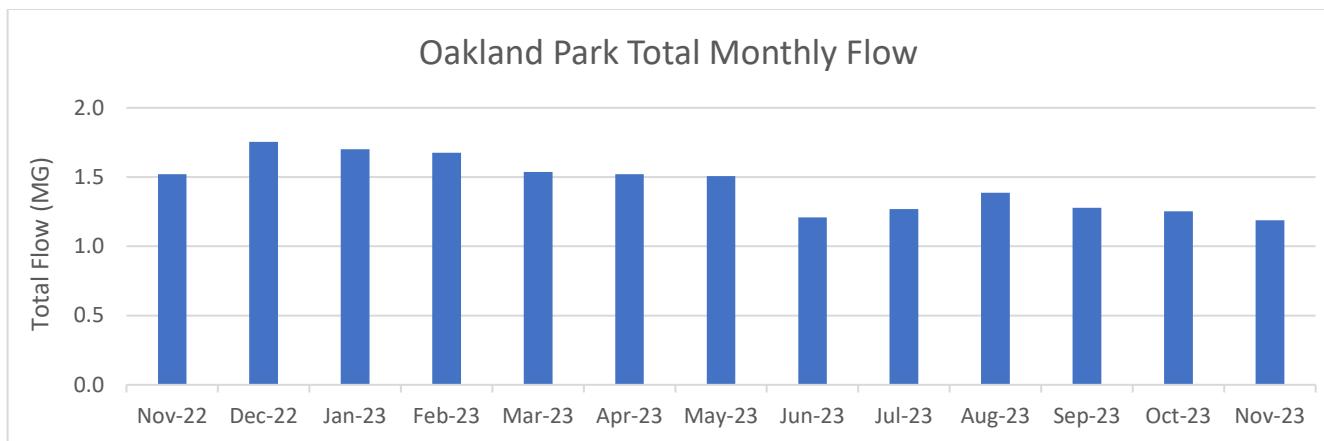
## Data Trending:

The following charts depict a graphical analysis of effluent quality monitoring and treatment plant daily and total monthly flows.

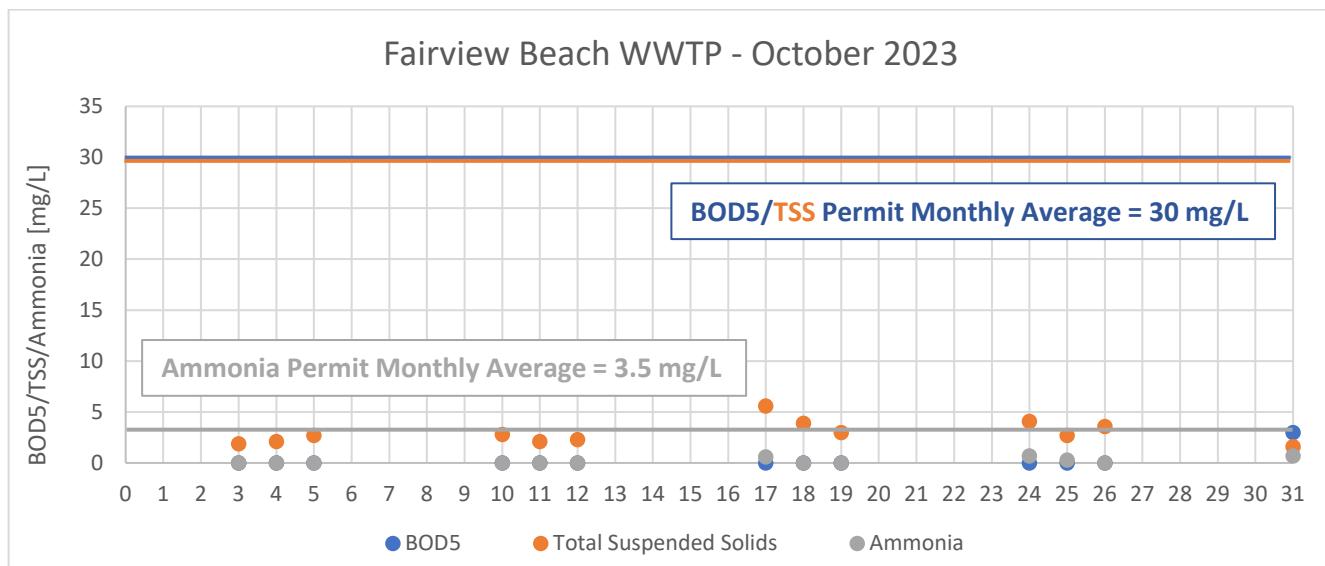
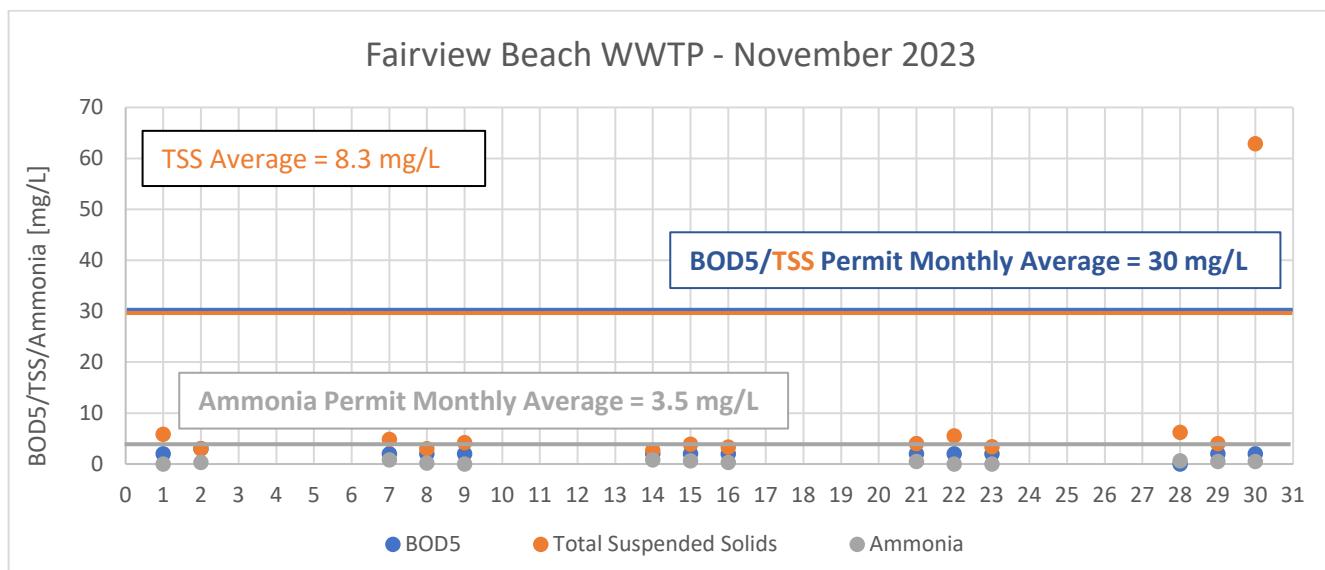
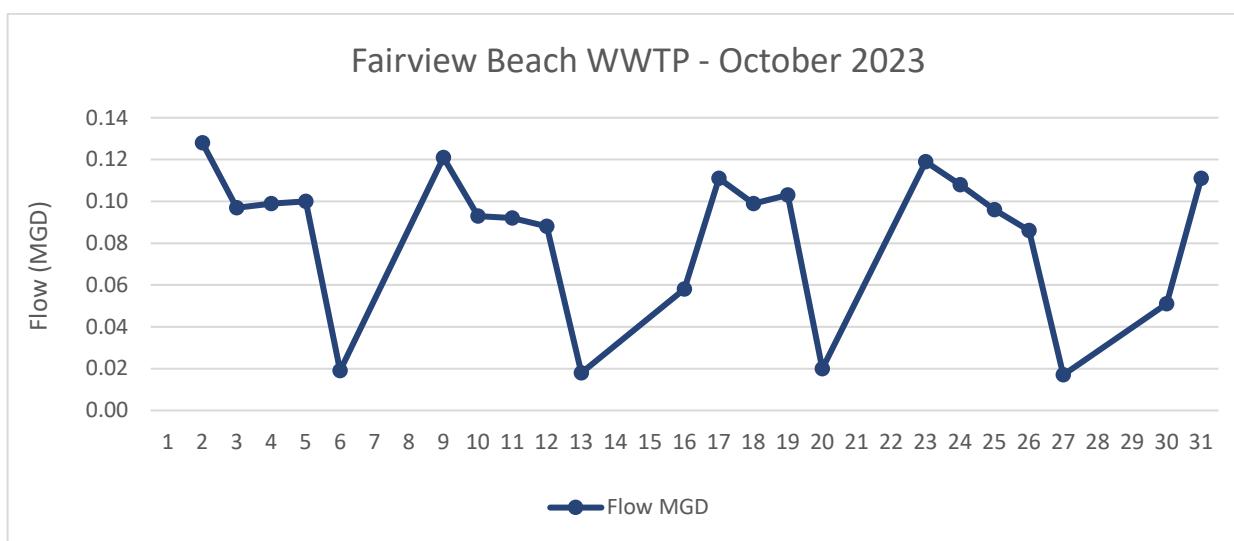
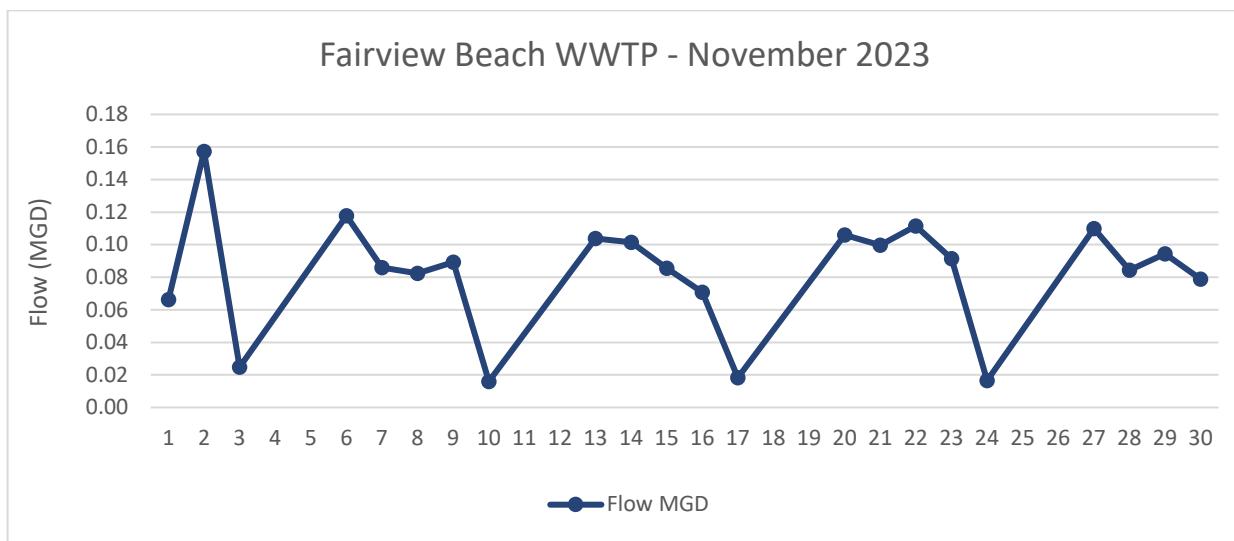
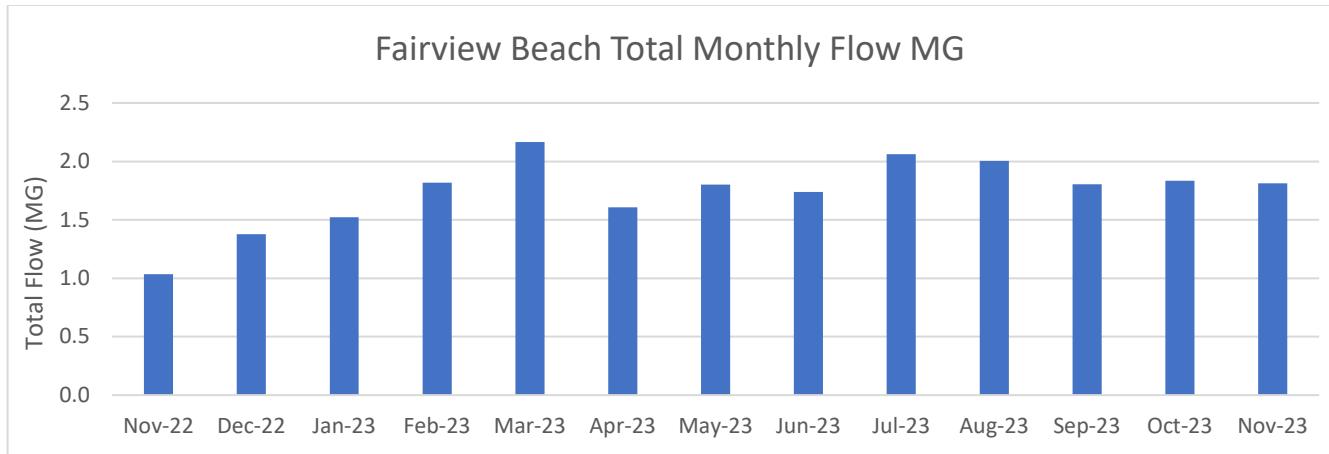
## Data Trending:

The following charts depict a graphical analysis of effluent quality monitoring and treatment plant daily and total monthly flows.
